## **Volunteer Captain Dies After Floor Collapse Traps Him in Basement – New York**

### **Executive Summary**

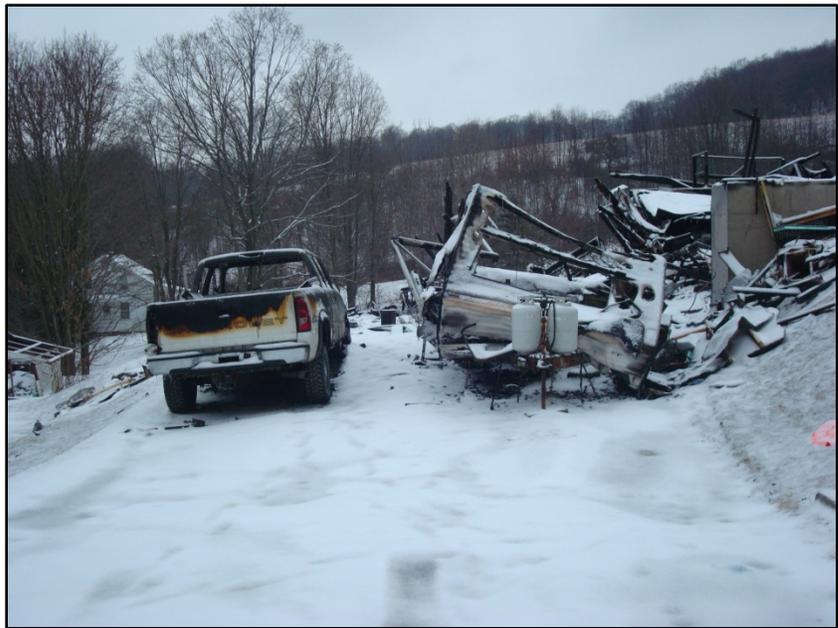
**Shed fire location in front of camper and truck which spread to house.**  
*(NIOSH Photo)*

According to the state fire marshal's office, the fire originated in a shed approximately 15 feet away from the B/C corner of the house. The fire spread to a camper just in front of the shed and then to the house adjacent to the camper.
