NIOSH
Fire Fighter Fatality Investigation
and Prevention Program

Fire Fighter (Captain) Dies After Fall From Ladder During a Training Exercise - California

Fatality Assessment and Control Evaluation Investigative Report #99F-25

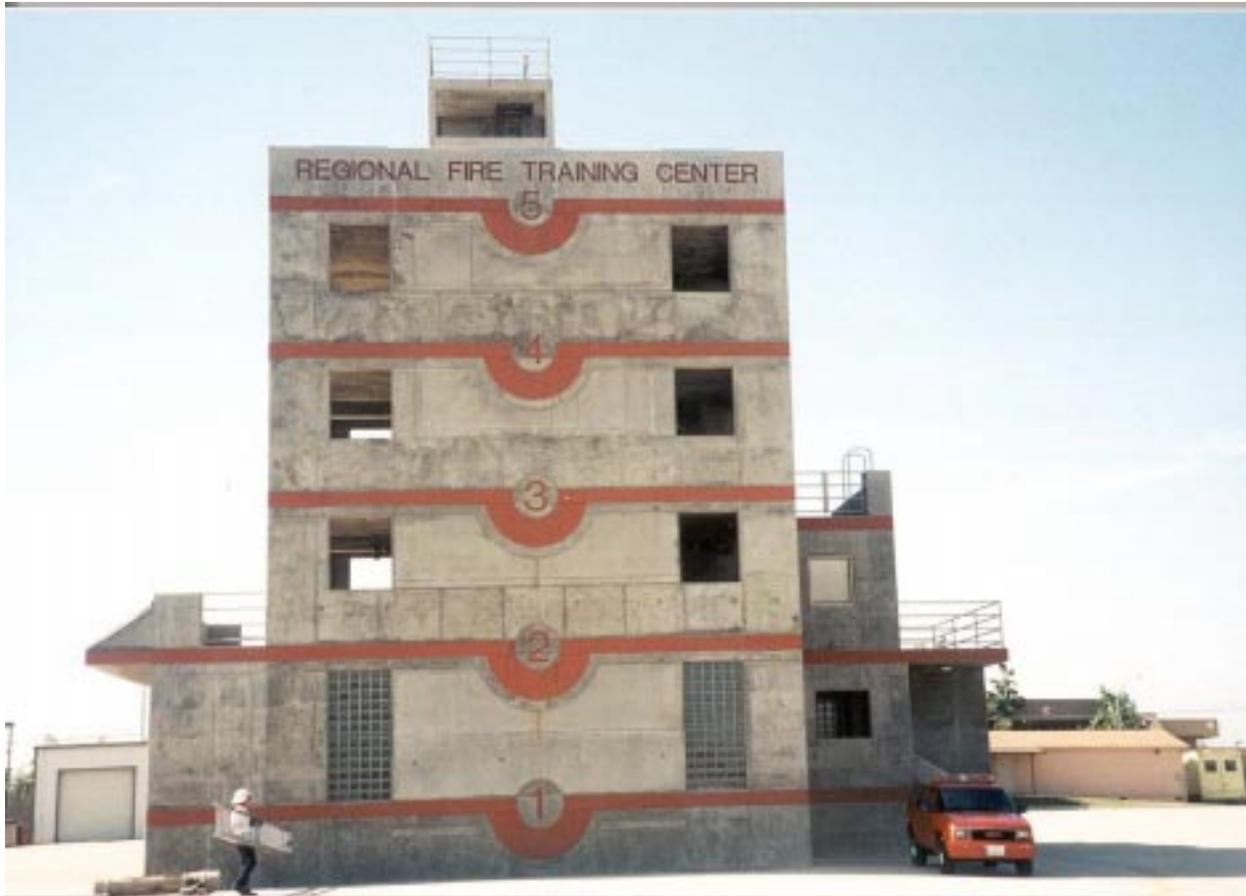
Photo 1. Regional Fire Training Center

On June 16, 1999, fire fighters and emergency medical technicians (EMTs) from five engine companies arrived at the regional fire training center (see Photo 1) to conduct a multi-jurisdictional, multi-company training drill (South County Fire Fighters Annual Training). The drill involving the fire fighters

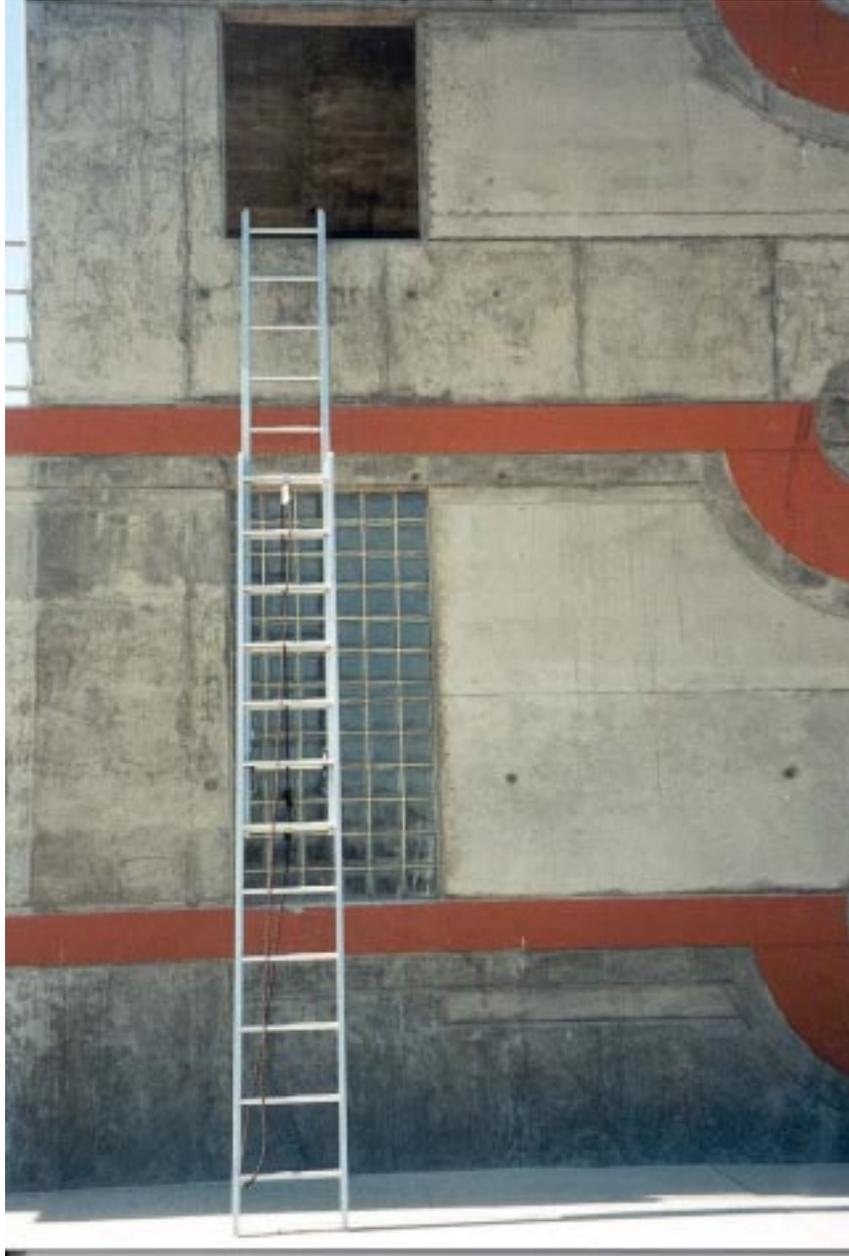
Photo 2. Twenty-four-foot Aluminum Extension Ladder

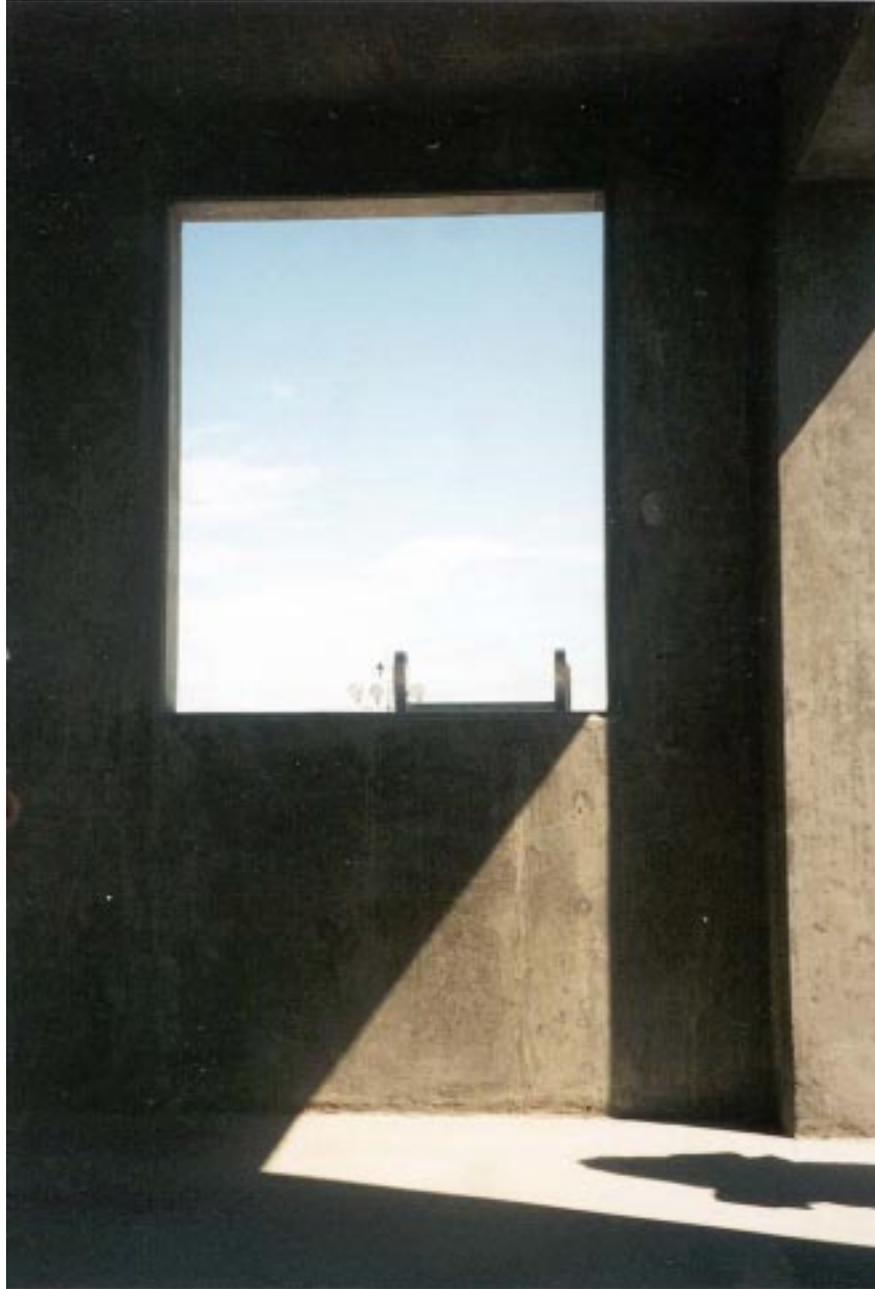
Photo 3. Forty-two-inch Window Sill and Ladder Tip

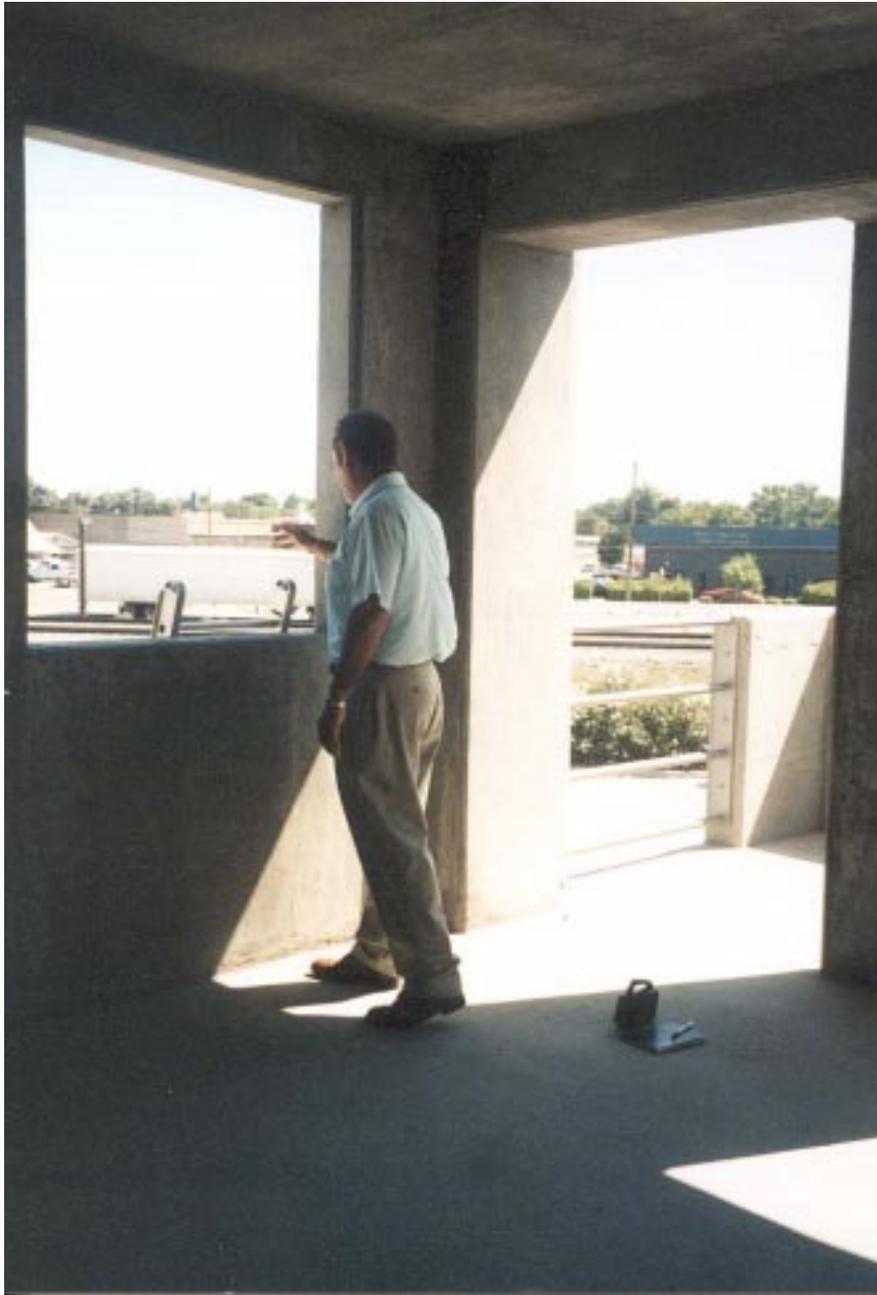
A fire fighter, who arrived at the window first, looked outside and saw that no one was footing the ladder. He moved back from the window and instructions were then heard coming over the radio from the Captain of Division C to have the ladder footed. While the fire fighter who arrived at the window first and the victim waited for someone to arrive to foot the ladder, the fire fighter said, “Hey, this is a time I could use the emergency ladder slide.” The victim responded, “Yeah, let’s do it.” Without further hesitation and to the surprise of the fire fighter (who later stated he had been joking about doing the ladder slide), the victim stepped toward the top of the ladder, which was about 9 inches above the 42-inch window sill (see Photo 3) and leaped over the top of the ladder, head-first (see Photo 4). Without being able to adequately hook a ladder rung or grasp a ladder side rail, the victim fell headfirst down the side of the ladder to the concrete landing. The fire fighters and medics at ground level who witnessed the fall ran to aid the victim. The first fire fighter who arrived at the victim rolled him over to see the extent of his injuries. The victim was unconscious, bleeding from the mouth and nose, but had a pulse. The victim’s airway was cleared, and he was immobilized with a cervical collar and given oxygen. The victim was then loaded into an ambulance and transported to the local hospital where he was pronounced dead about 40 minutes after the incident had occurred.

Photo 4. Position of Victim Prior to Incident
