Evaluation of Cancer, Indoor Environmental Quality, and Potential Chemical Hazards at a Police Department

Health Hazard Evaluation Report HETA 2008-0237-3097 Cincinnati Police Department Criminal Investigation Section Cincinnati, Ohio December 2009

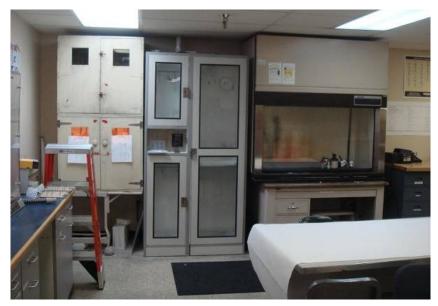
The crime lab (Figure 1) was on the fifth floor in the CIS. The crime lab was approximately 225 ft² and contained a fume hood for working with chemicals, a downdraft table for working with fingerprint powders, and two super glue fuming chambers. The large super glue fuming chamber vented to the outdoors, while the small fuming chamber had an organic vapor filtration system that vented to the indoors. The crime lab also contained an overhead exhaust hood for other work involving chemicals or dusts and a ninhydrin development cabinet that was not exhausted.

Figure 1. Ninhydrin development cabinet (left), large super glue fuming chamber (middle), and chemical fume hood (right) inside the crime lab.

- 6. Begin to replace super glue fuming chambers with ones that have the following safety features: (1) glass window enclosures with locking mechanisms that cannot be opened during use until the chambers are fully evacuated, (2) exhaust systems that vent to the outdoors and/or contain organic vapor filtration systems, (3) laboratory determined filter change out schedule based on number of cycles or end of service life indicator, and (4) counters that display the number of cycles run since last filter change out.

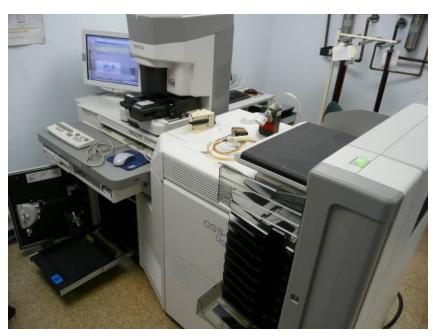
A darkroom and photo processing lab (Figure 2) were adjacent to the crime lab. The darkroom, currently used for storage, contained an overhead exhaust hood. This hood used the same ventilation ductwork as the overhead exhaust hood in the crime lab. The photo processing lab did not contain a dedicated exhaust system but did contain an HVAC supply and return duct.

Figure 2. Photo printer inside the photo processing lab.

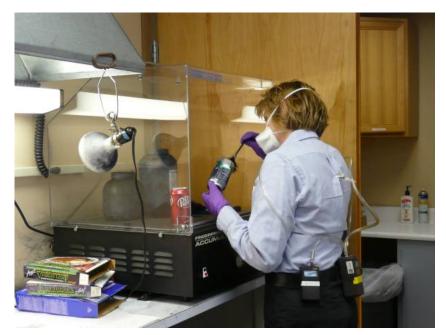
Figure 3. Application of black fingerprint powder to criminal evidence inside the enclosed downdraft table.

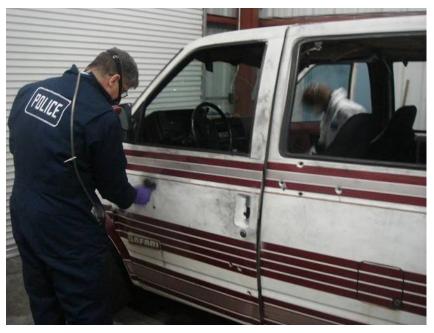
Figure 4. Application of black fingerprint powder to an automobile inside the District 1 garage.

- 3. Monitor uncontrolled carbon black exposures at a crime scene to determine whether respiratory protection is needed. Our data indicate that respirators are not required under the OSHA Respiratory Protection Standard [29 CFR 1910.134] because the exposures we measured in the crime lab were below applicable OELs. When they are working and used properly, engineering controls such as super glue fuming chambers and chemical fume hoods should adequately control irritating chemical odors. However, we recommend additional monitoring of carbon black exposures during the application of fingerprint powders at a crime scene (where engineering controls are not available). If these monitoring results are consistently below the OELs for carbon black, then this is a further indication that respirators are not required during this activity.

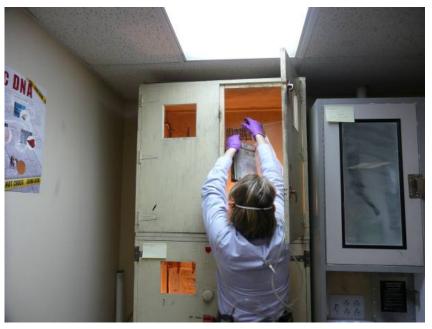
Figure 5. Transfer of criminal evidence previously sprayed with ninhydrin solution under the chemical fume hood to the ninhydrin development cabinet.

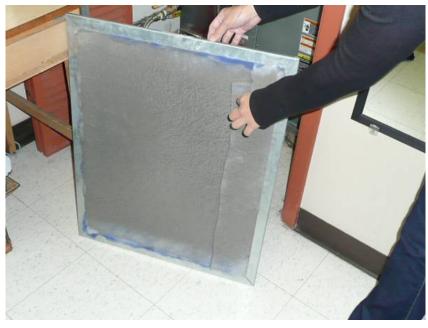
Most of the filters in the AHUs of the HVAC systems on the fourth and fifth floors were dirty and needed immediate replacement. Several filters were pieced together using roll-type low-efficiency prefilter material (Figure 7), rather than properly sized and framed higher efficiency filters. The downdraft table in the crime lab had a prefilter and high-efficiency filter. Visual assessment revealed that most of the fingerprint powder was collected by the prefilter. The high-efficiency filter had not been changed in 9 years and showed visible evidence of breakthrough (fingerprint powder on the back of the filter). The small super glue fuming chamber contained an organic vapor filtration system consisting of a prefilter and activated-carbon filter. Neither filter had been changed in several months. We could smell ethyl cyanoacrylate vapors coming through the filtration system during the super glue fuming operation, suggesting either that the activated carbon filter had become saturated with ethyl cyanoacrylate vapors or that there was leakage around the filter.

Figure 7. Dirty air filter removed from the HVAC system made of pieces of roll-type low-efficiency prefilter material.

Several air filters examined in the HVAC systems, as well as the LEV systems in the crime lab, were dirty and needed immediate replacement (see Figure 7). Dirty filters increase the back-pressure on the ventilation system and potentially decrease the amount of air delivered to the occupied spaces (for HVAC systems) or decrease the amount of air that is exhausted (for LEV systems). Similarly, the organic vapor filters like the one used in the small super glue fuming chamber should be changed according to manufacturer's recommendations. Otherwise the activated carbon in the organic vapor filters can become saturated over time and lose the ability to collect organic vapors. This is likely why ethyl cyanoacrylate vapors were detected in the exhaust stream of the small super glue fuming chamber. Finally, we observed air filters in several HVAC systems that consisted of a combination of several loose sections of filter material that did not fit tightly within the filter frame. This could allow unfiltered air to leak around the sides of the filters.

- 2. Replace air filters routinely. Filters used in the HVAC system and prefilters used in the fingerprint powder downdraft table should be replaced at least every 3 months with properly sized filters rated per the manufacturer specifications. According to manufacturer specifications (Payton Scientific, Buffalo, New York), the high efficiency filter in the fingerprint powder downdraft table should be replaced every 4–6 months in a busy laboratory. The pressure gauge can also be used to determine when the filter should be replaced [Fingerprint Powder Accumulator 2005].

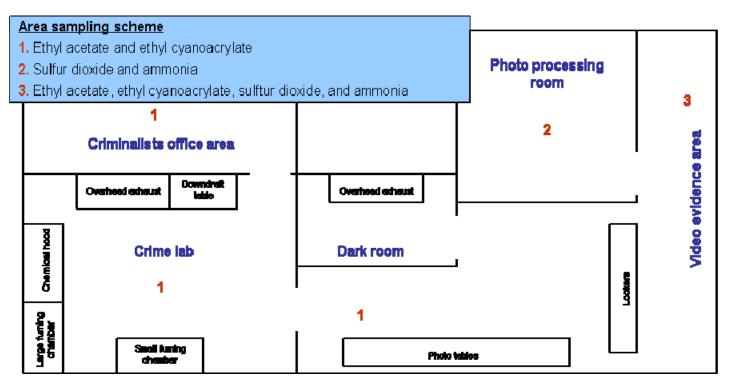
Figure C1. Area sampling locations and chemicals monitored at each location.

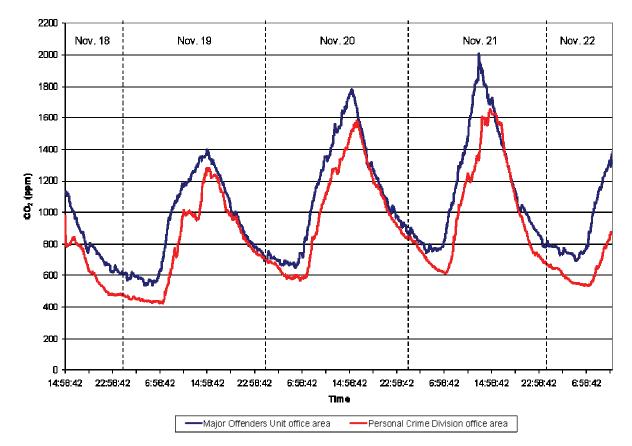
Figure C2. Carbon dioxide levels over time in the occupied office areas of the fourth floor.

- 1. Further evaluate the HVAC systems on the fourth, fifth, and sixth floors to determine the best approach to ensure that an adequate amount of outdoor air is delivered to the occupied workspaces. Refer to ANSI/ASHRAE Standard 62.1-2007 for guidance [ASHRAE 2007a]. We were unable to pinpoint the primary reason for the inadequate amount of outdoor air supply because the HVAC systems were made up of several AHUs that were controlled by separate thermostats set to different settings (auto, on, off). Ideally, outdoor air intakes should be ducted to the AHUs rather than emptying to the plenum, each HVAC system should have a single AHU that operates continuously, and thermostats should be set to temperatures within the acceptable range for the humidity level as specified in ANSI/ASHRAE Standard 55-2004 [ASHRAE 2004]. This arrangement would allow greater control of the outdoor air supply, airflow, and thermal comfort levels throughout the different floors of the building.

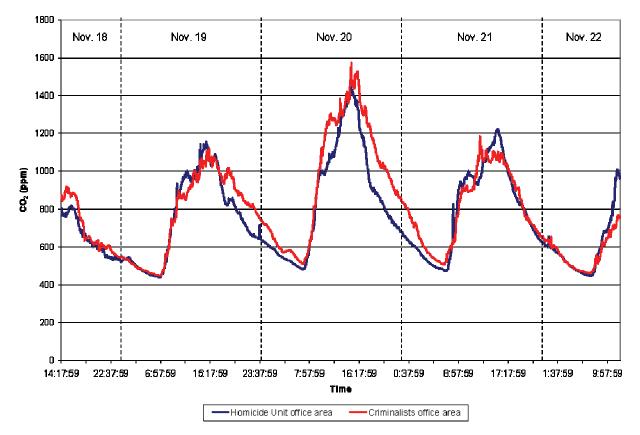
Figure C3. Carbon dioxide levels over time in the occupied office areas of the fifth floor.

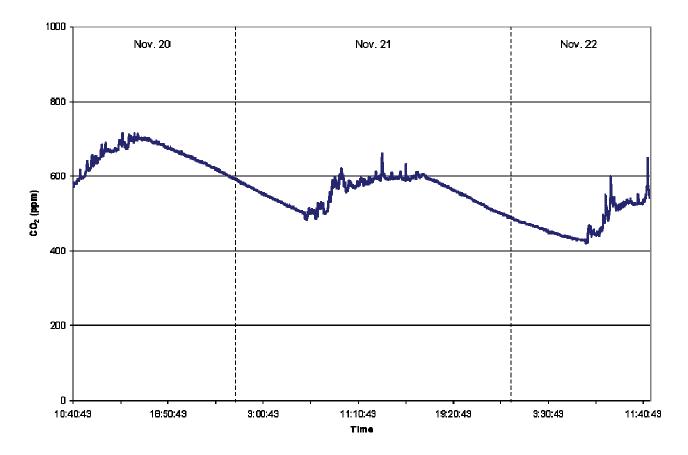
Figure C4. Carbon dioxide levels over time in the evidence room on the sixth floor.
