# Evaluation of indoor environmental quality with limited surface sampling for metals at an office building

Health Hazard  
Evaluation Program

Report No. 2018-0046-3346  
March 2019

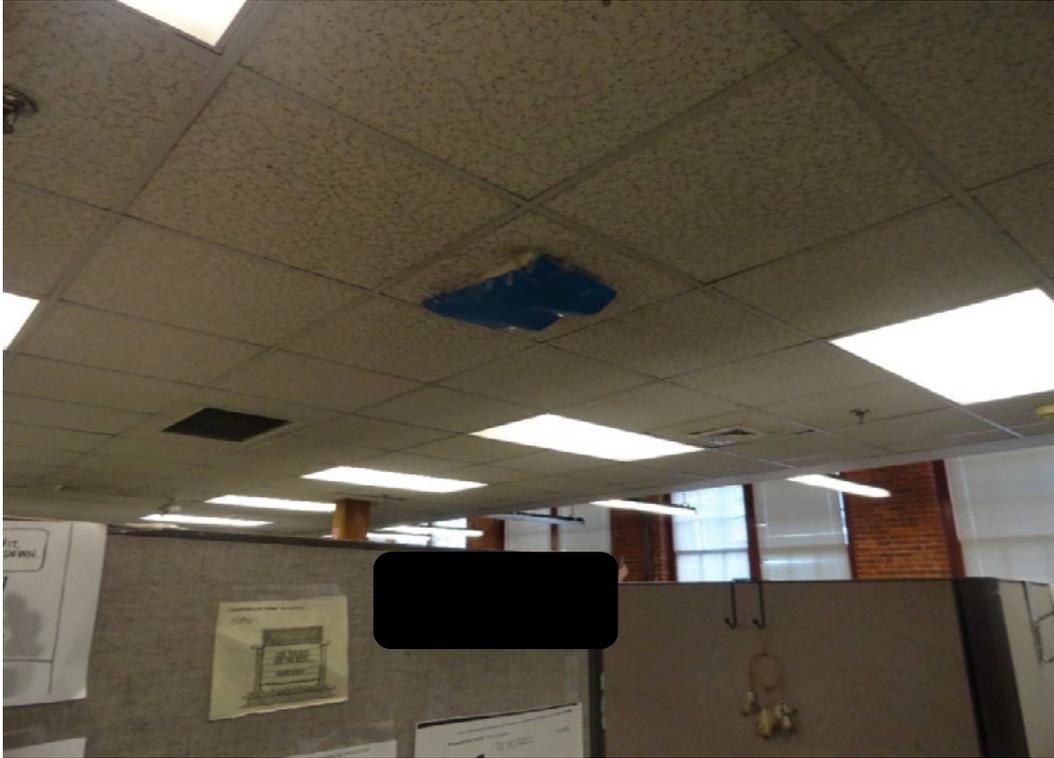
Our walkthrough indicated the HVAC was improperly functioning based on blocked vents and the presence of the black particulates at most seams and vents throughout the building. Retrofitting the industrial building to an office building and having irregular occupancy density likely contributes substantially to the unbalanced HVAC system. Poor ventilation in buildings is a common problem and is frequently caused by lack of proper attention to the building’s HVAC system. HVAC systems include all of the equipment used to ventilate, heat, and cool the building; to move the air around the building (ductwork); and to filter and clean the air. These systems can have a significant impact on how pollutants are distributed in and removed from spaces. They can even act as sources of pollutants in some cases, such as when ventilation air filters become contaminated with dirt and/or moisture, when microbial growth results from stagnant water in drain pans, or from uncontrolled moisture inside of air ducts.

Figure B1. Vent blocked in personal workspace at office building on June 1, 2018. Photo by NIOSH.

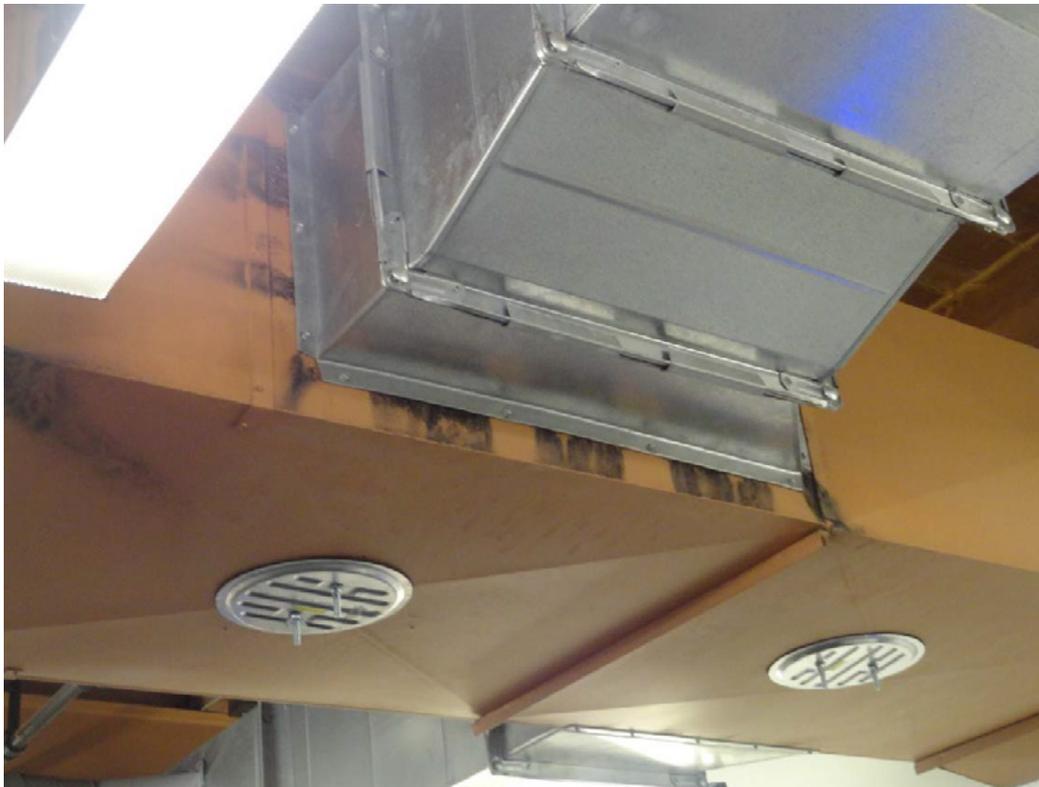
Figure B2. Example of black dust from heating, ventilation, and air-conditioning system at office building on June 1, 2018. Photo by NIOSH.

3. Follow the manufacturer's recommended maintenance schedules for the HVAC system, including replacing air filters, checking drip pans, ensuring thermostats are in working order, and checking and cleaning ventilation system dampers to ensure proper functioning.

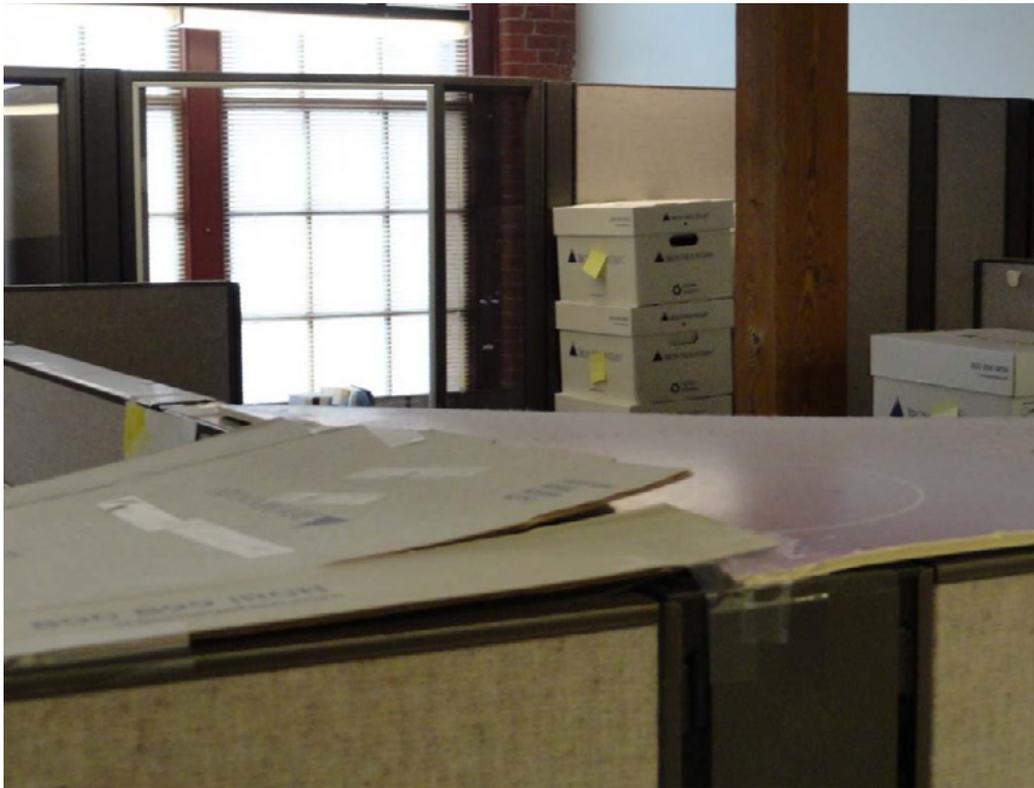
Figure B3. Personal workspaces partially covered with poster board to block dust from heating, ventilation, and air-conditioning system at an office building on June 1, 2018. Photo by NIOSH.

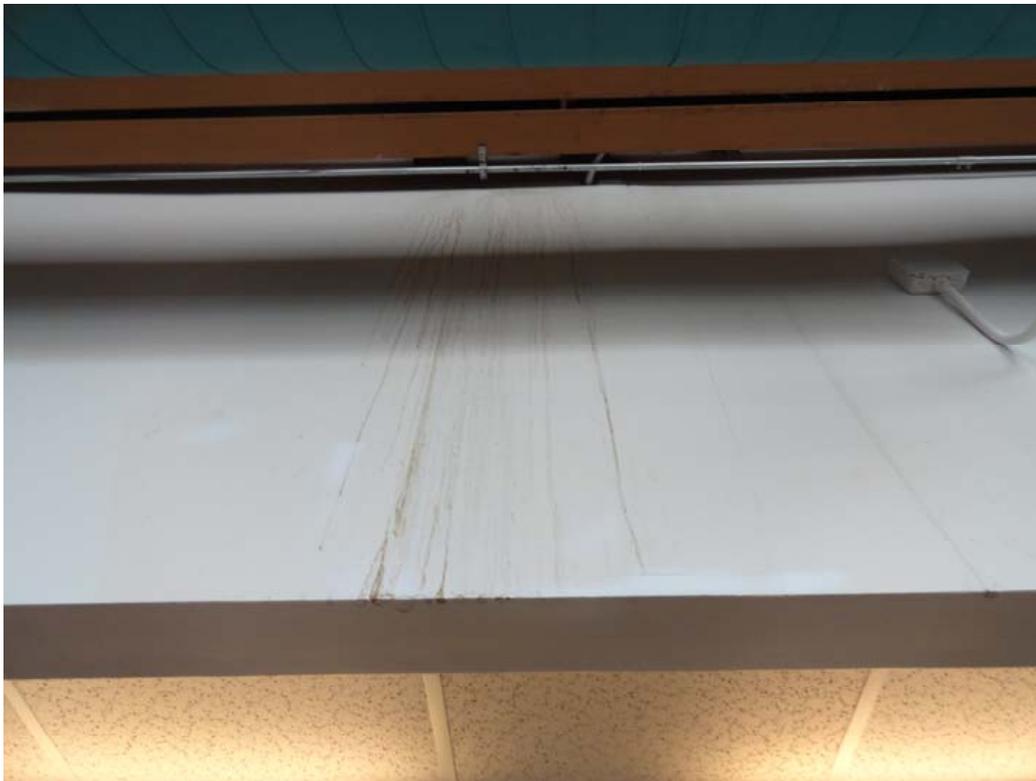
We saw evidence of recent water damage during the walkthrough. We also observed potential sources of water in individual workspaces such as fish tanks. Research has found that damp building conditions can lead to respiratory illnesses in occupants. Dampness in buildings can occur for a variety of reasons such as high indoor humidity, condensation, and roof leaks. Damp building conditions promote the growth of mold, bacteria, and other microbial agents, as well as dust mites and cockroaches. Dampness can also contribute to the breakdown of building materials and furniture. Musty odors are a sign of microbial contamination. Building occupants in damp buildings can be exposed to pollutants in the air from biological contaminants and the breakdown of building materials.

Figure B4. Evidence of recent water damage at an office building on June 1, 2018. Photo by NIOSH.

4. Maintain indoor temperature and relative humidity levels according to the guidelines discussed.
  5. Routinely inspect the building for water intrusion and damage and correct these upon discovery. During and after heavy rains, walk through the building and check for water incursion.

- a. Identify any potential sources of dampness or mold through visual inspection and make proper repairs to prevent further problems from occurring.
