**FINAL REPORT OF INVESTIGATION**  
**TO THE DIESEL EMISSIONS EVALUATION PROGRAM**  
**(DEEP)**

**NORANDA INC. - BRUNSWICK MINE**  
**DIESEL PARTICULATE FILTER**  
**(DPF)**  
**FIELD STUDY**

**OCTOBER 2004**

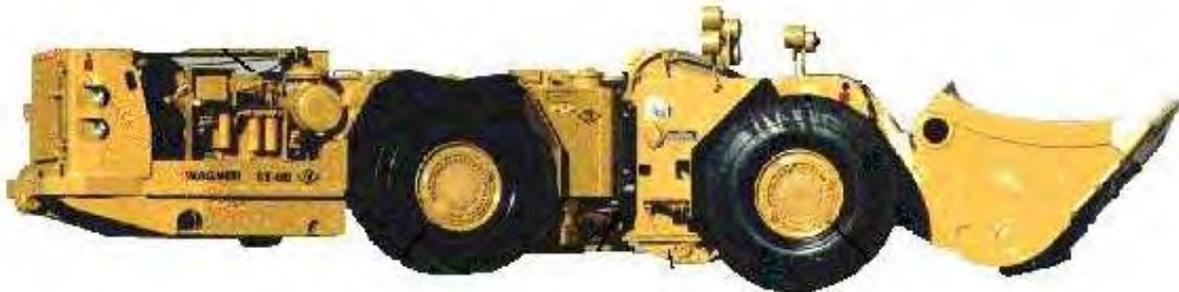
**Figure 1 - Atlas Copco Wagner ST8B Scooptram®**

Fuel Tank	379 Liters (105 gallon)
Torque Converter	Clark C-8000 Single Stage
Transmission	Clark 5000 Modulated Power Shift
Vehicle Speeds	1 <sup>st</sup> 2 <sup>nd</sup> 3 <sup>rd</sup> 4 <sup>th</sup>
	5.3    9.0    15.1    24.6 (km/hr)
Tramming Capacity	13608 kg (30000 lbs)
Operating Weight (Empty Approximately)	39474 kg (87,040 lbs)

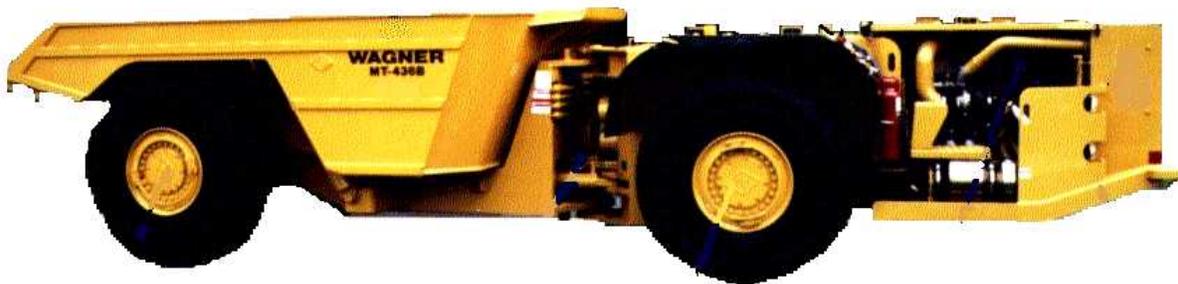
**Figure 2 – Atlas Copco Wagner MT436-B Haulage Truck**

Fuel Tank	439 Liters (116 gallon)
Torque Converter	Clark CL-6000 Single Stage with Lockup
Transmission	Clark 6000 Full Power Shift
Vehicle Speeds	1 <sup>st</sup> 2 <sup>nd</sup> 3 <sup>rd</sup> 4 <sup>th</sup>
	4.8      8.4      14.0      23.0 (km/hr)
Payload	32659 kg (72000 lbs)
Operating Weight (Empty Approximately)	31298 kg (69000 lbs)

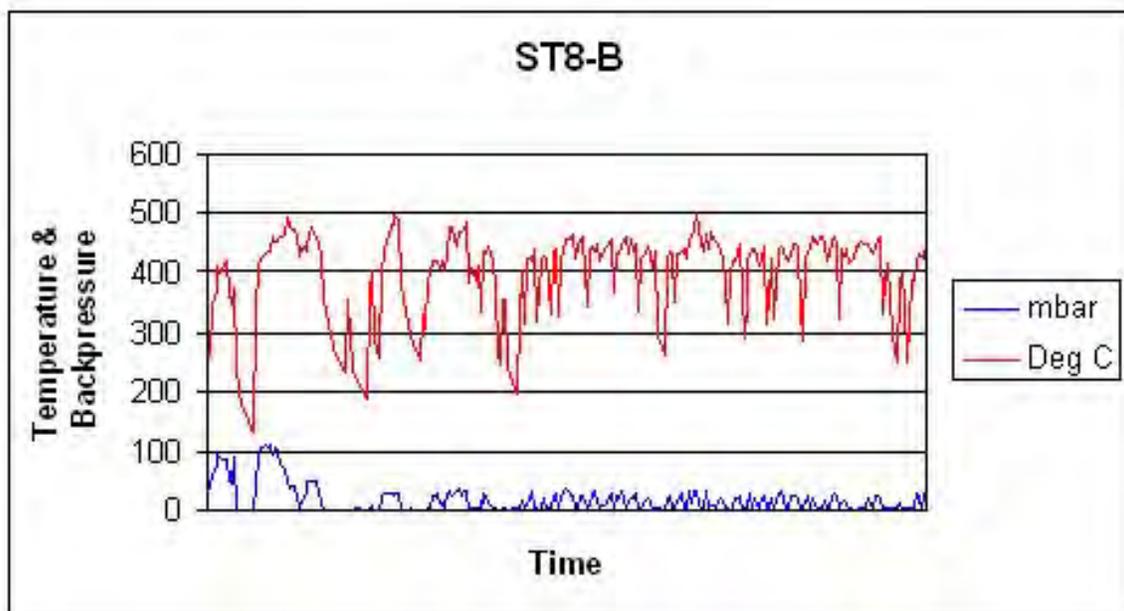
Figure 3 - ST8-B Scooptram® Duty Cycle

These duty cycle parameters allowed manufacturers to select and optimize DPF systems for the applications with respect to the exhaust temperatures and other features of vehicle operation. Figures 3 and 4 show a portion of the data that was presented to the DPF manufacturers. The traces in red at the top of the charts are exhaust temperatures from two points on the exhaust system and the blue trace at the bottom is exhaust backpressure. The chart in figure 3 demonstrates the short tight cycles with high exhaust temperatures typical of the LHD application. The chart in figure 4 shows the longer cycles with lower exhaust temperatures typical of the haulage truck application.

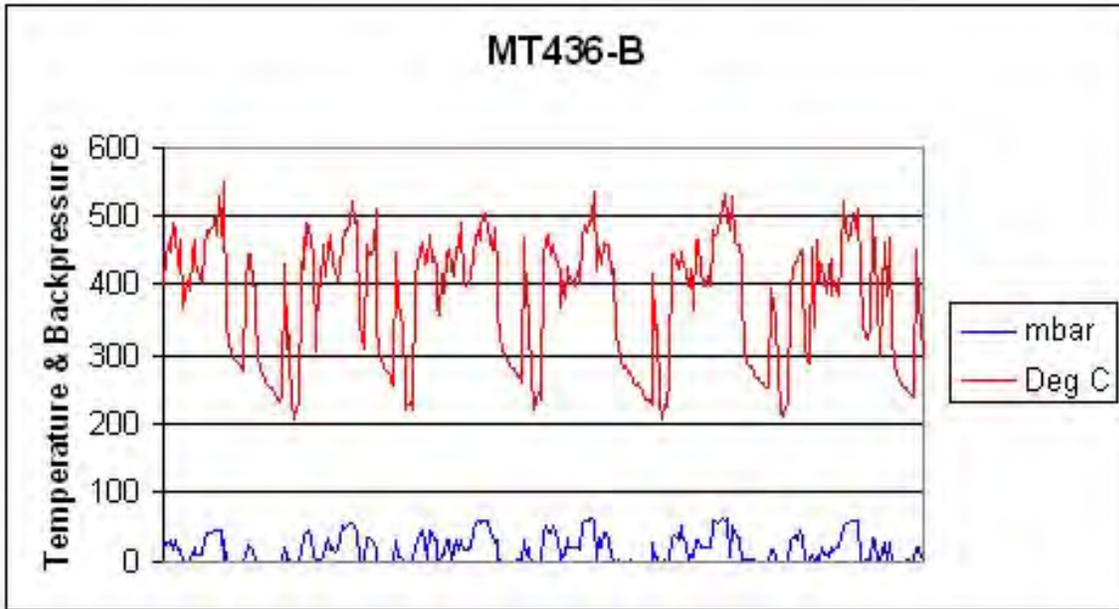
Figure 4 - MT436-B Truck Duty Cycle

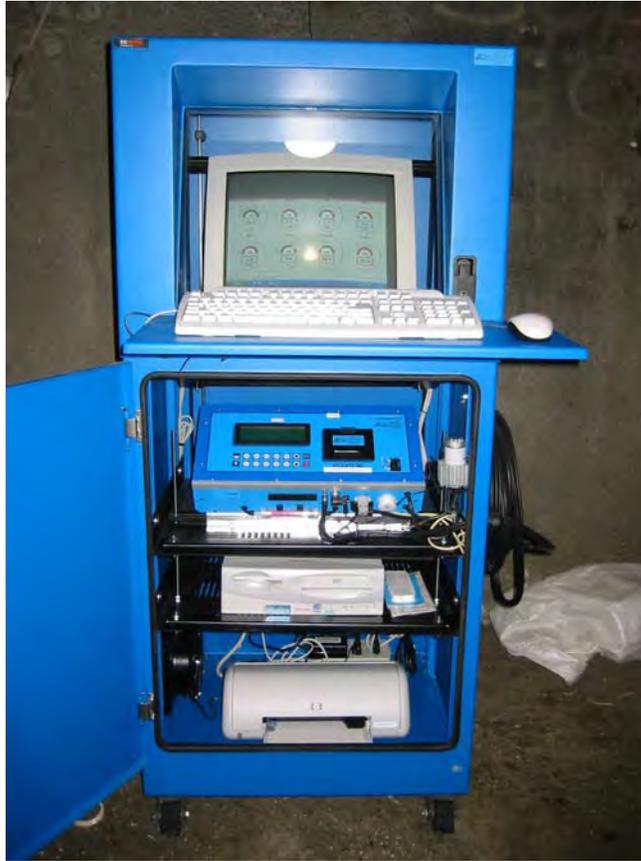
**Figure 5 - UGAS Emissions Testing System**

<b>Measured Parameters</b>	<b>Range</b>	<b>Accuracy</b>	<b>Resolution</b>
Oxygen (O <sub>2</sub> )	0 - 21%	2% of reading	0.1%
Carbon Monoxide (CO)	0 - 4000 ppm	4% of reading	1 ppm
Nitric Oxide (NO)	0 - 4000 ppm	4% of reading	1 ppm
Nitrogen Dioxide	0 - 500 ppm	4% of reading	1 ppm
Ambient Temperature	0 - 250° F	3 degrees	1° F
Gas Temperature	0 - 1600° F	3 degrees	1° F
Gas Draft (Pressure)	0 - 40.0" H <sub>2</sub> O	2% of reading	0.01" H <sub>2</sub> O
<b>Calculated Parameters</b>	<b>Range</b>	<b>Resolution</b>	
Combustion Efficiency	0 - 100%	1.0%	
Carbon Dioxide (CO <sub>2</sub> )	0 - 40%	0.1%	
Lambda ( $\lambda$ )	0 - 50%	0.01%	
Losses	0 - 100%	1.0%	
O <sub>2</sub> Correction	0 - 10,000 ppm	1 ppm

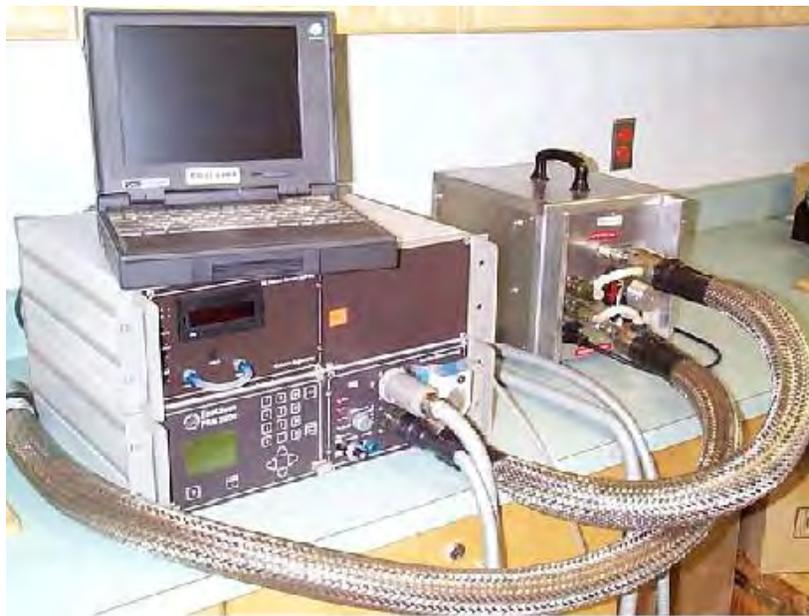
**Figure 6 - NanoMet Diesel Particulate Analysis System**

The NanoMet Diesel Particulate Measurement System (Matter Engineering AG, Wohlen, Switzerland) shown in Figure 6 was acquired by CANMET for the purpose of conducting periodic assessments of performance of diesel particulate filters. Although sold as a portable field instrument, the NanoMet is essentially a laboratory grade instrument modified for field measurements [Kasper et al. 2001]. The NanoMet was found to be a sophisticated but complex instrument that required a trained operator.

The combination of the two sensors with the heated sampling and dilution permits differentiation between solid and liquid fraction of the sampled aerosols. The diffusion charging particle sensor uses corona discharge to non-selectively charge solid and liquid aerosols. The instrument characterizes the particles in terms of the active surface. The PAS 2000 is a photoelectric real-time aerosol sensor. The aerosol is photo charged at the inlet to the sensor using an exciter lamp. Since only aerosols with solid core can be efficiently charged using photoemission there is belief that the output of the instrument is strongly correlated to the elemental carbon (EC) fraction in the DPM samples. The instrument has quick response time and wide particle size range. The PAS 2000 proved to be a more reliable and consistent instrument for assessing penetration and filtration efficiency of the DPF systems than the DC. No absolute values of particle concentrations were acquired in the testing with the Nanomet and calculations of filtration efficiencies were based only on the PAS 2000 values.

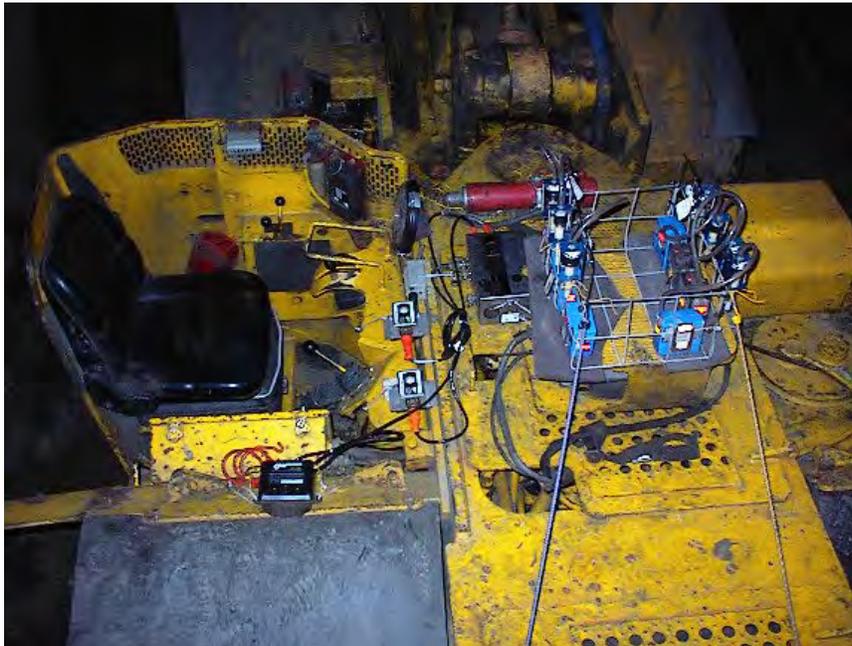
**Figure 7 - RCD and NIOSH 5040 Operator DPM Sampling Trains**

The NIOSH 5040 method [NIOSH Manual for Analytical Methods, 1999] uses the same sampling train as above except for the addition of a size impactor between the cyclone and cassette to block particles greater than 0.8 microns, the usual cutoff point for diesel and non-diesel particles. The sampling pump for this method is calibrated to 2 litres per minute. Samples are acquired on quartz-fiber filters in the cassettes. Analysis is performed at a laboratory by first using a punch to remove a  $1.5 \text{ cm}^2$  cutout from the sample filter. The cutout is analyzed with an instrument that uses temperature and atmosphere control while measuring optical transmittance of the sample. Analysis is done in two stages with speciation of organic and elemental carbon defining a “split” between the two as shown in figure 8. The first stage of the analysis defines organic carbon evolved in a helium atmosphere at a temperature stepped to  $850^\circ \text{ C}$ . The second stage defines the elemental carbon split with an oxygen-helium atmosphere at a temperature stepped to  $940^\circ \text{ C}$ . This is the same analysis method used to calculate the values from the undiluted samples with the Ecom probe mentioned in the previous section.

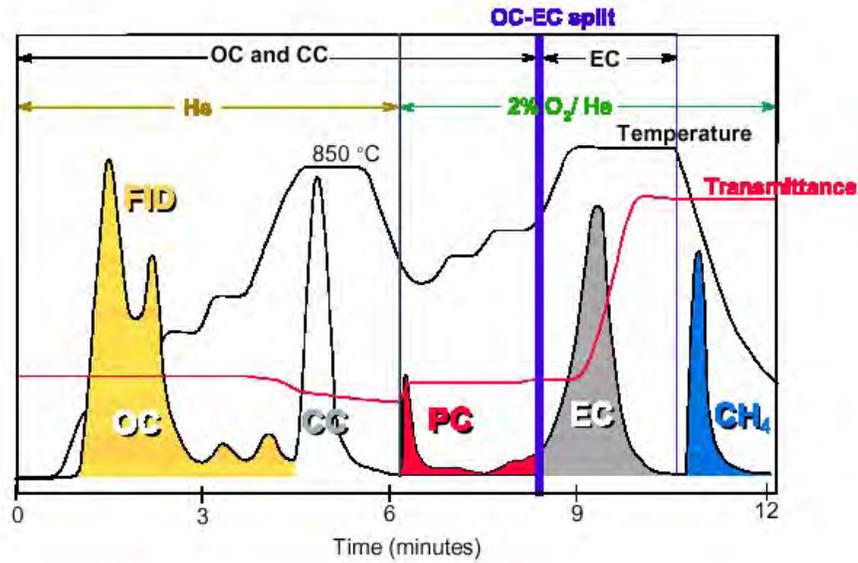
Figure 8 - Method 5040 Analysis Example

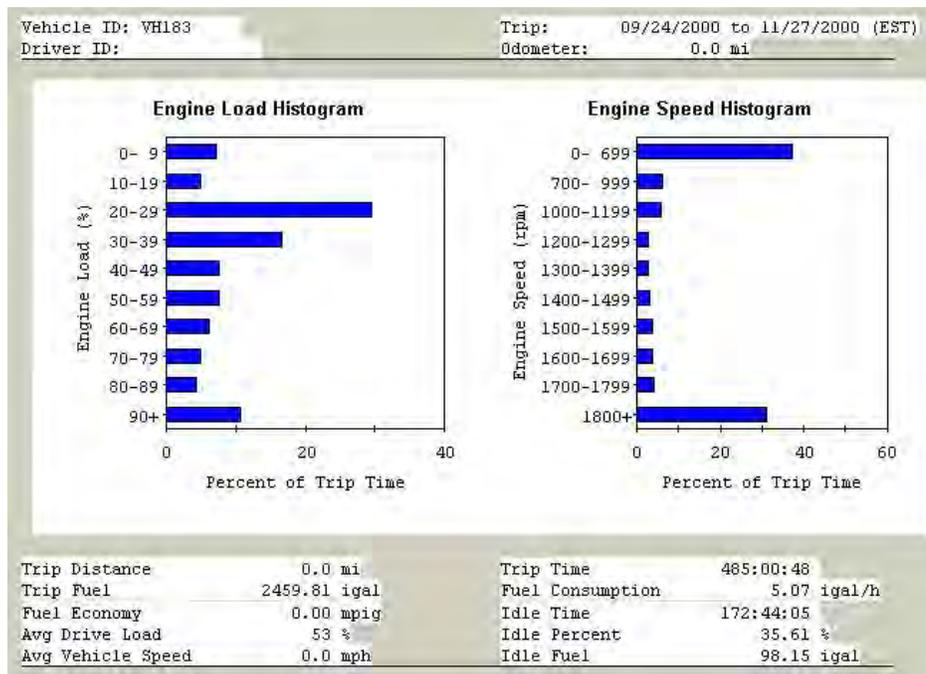
**Figure 9 - DDEC Reports Engine Operating Statistics**

The four vehicles used in this study were powered with Detroit Diesel electronically controlled (DDEC) engines. The engine control module (ECM) computer onboard the tested vehicles provided data on operating hours, idling hours, fuel consumption, and engine operating profiles with incremental engine speeds and loads over test periods (see Figure 9). This data proved to be the very valuable and accurate for establishing operating trends on the tested vehicles.

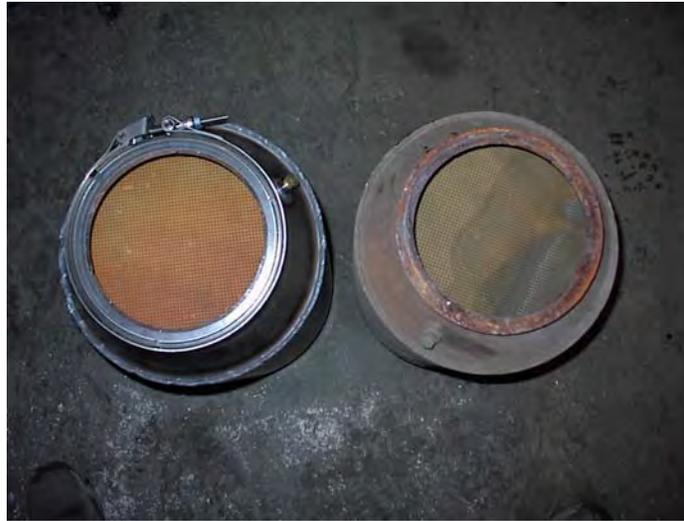
**Figure 10 - ECS CatTrap Ceramic Monoliths**

One of the DPF systems presented by Engine Control Systems (ECS) was chosen for one of the LHD applications. The design was selected because of its simplicity and proven reliability. Two ceramic Cordierite EX-80 monoliths as shown in Figure 10 were mounted horizontally between inlet and outlet manifolds of the DPF system. Ceramic filter monolith technology from Corning has been proven to be durable in use in mines since the 1980's. To secure regeneration of the DPF elements during the duty cycle of the LHD the monoliths were wash coated with a base metal catalyst. The coating was designed to lower regeneration temperatures without increasing gaseous emissions, in particular NO<sub>2</sub>. The system was designed as a fully passive system. The regeneration of the system should occur during the typical LHD operating cycle and was completely transparent from the operator's perspective. ECS assigned the product name of CatTrap to the system and to which it is herein referred in this report.

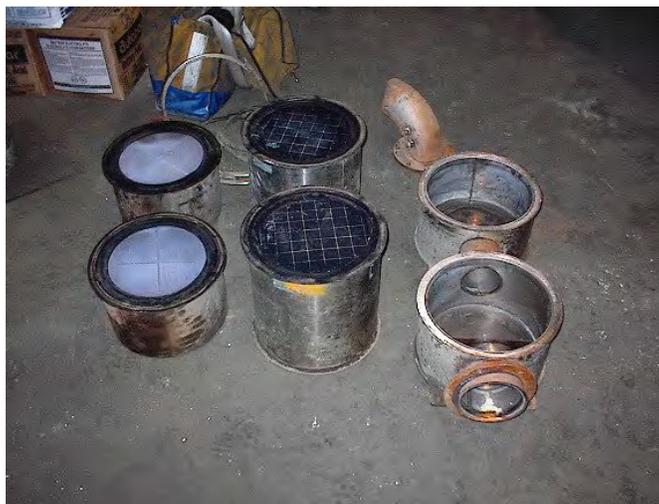
**Figure 11 - ECS Octel DPF Components**

A second system proposed by ECS was chosen for application on an MT-436B truck. The DPF system shown in Figure 11 was a modified ECS Unikat Combifilter design which used twin K18 silicon carbide filter monoliths and canisters, but substituted a catalytic converter (DOC) above each monolith section instead of the electric heater assemblies normally mounted in the upstream housings. The silicon carbide monolith technology has a proven track record for durability and higher resistance to thermal stress than Cordierite ceramic materials. A fuel-borne catalyst was used with the system to ensure regeneration of filter elements at the lower exhaust temperatures characteristic of relatively cold duty cycles observed for the haul trucks. The fuel-borne catalyst was supplied by Associated Octel Limited under the product name of Octimax 4804. The active components of this catalyst are iron and strontium. The product was proven through the research projects conducted in Europe [Vincent et al. 2000].

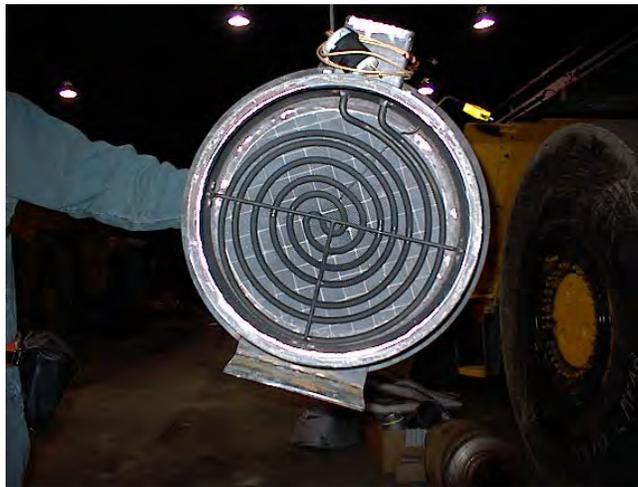
**Figure 12 - DCL Bluesky DPF Silicon Carbide Monolith and Heater Element**

A DPF system proposed by DCL International was chosen and adopted for retrofit on the other LHD vehicle included in the research. The system was chosen as a test of a promising active DPF technology that could reasonably fit within the constraints of Brunswick Mine operation requirements. This DPF system was designed around a single silicon carbide filter monolith. The monolith was wash coated with a platinum catalyst. An active electric heating system was added to the system to ensure DPF regeneration. This system had a 600-volt electrical element as shown in Figure 12 mounted in the inlet cone of the DPF housing. A regeneration station with the electrical power supply, switches, and controls and compressed air connections was designed as a separate unit external to the vehicle. The system was designed to be electrically regenerated at the end of each shift. The regeneration station was located in the garage on 3250 level. The plan was to have the operator(s) bring the vehicle to the garage at the end of each shift where the DPF system would be connected to the regeneration station. The two and a half hour window between work shifts was found to be sufficient to complete the regeneration cycle. The DCL system is referred hereinafter under the product name Bluesky.

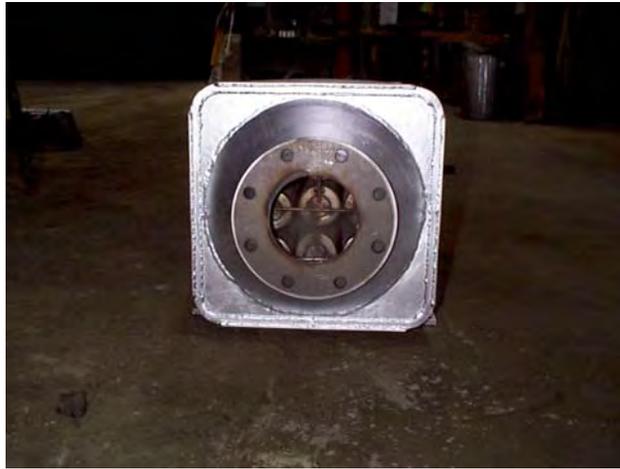
**Figure 13 - Oberland Mangold DPF Glass Fiber Cartridges**

A system proposed by Oberland Mangold of Germany was selected for application on the second MT436-B truck. The system used a glass fiber filter technology instead of wall flow monoliths of the other tested systems. The glass fiber cartridges had been approved by VERT following European tests [Mayer A, 1998]. The system also included a fuel-borne catalyst in the design to meet the regeneration requirements of lower exhaust temperatures in typical truck duty cycles. Oberland Mangold agreed that the Octimax 4804 additive would be appropriate for this use. The Oberland Mangold DPF system is shown below in Figure 13.

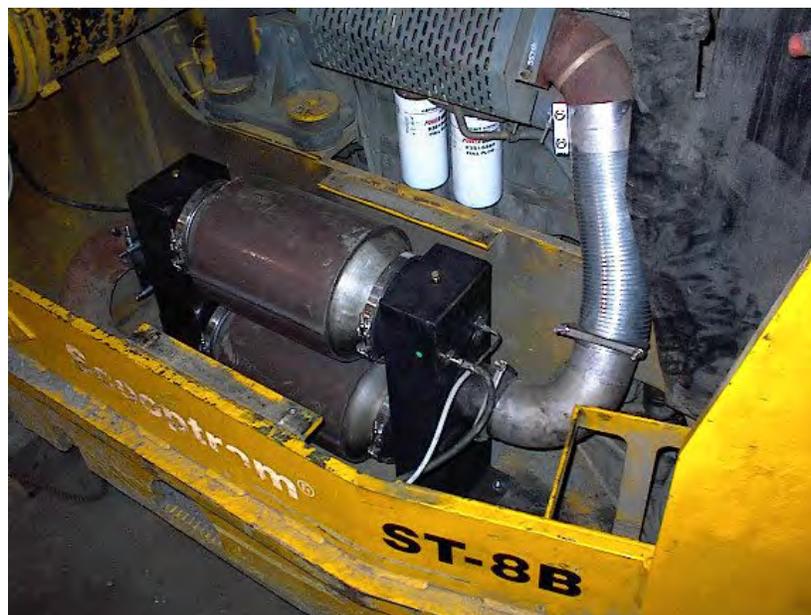
**Figure 14 - ECS CatTrap Installation**

Manufacturer	Engine Control Systems (ECS)
Filter Type	Cordierite EX-80 – Catalyzed Base Metal
Regeneration	Passive
Filter Volume	39.10 liter
Configuration	Twin Canisters with Manifold Horizontally Mount
Retrofit Installation Effort	64 Manhours

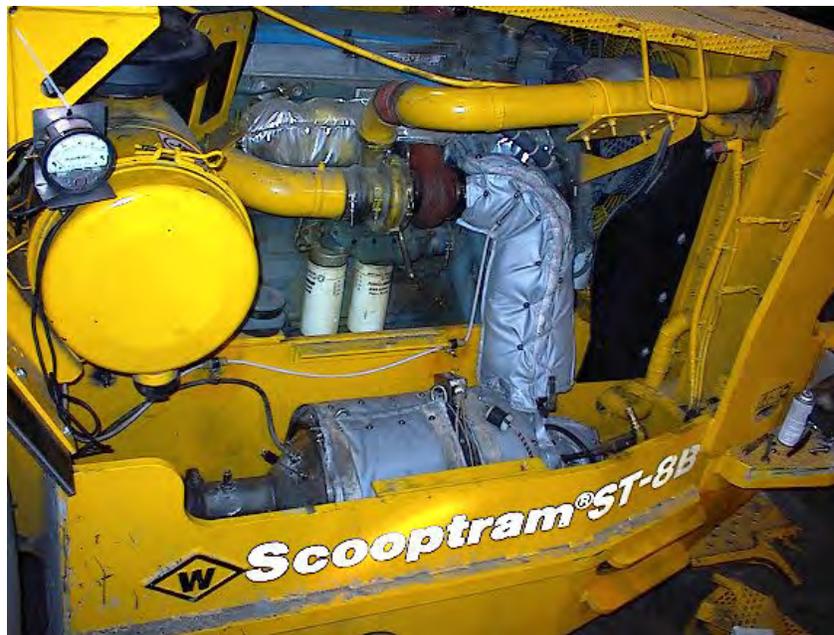
**Figure 15 - DCL Bluesky Installation on VL247**

Manufacturer	DCL International
Filter Type	Silicon Carbide – Catalyzed Platinum Washcoat
Regeneration	Active – On/Off Board Electric
Filter Volume	34.2 liters (381mm X 300mm)
Configuration	Single Cylinder Horizontal Mount
Installation Effort	104 Manhours

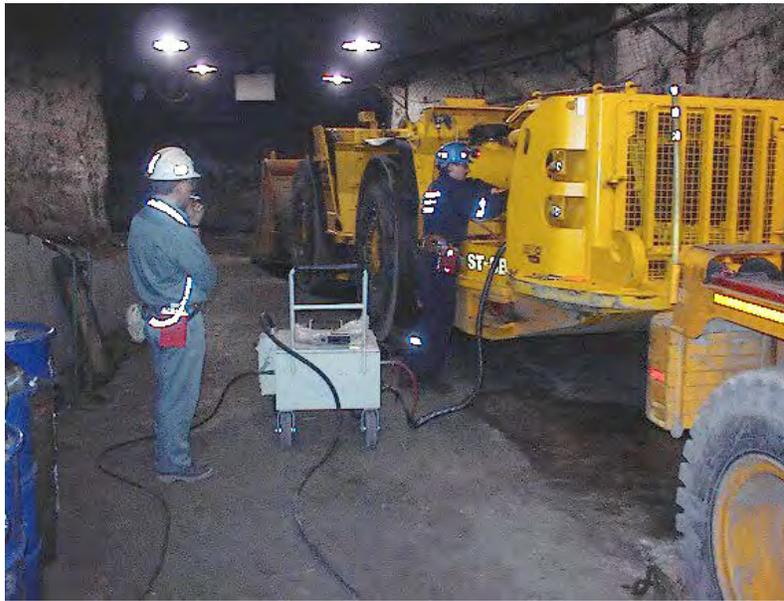
**Figure 16 - DCL Regeneration Plug In Unit**

The original plan was to regenerate DPF system in the shop at the end of each shift. The regeneration cycle, which was fully automated, would take 90 minutes from start to finish. Unfortunately, getting the electrical regeneration system connected and working properly presented a significant challenge. Within the first 8 hours of operation, the heating element that was designed to preheat the air entering the system failed. The investigation revealed that the element was inadequately designed. The preheat element was removed from the system leaving only the primary heat coil. This resulted in extending the regeneration cycle from 90 minutes to 120 minutes. At the same time two thermocouple connections were eliminated for simplicity and robustness. The elimination of these connections left only the 600v heating element connection and the compressed air connection. These modifications greatly simplified the connection procedure.

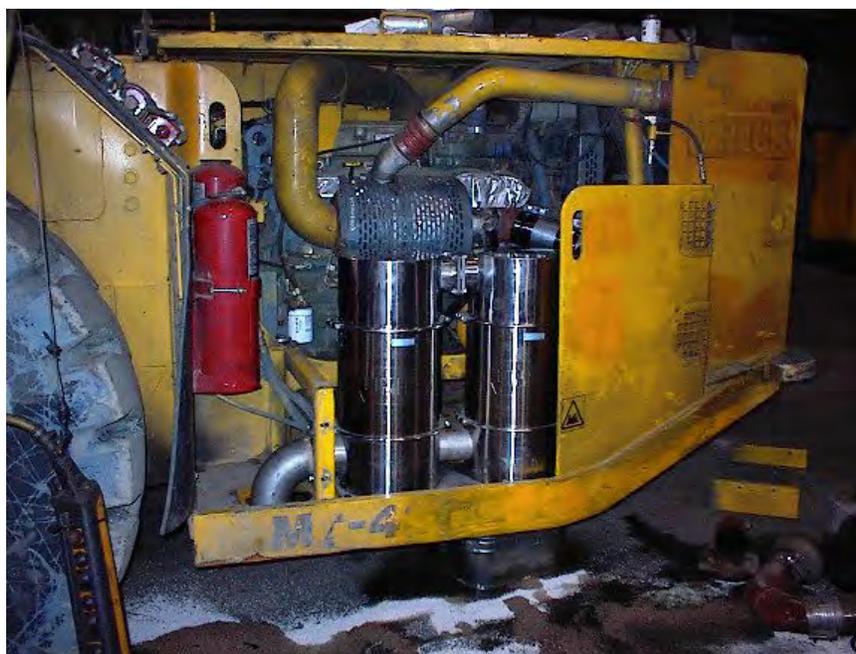
**Figure 17 - ECS Octel Installation on VH183**

Manufacturer	Engine Control Systems (ECS)
Filter Element Composition	Silicon Carbide with in-line DOC
Regeneration	Fuel Borne Catalyst – Octimax 4804 @400ppm
Filter Volume	39.10 liter
Geometric Configuration	Twin Canisters with Manifold–Vertical Mount
Installation Effort	96 Manhours

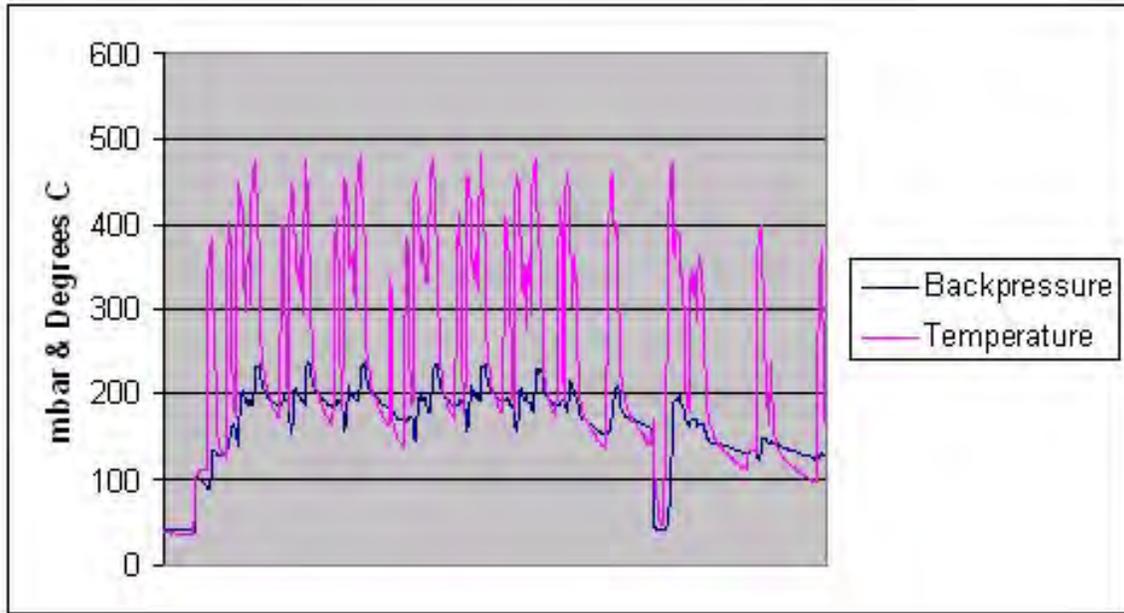
The original DPF system accumulated 300 operating hours before removal and replacement with the larger volume unit. Figure 18 shows exhaust temperature (red line) and backpressure (blue line) traces for the first four days of operation. The exhaust backpressure was exceeding 200 mbar(80 in. wc) or twice the engine manufacturers limit of 100 mbar (40 in. wc)in the first days of operation.

**Figure 18 - Exhaust Temperature and Backpressure Traces for First Oberland Mangold DPF**

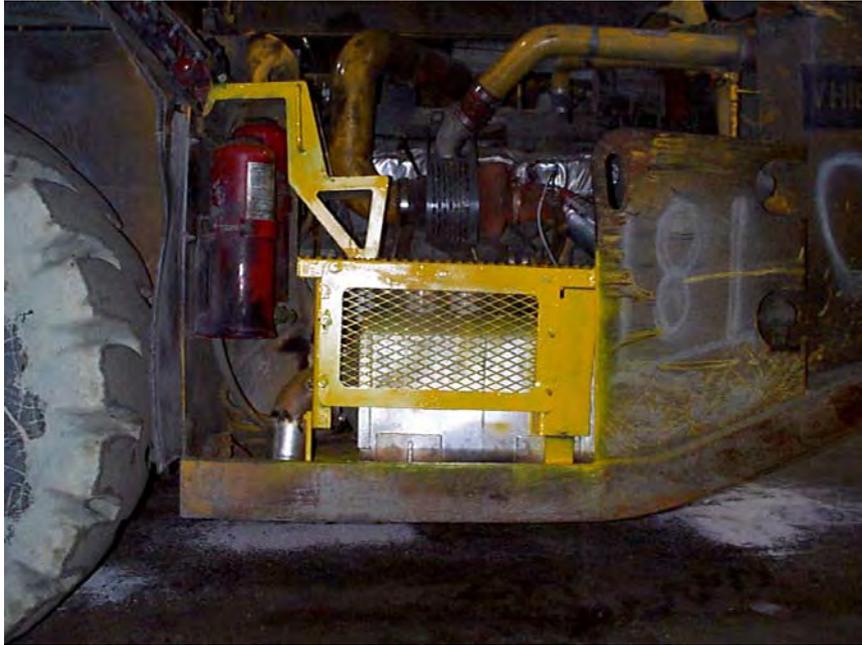
**Figure 19 - Original Oberland Mangold DPF Installation**

High exhaust backpressure problems eventually forced the decision to replace the original Oberland Mangold system with a larger volume unit. A new system was delivered to the mine and installed within two months Figures 19 and 20 show the two Oberland Mangold systems.

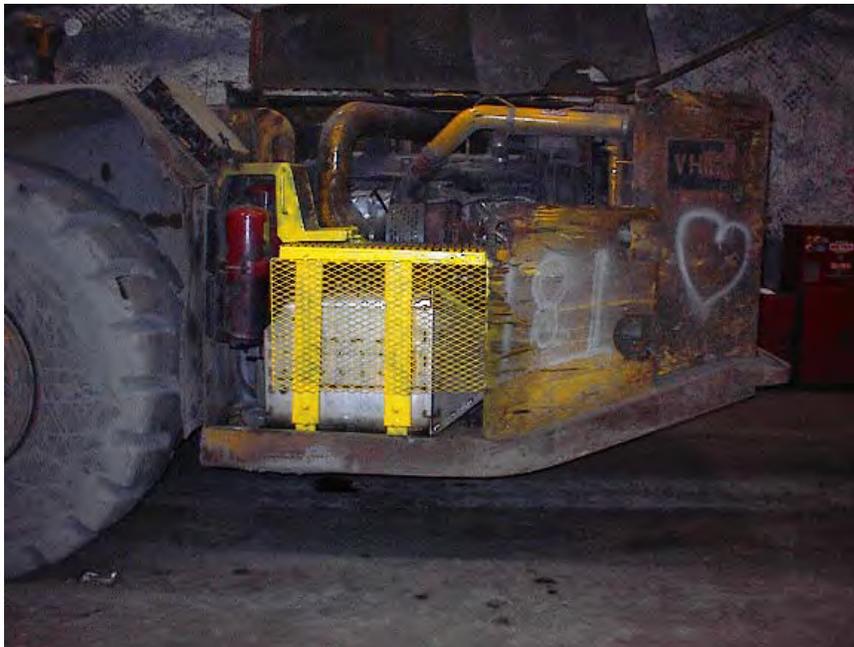
**Figure 20 - Final Oberland Mangold DPF Installation**

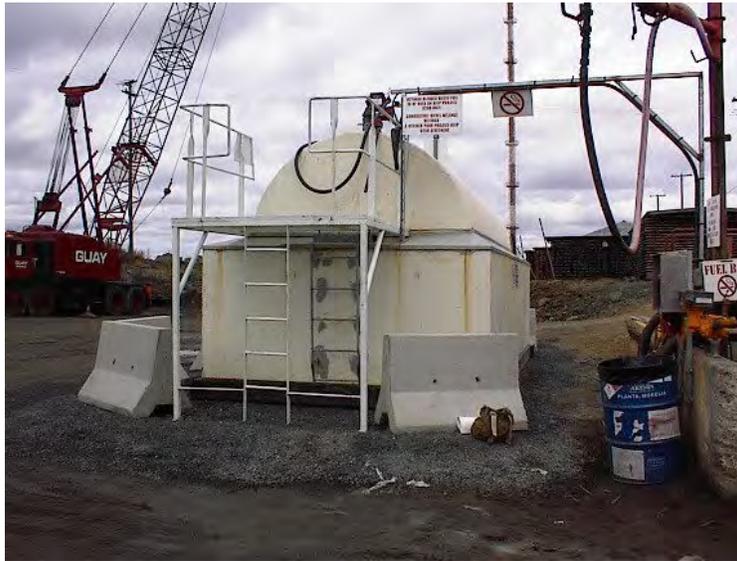
**Figure 21 - Blended Fuel Storage on Surface**

The bulk blending of fuel required an elaborate infrastructure for mixing, storing, and distributing blended fuel. It was important to limit use of blended fuel to the vehicles equipped with DPF systems. This was due to potential health risks associated with emissions of metallic compounds. A discreet bulk fuel supply was required with redundant fail-safe mechanisms to ensure that the two DPF equipped haulage trucks were the only vehicles capable of filling with the blended fuel. A six-thousand gallon bulk storage tank was installed on surface where the Octimax 4804 was added to the fuel at concentration of 400 ppm. Blending was done manually. The recommended volume of additive was hand poured into the tank during refilling process. The volume of fuel added to the tank was measured using a fuel meter. This process was sufficient to secure homogeneous mix of the two. Once homogenized, the blend remained in that state thanks to the stabilizing agent from the Octimax additive. A set of portable cube reservoirs were designated for transport and store blended fuel. Those reservoirs were equipped with a discreet fill/evacuation system. The cubes were moved underground to the "1000 level" fuel bay by vehicle transport and shaft access. A second bulk fuel tank of three thousand gallon capacity was installed at the fuel bay on "1000 level". Blended fuel from the cubes was transferred to this tank. A separate fill pump and nozzle system was installed at 1000 fuel bay. The system had a Wiggins quick disconnect fuel nozzle connection. The matching female quick connect fittings were installed on the two DPF equipped trucks.

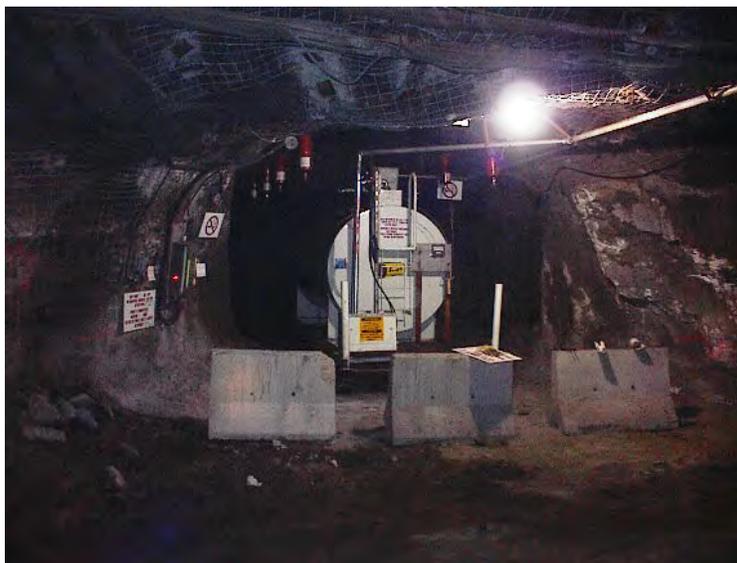
**Figure 22 - Blended Fuel Storage at 1000 Level**

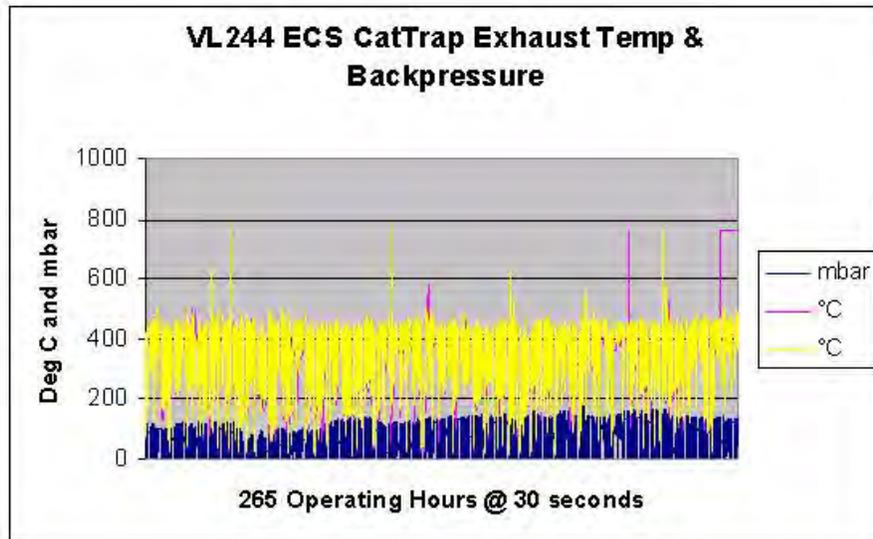
The typical exhaust temperature and backpressure trace for LHD VL244 is shown in Figure 23. Temperature peaked between 375° and 400°C. The system manufacturer expected that the filter would be successfully regenerating at those temperatures for 30% or more of the total duty cycle. Backpressure reached a plateau of around 120 mbar or 50 inches of water. The backpressure values measured by mechanics at monthly PM inspections were consistent with those measured by the loggers.

**Figure 23 - ECS CatTrap Exhaust Temperature and Backpressure**

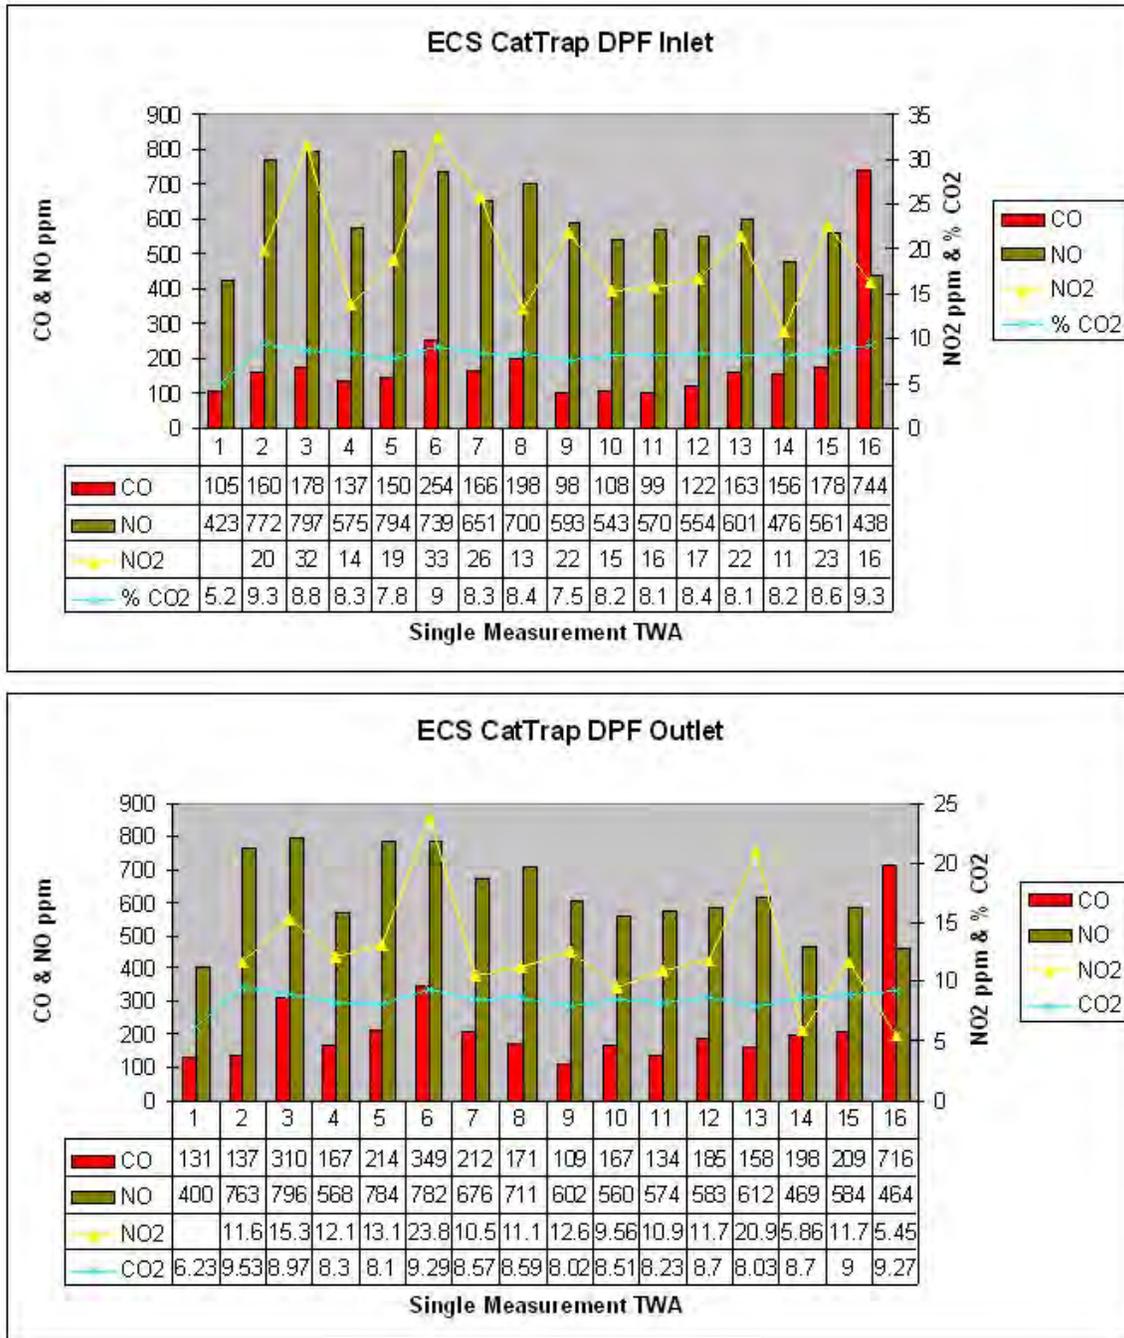
Over the course of the project a total of 16 emissions tests were performed using UGAS at both the inlet and outlet of the DPF. The results are shown in Figure 24. The results showed that nitrogen dioxide emissions were not substantially affected by the base metal catalyst. Carbon monoxide emissions were consistent and correlating well to small fluctuations in carbon dioxide. All measured CO<sub>2</sub> emissions were near 8 to 9% indicating good tests at full engine stall condition.

Figure 24 – Gaseous Emissions For VL244 With ECS CatTrap

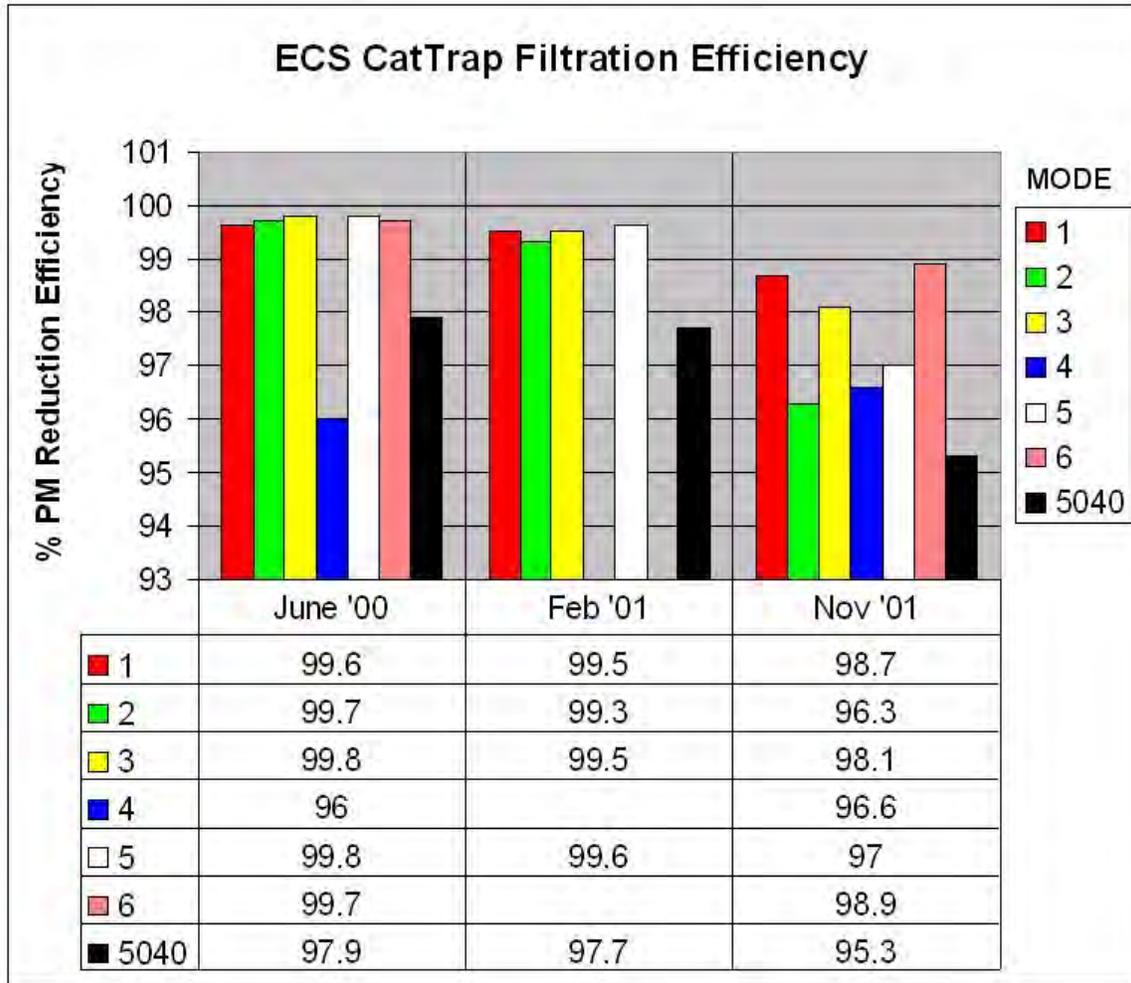
The carbon content test results obtained using 5040 method were found to correlate well to the results obtained using the six-mode testing and the NanoMet instrument.

**Figure 25 – DPM Filtration Efficiencies For ECS CatTrap DPF System**

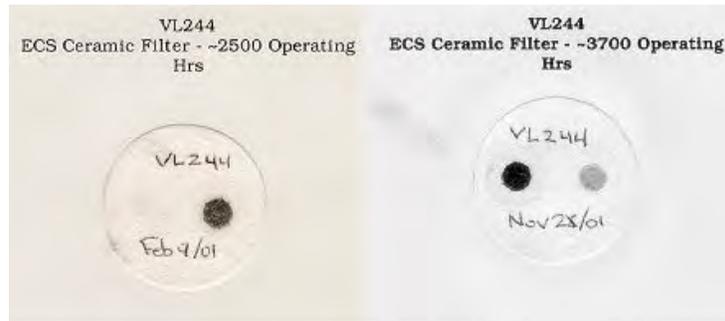
The Figure 26 shows the filter sample taken by mechanics with the UGAS using Bacharach smoke index (BSI) option.. The black dot represents the DPM sample collected from the inlet side of the filter and the light gray dot represents the sample collected at the outlet side of the filter. The samples collected at the final tests in November 2001 indicate the reduced efficiencies observed with other methods (see Figure 25).

**Figure 26 – Bacharach Smoke Index Measured for ECS CatTrap DPF System**

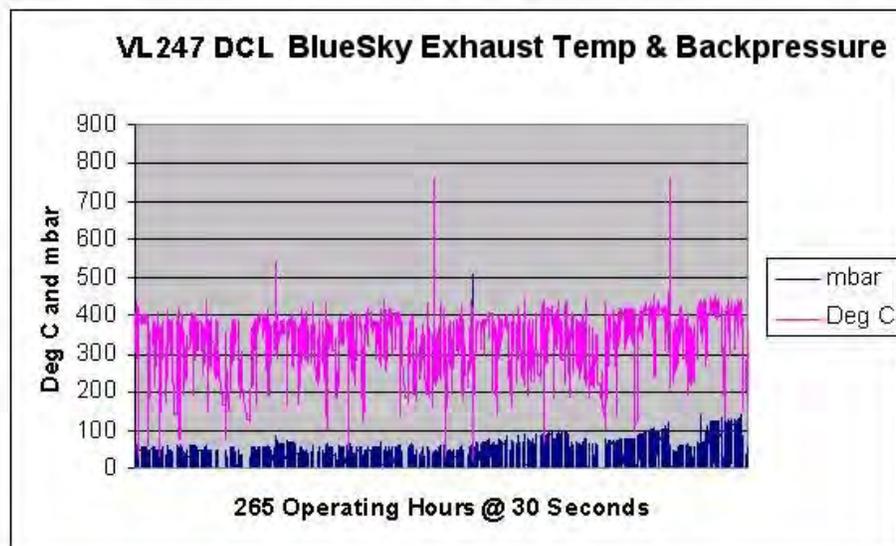
The Nothiger datalogger and sensor system used on VL247 to establish time traces of exhaust temperature and backpressure was prone to technical problems throughout the study. The RTD temperature sensors used at the DPF inlet side were particularly prone to failures due to their proximity to the electrical regeneration unit that generated the additional heat. Figure 27 shows temporal distribution of exhaust temperature and engine backpressure. This data is fairly consistent with corresponding data obtained for the LHD VL244. Exhaust temperatures at peak engine load were between 350° and 400° C, These temperatures were theoretically within the range of temperatures needed for passive regeneration of this system. Backpressures observed with this system were slightly lower than those observed for the ECS system on LHD VL244. The backpressure reached a plateau at approximately 100 mbar or 40 inches of water. This indicates that regeneration was occurring frequently enough during the duty cycle to sustain continuous operation of the system. This was verified by the additional measurements of engine backpressure done by mechanics during monthly PM inspections.

Figure 27 - Exhaust temperatures and engine backpressures recorded for LHD VH247 equipped with DCL Bluesky DPF system

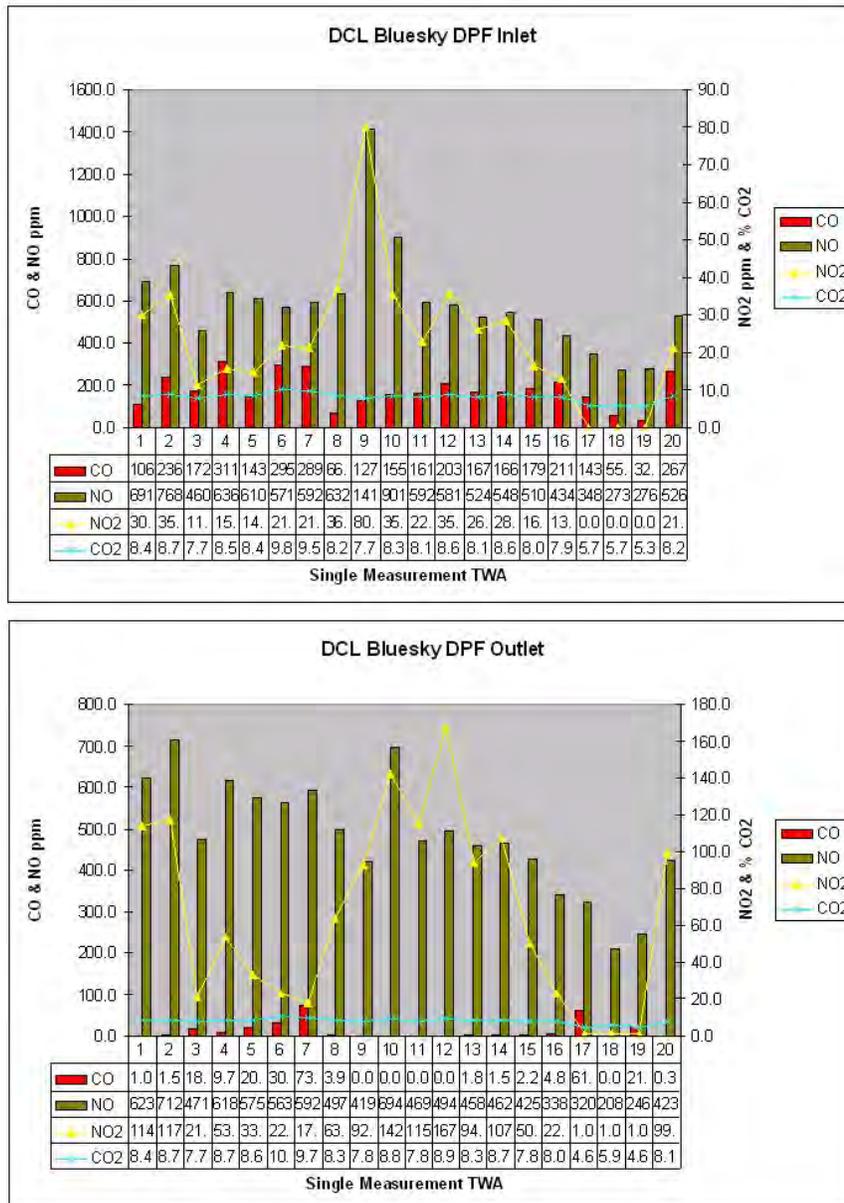
Results of the emissions measurements conducted during 20 tests are shown in Figure 28. The measurements were conducted at the inlet and outlet sides of the DPF using the UGAS system. The CO was converted almost completely across the platinum catalyzed filter (see Figure 28). In some cases measurements showed that the concentrations of NO<sub>2</sub> at the outlet of the DPF were four fold higher than corresponding concentrations on the inlet side of the DPF. These results emphasized the importance of including gaseous emissions measurements in tests designed for evaluation of the effects of DPF systems on the particulate matter emissions.

Figure 28 - Gaseous Emissions For VL247 With DCL Bluesky DPF System

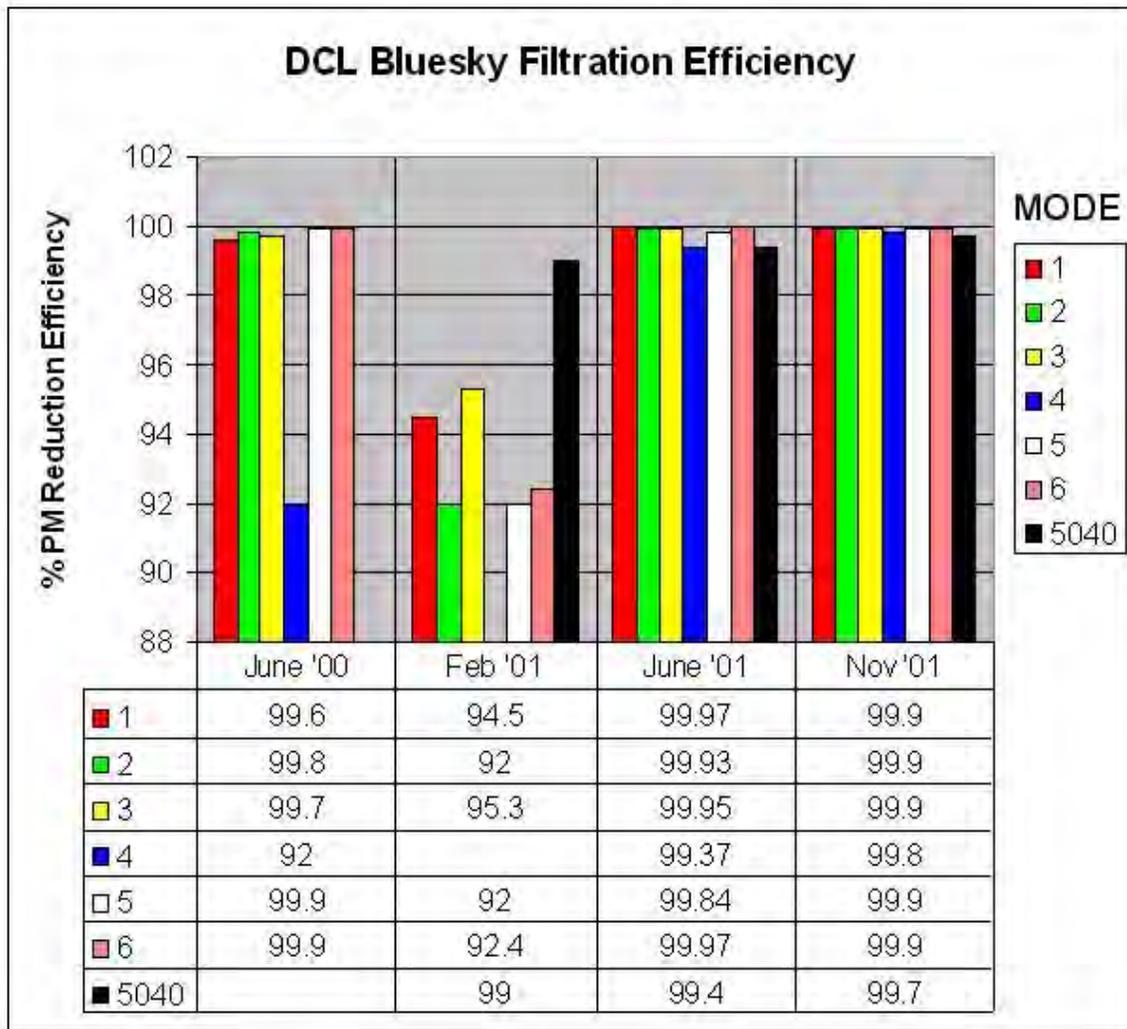
The results of particulate matter emissions measurements conducted during four detailed performance evaluations are shown in Figure 29. In terms of filtration efficiency, this system was the best performer of all systems tested in the project. The results were consistently indicating filtration efficiencies in excess of 99 percent. The results obtained with NanoMet during tests conducted in February of 2001 were found to be inconsistent due to instrumentation problems but are presented nonetheless. It is important to note that these tests were conducted during the isolated zone study in a drift at ambient air temperature just above the freezing point. We believe that the NIOSH 5040 method provided accurate results.

Figure 29 - DPM Filtration Efficiencies For DCL Bluesky DPF System

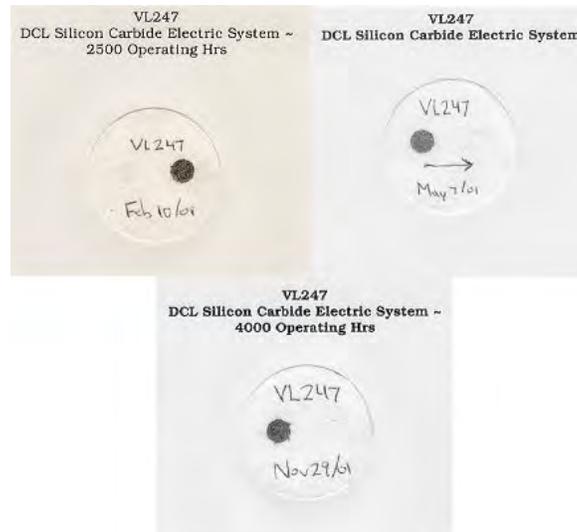
Figure 30 shows the filter sample taken by mechanics with the UGAS using the BSI option on the Ecom analyzer. The black dots represent the DPM sample collected from the exhaust at the inlet side of the filter (an 8 on the 0-9 index scale) and the light gray dot represents the DPM sample collected at the outlet from the filter (a 1 on the 0-9 index). The results of smoke density tests confirmed the results obtained using other more sophisticated methods.

**Figure 30 – Bacharach Smoke Density Results on VL247 with DCL Bluseky DPF System**
