**FINAL REPORT OF INVESTIGATION**  
**TO THE DIESEL EMISSIONS EVALUATION PROGRAM**  
**(DEEP)**

**NORANDA INC. - BRUNSWICK MINE**  
**DIESEL PARTICULATE FILTER**  
**(DPF)**  
**FIELD STUDY**

**OCTOBER 2004**

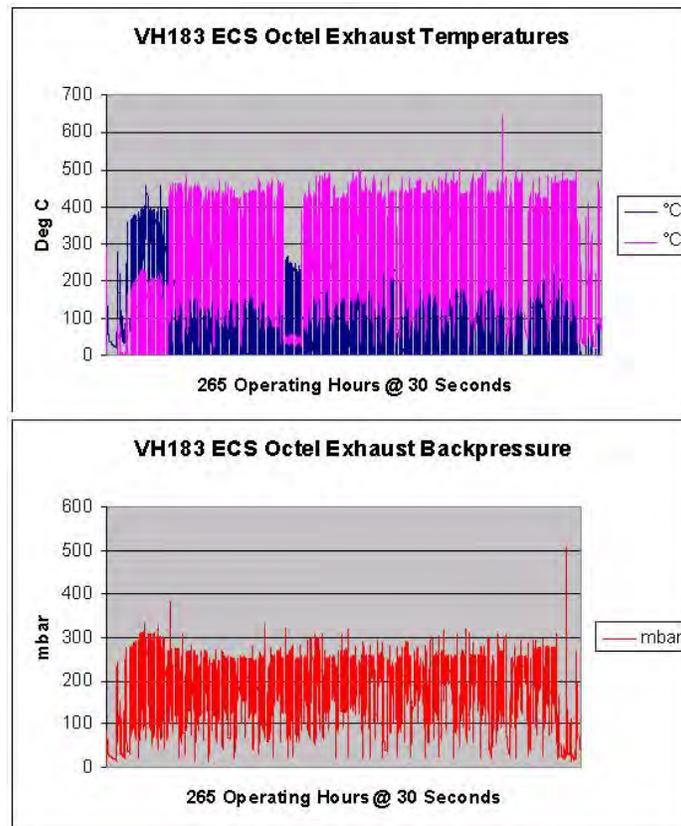
lower DPF regeneration temperatures to approximately 300° C. Therefore, regeneration should have occurred more frequently than it was observed.. Figure 31 also shows that the backpressures were for a substantial time above 200 mbar and reaching periodically even 300 mbar. This high backpressure indicates that the regeneration process was slow and insufficient. The Octel representative offered the hypothesis that regeneration did not occur over the duty cycle since the moisture content of the soot buildup inside the filter monolith was less than expected. Low organic carbon content was hypothesized to be the result of efficient combustion inside the electronically controlled engine and operating conditions. These factors in combination with excessive engine idle times contributed to the insufficient DPF regeneration.

Figure 31 - ECS Octel Exhaust Temperature and Backpressure

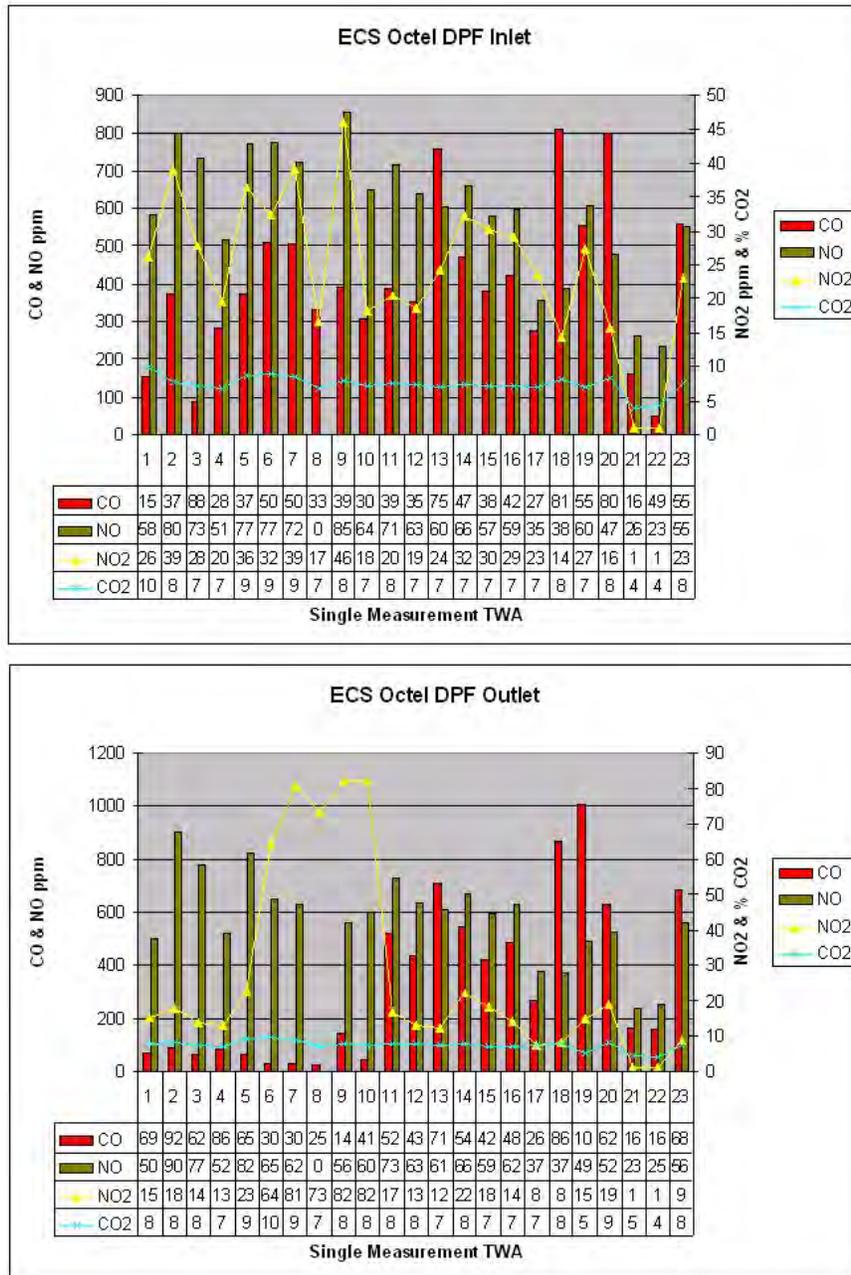
while the diesel oxidation catalyst was in place showed the CO conversion and reduction (see Figure 32). Once the diesel oxidation catalyst was removed, CO emissions at the outlet were often higher than those at the inlet due to combustion of DPM inside the filter while the engine was under full stall testing conditions. Measurable conversion of nitrogen oxide to nitrogen dioxide was taking place in the system while the oxidation catalyst was in place, but when the catalyst was removed conversion was not measurable.

Figure 32 - Gaseous Emissions For VH183 ECS Octel DPF System

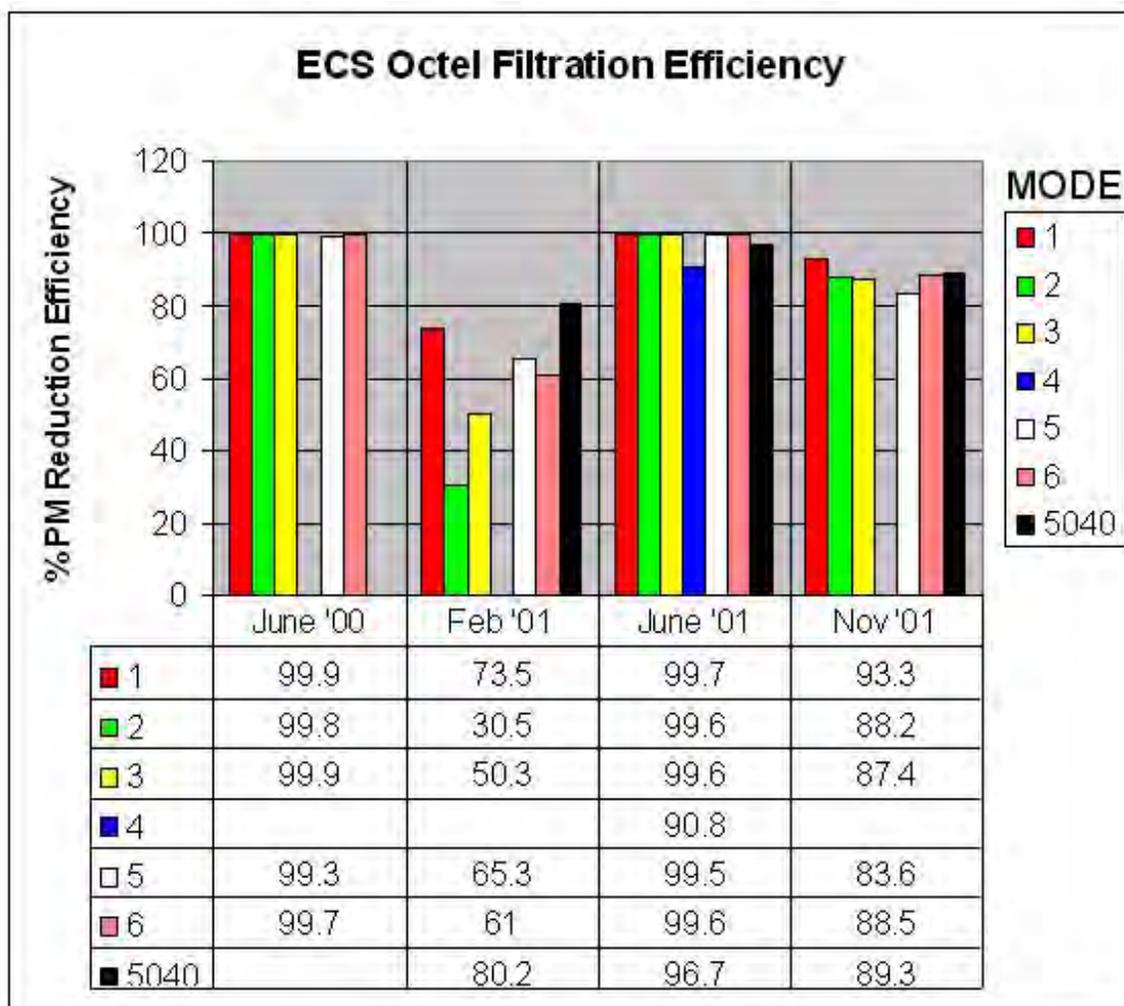
The filtration efficiency test results, shown in Figure 33, illustrate the high efficiencies of the newly installed system. The tests in February 2001 show a severely failed filter and the final tests in November 2001 show a partially failed filter. The results of the 5040 method carbon content analysis on the samples collected during the last three sets of tests correlate very well with the filtration efficiency measured by the NanoMet instrument. Test results showed that the new filters had efficiencies of approximately 98%, similar to the other tested DPFs. The severely damaged filter system had efficiency as low as 30%, and the partially damaged system had efficiency as low as 82% depending on which test mode was used for analysis.

Figure 33 – DPM Filtration Efficiencies for ECS Octel DPF System on VH183 Truck

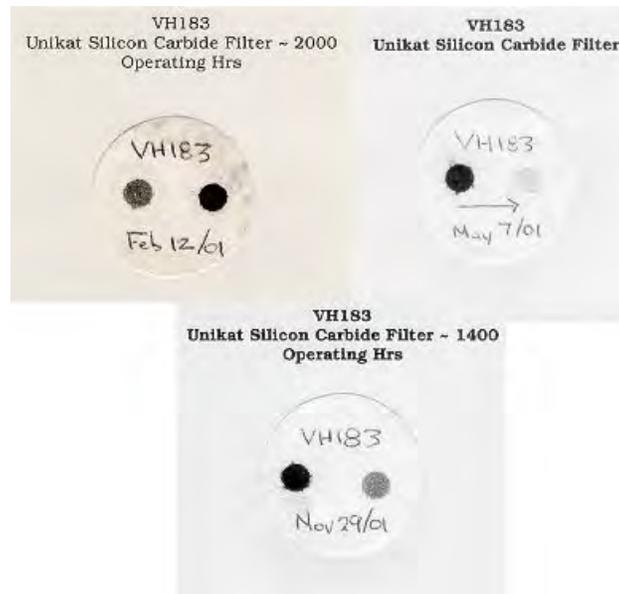
The results of the Bacharach Smoke measurements are shown in Figure 34. The BSI measurements showed that DPF systems on VH183 failed in two instances. The first set of filters failed after 2000 operating systems hours and the second set of filters failed after 1400 operating hours. At other test instances when the DPF system was not compromised the efficiency was relatively high. These results are in direct correlation with results obtained using other more sophisticated methods. Therefore this method is suitable for quick and inexpensive verifications of DPF system performance.

**Figure 34 - Bacharach Smoke Density Results on VH183 with ECS Octel DPF System**

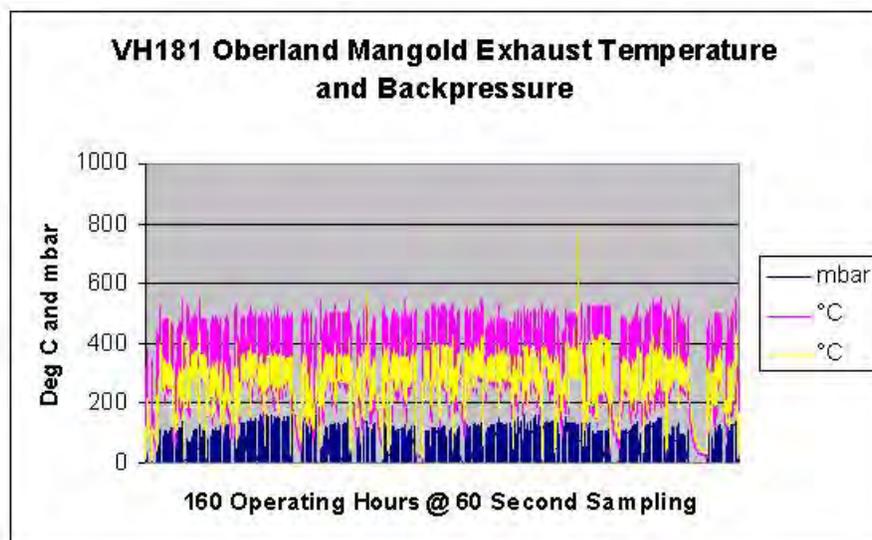
The data that was retrieved from the datalogger was backed up by measurements of backpressure performed by mine mechanics at monthly intervals. The backpressure reached a plateau of approximately 120 mbar or 50 inches of water. The data presented in Figure 35 shows backpressure values increasing and decreasing in a regular pattern, which indicates at least partial regeneration occurring during the duty cycle. The exhaust temperature traces show temperatures at the inlet to the system well above 400° C. The temperature profile compares well to one for the other truck used in the project but the backpressures and apparent regeneration profiles are drastically different. The glass fiber filter media appear to have captured less particulate than silicon carbide monolith media used in the other system. The lower loading inside the filter media made it easier to regenerate when temperatures reached high enough levels to ignite the trapped soot.

Figure 35 - Oberland Mangold Exhaust Temperature and Backpressure

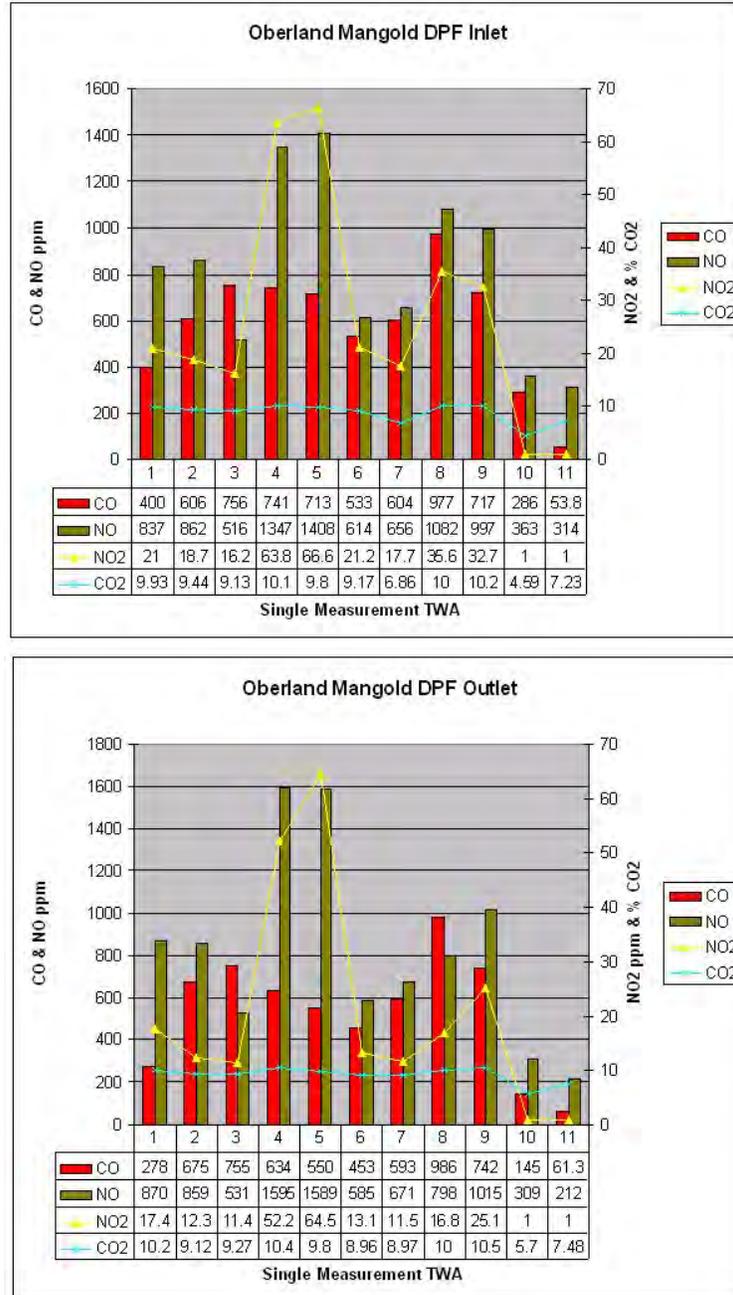
The results of gaseous emissions measurements made on VH181 truck equipped with the Oberland Mangold DPF system are shown in Figure 36. The non-catalyzed DPF with glass fiber media did not affect either carbon monoxide or nitrogen dioxide emissions. Carbon dioxide emissions and exhaust temperatures were consistent throughout the tests with the exception of the final test indicating that proper testing protocol was followed with full engine stall.

Figure 36 – Gaseous Emissions For VH181 With Oberland Mangold DPF

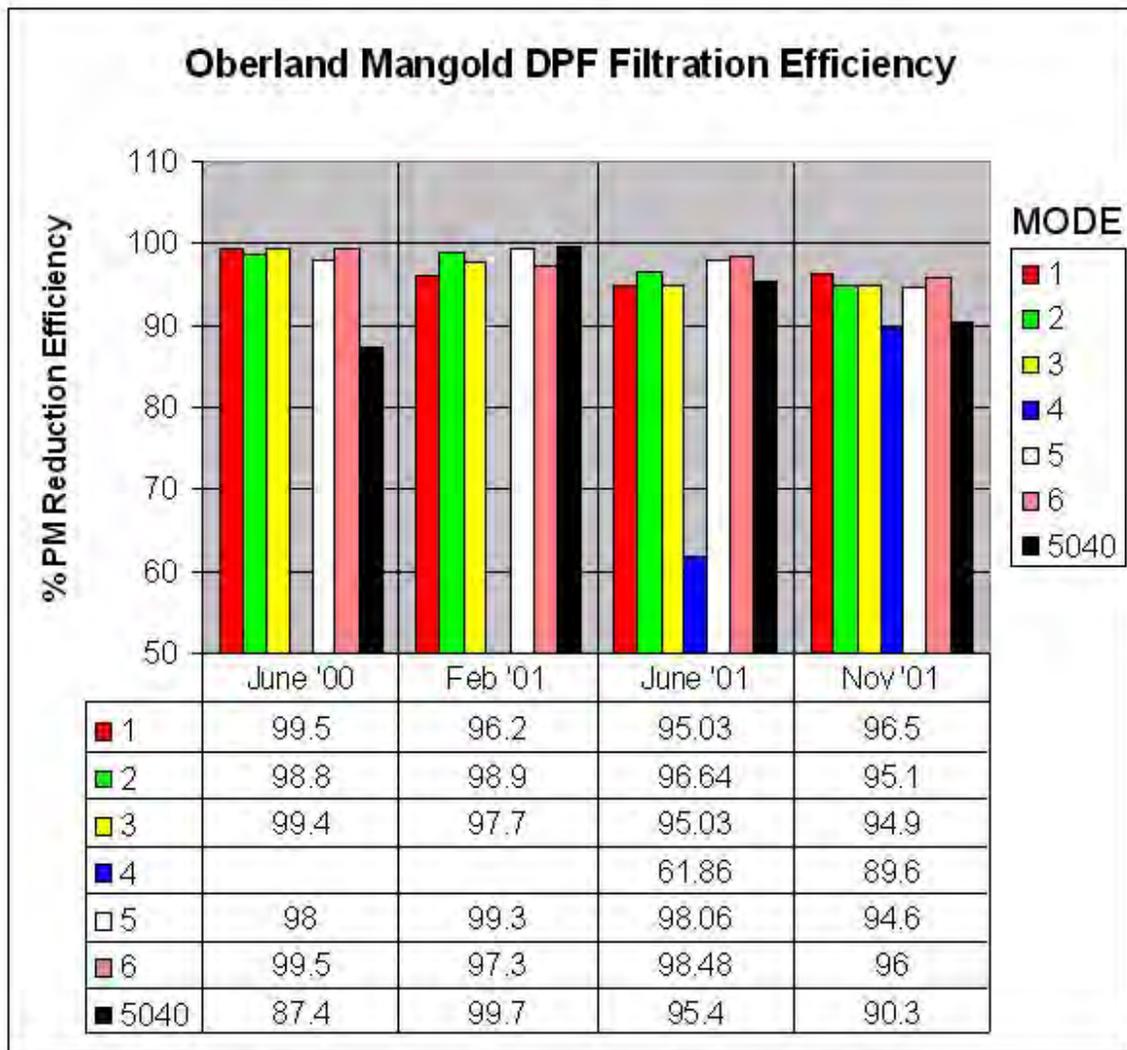
The results of particulate matter emissions measurements, shown in Figure 37, indicate that fiber knitted filter consistently exhibited lower filtration efficiency than the other three wall flow monolith DPF systems tested in this study. The first set of results was generated in June 2000 during the tests involving the original DPF with 25 filter cartridges. The other three tests were performed with the larger, 52 cartridge DPF system. The efficiency of the system was found to be lowest when particulate matter emissions obtained for tests at mode 4 (idle) were used for calculation. The PM emissions measurements obtained for remaining modes were providing consistent results and showed as low as 90% or slightly below. The NIOSH 5040 method analyses agreed very closely with NanoMet results in the 2<sup>nd</sup> and 3<sup>rd</sup> sets of tests but were 5 to 10% below NanoMet results in the 1<sup>st</sup> and 4<sup>th</sup> sets.

**Figure 37 – DPM Filtration Efficiencies For Oberland Mangold DPF System on VH181 Truck**

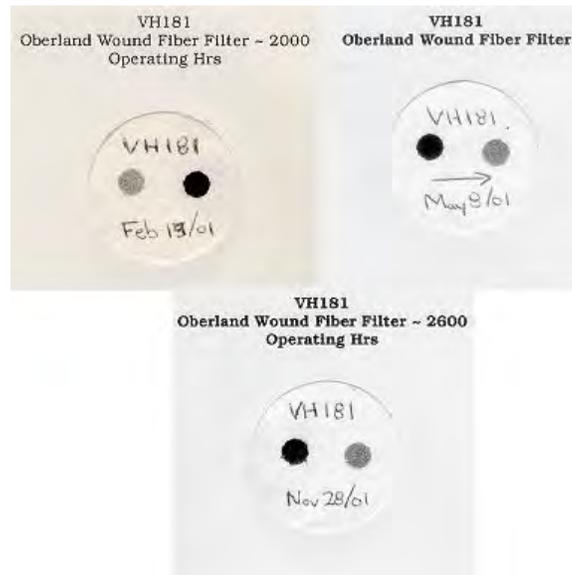
**Figure 38 - Oberland Mangold Octel Bacharach Smoke Density Results**

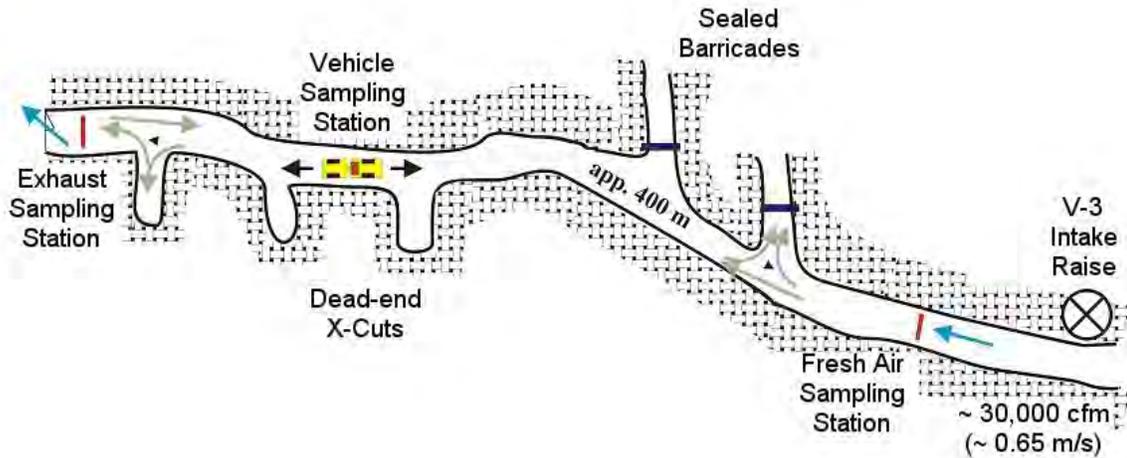
**Figure 39 - 525-5 Sublevel Isolated Zone**

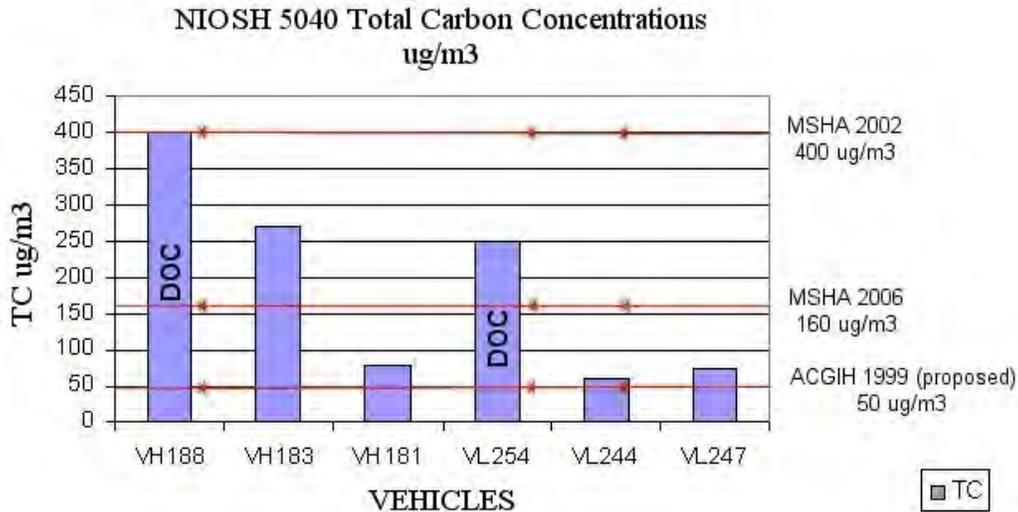
**Figure 40 – Total Carbon Concentrations in Isolated Zone for Different Test Vehicles**

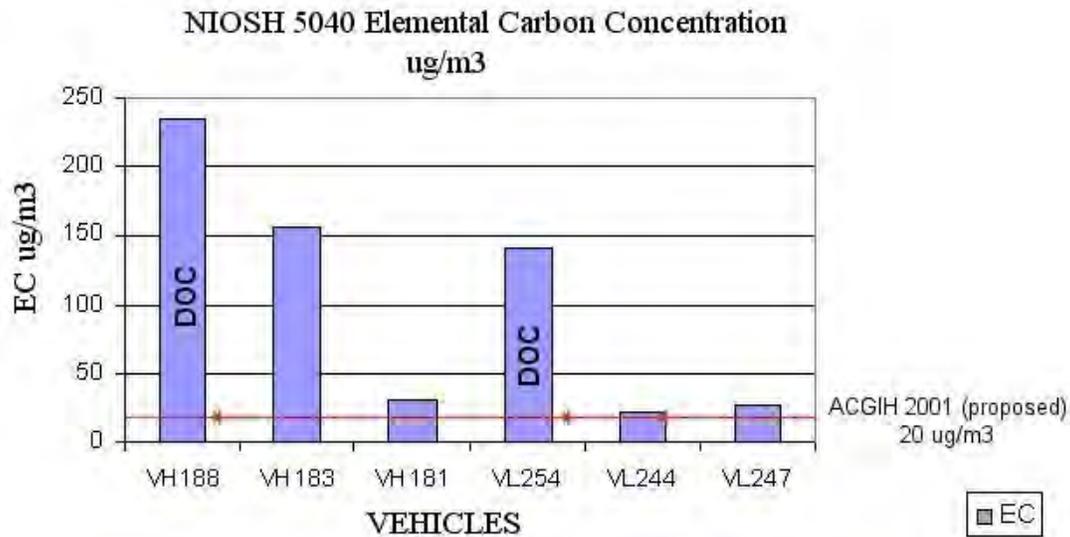
**Figure 41 - Elemental Carbon Concentrations in Isolated Zone for Different Test Vehicles**

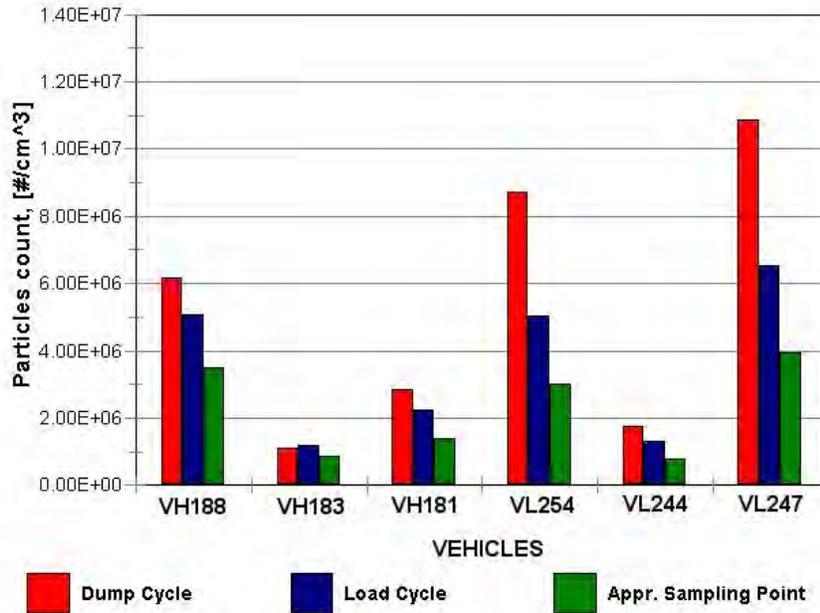
Figure 42 - Particle Concentrations by Number Measured in Isolated Zone for Different Test Vehicles

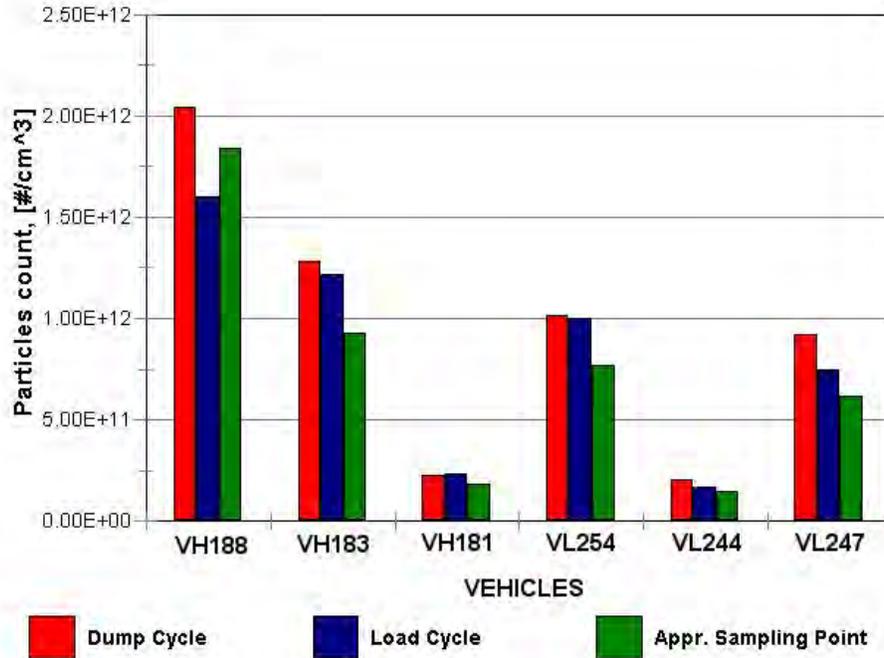
**Figure 43 - Particle Concentrations by Volume Measured in Isolated Zone for Different Test Vehicles**

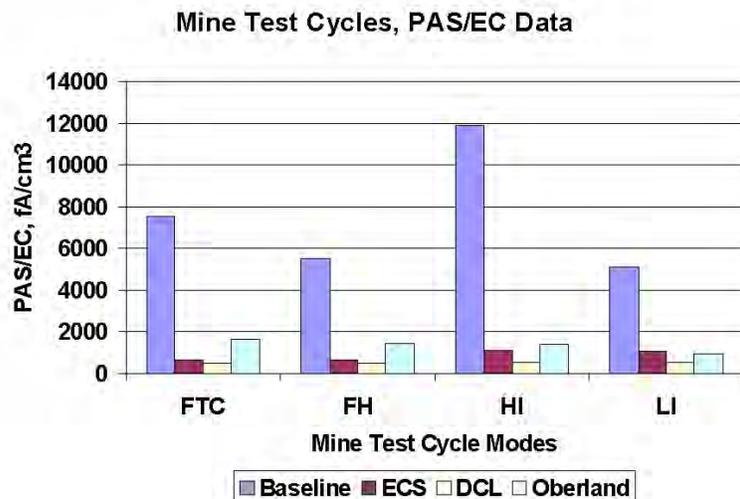
**Figure 44 – Results of Measurement with PAS 2000, Mine Test Cycles**

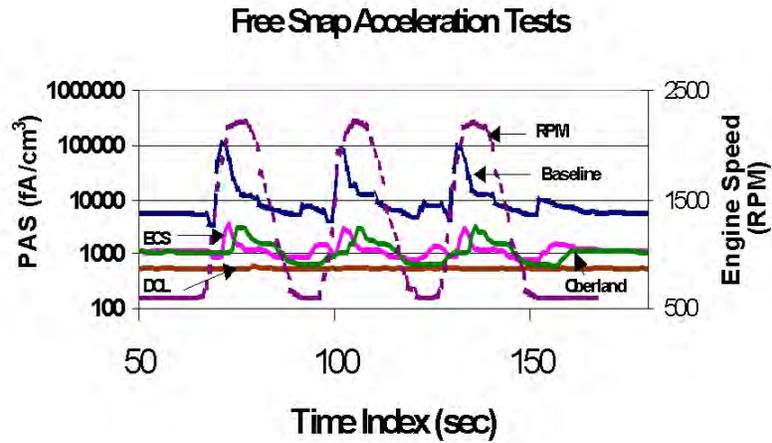
Figure 45 – Results of Measurement with PAS 2000, Snap Acceleration No-Load Tests

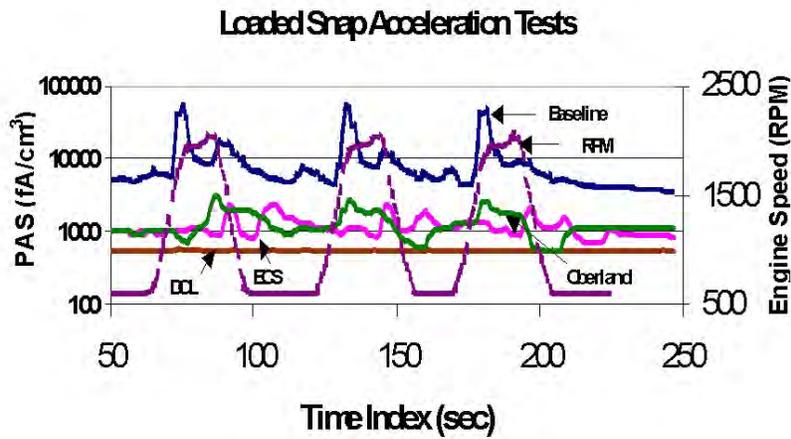
Figure 46 – Results of Measurement with PAS 2000, Snap Acceleration under Load Tests

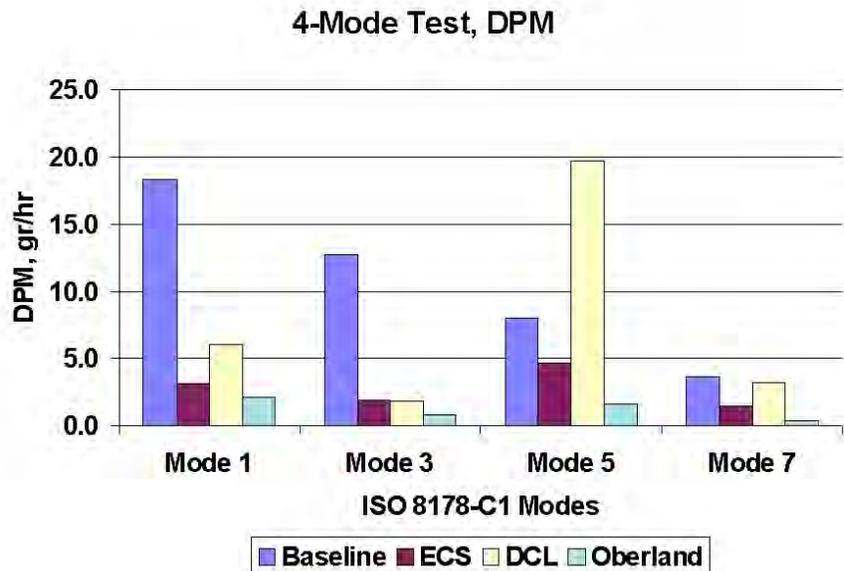
**Figure 47 – Average Total DPM Emissions Over Four-Mode Tests**

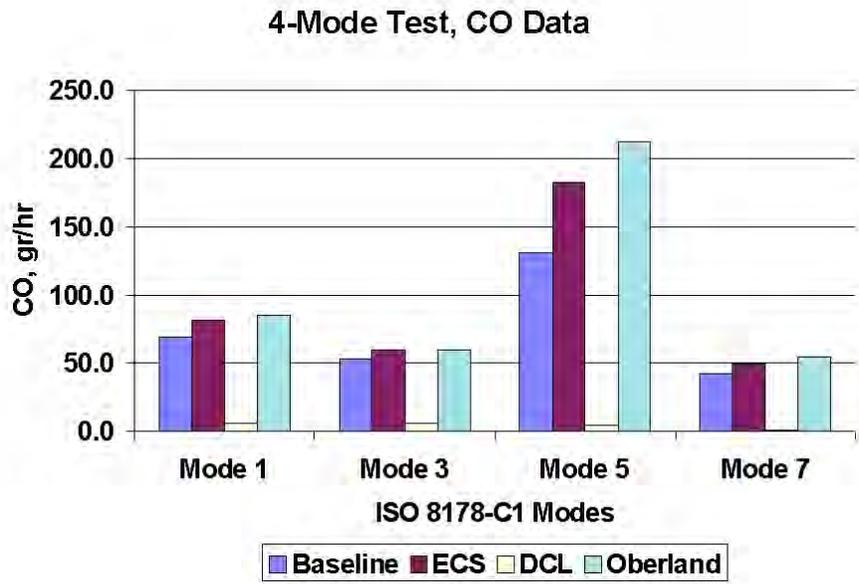
Figure 48 – Average Carbon Monoxide Emissions Measured Over Four-Mode Tests

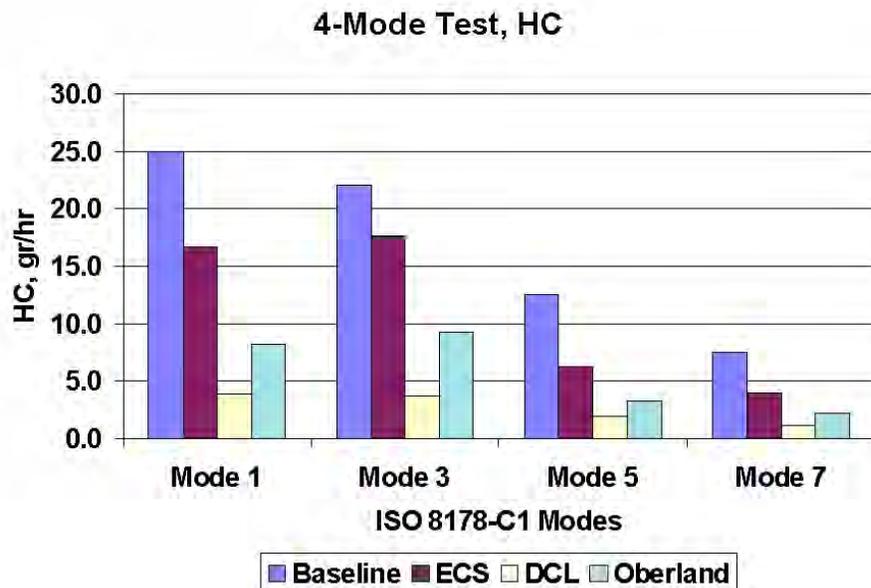
Figure 49 – Average Hydrocarbon Emissions Measured Over Four-Mode Tests

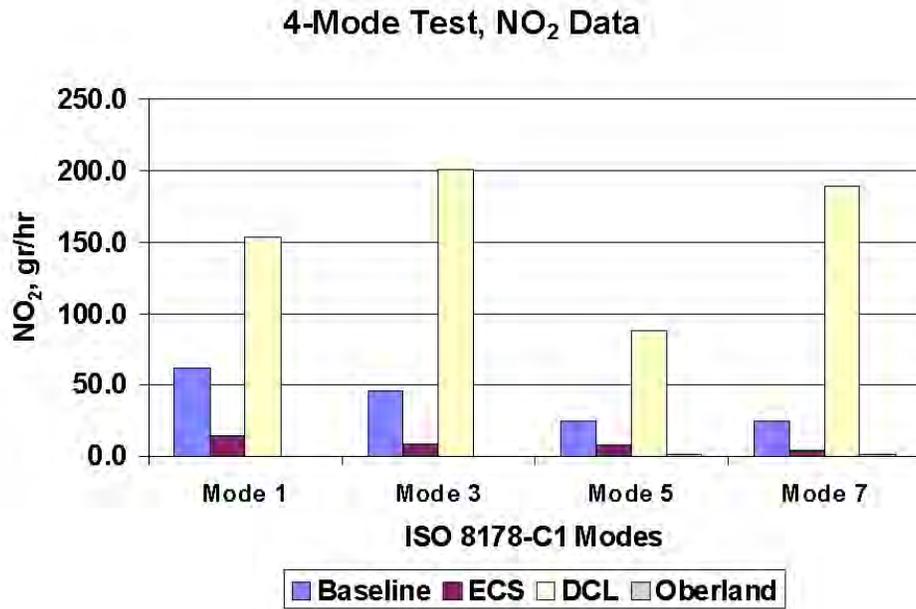
**Figure 50 – Average Nitrogen Dioxide Emissions Measured Across Four-Mode Tests**

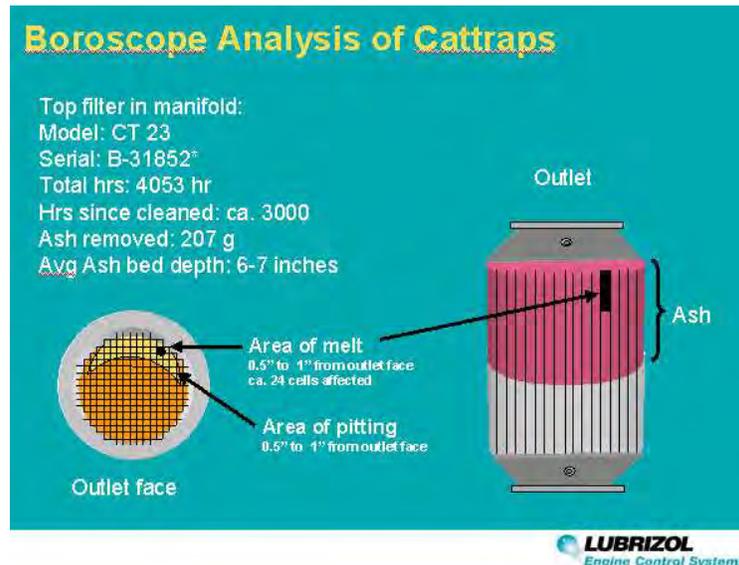
Figure 51 - Non-Destructive Testing of ECS CatTrap

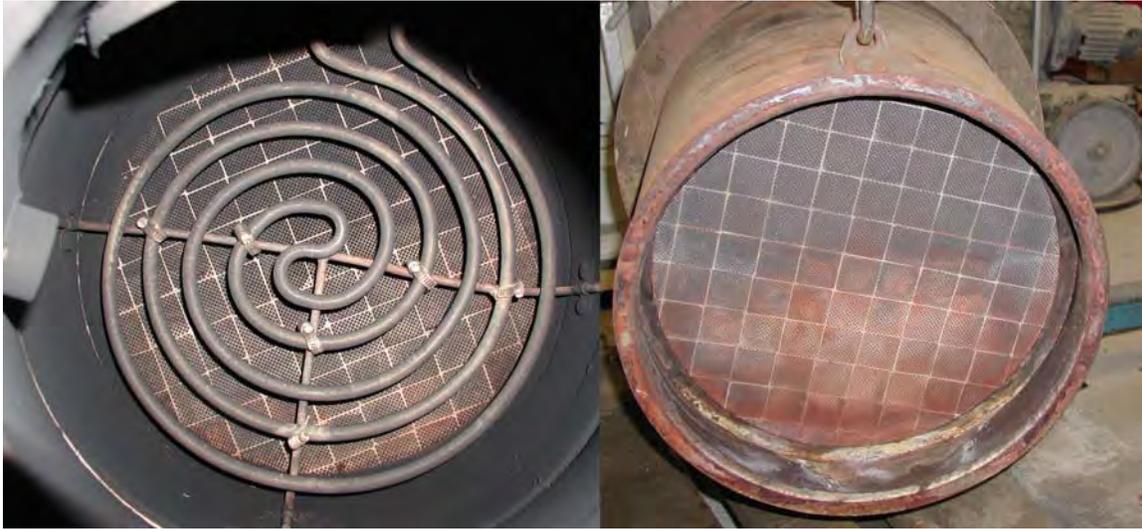
**Figure 52 - Inlet and Outlet Faces of DCL Bluesky DPF**

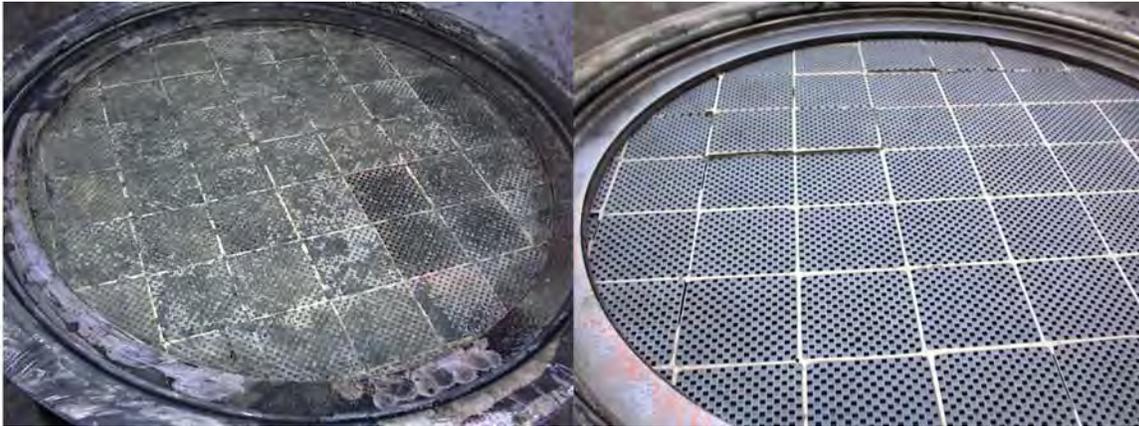
**Figure 53 - Inlet and Outlet Faces of ECS Octel DPF**

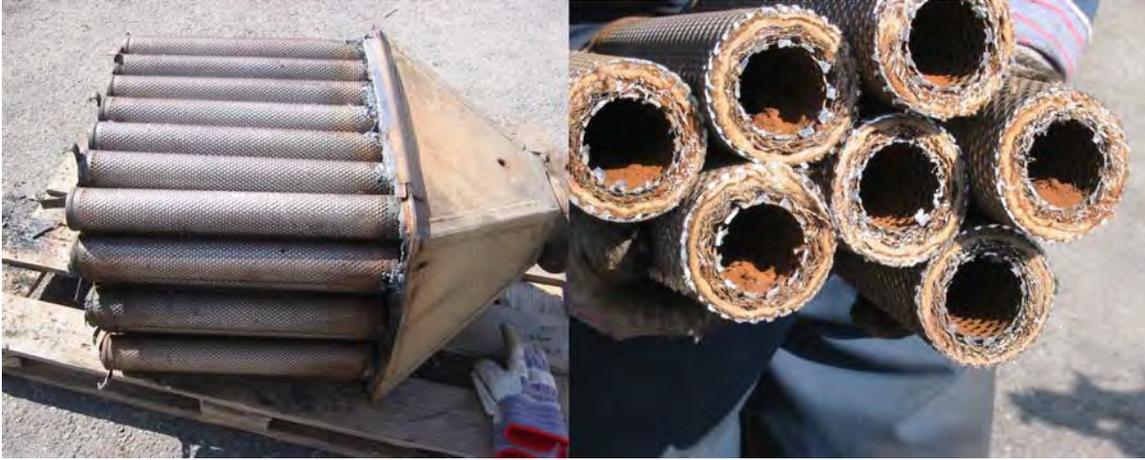
**Figure 54 - Oberland Mangold Fiber Cartridges and Iron Oxide Accumulation**
