Blasting Injuries in Surface Mining with Emphasis on Flyrock and Blast Area Security

*by T. S. Bajpayee, T. R. Rehak,
G. L. Mowrey, and D. K. Ingram*

Blasting injuries in surface mining with emphasis on flyrock and blast area security

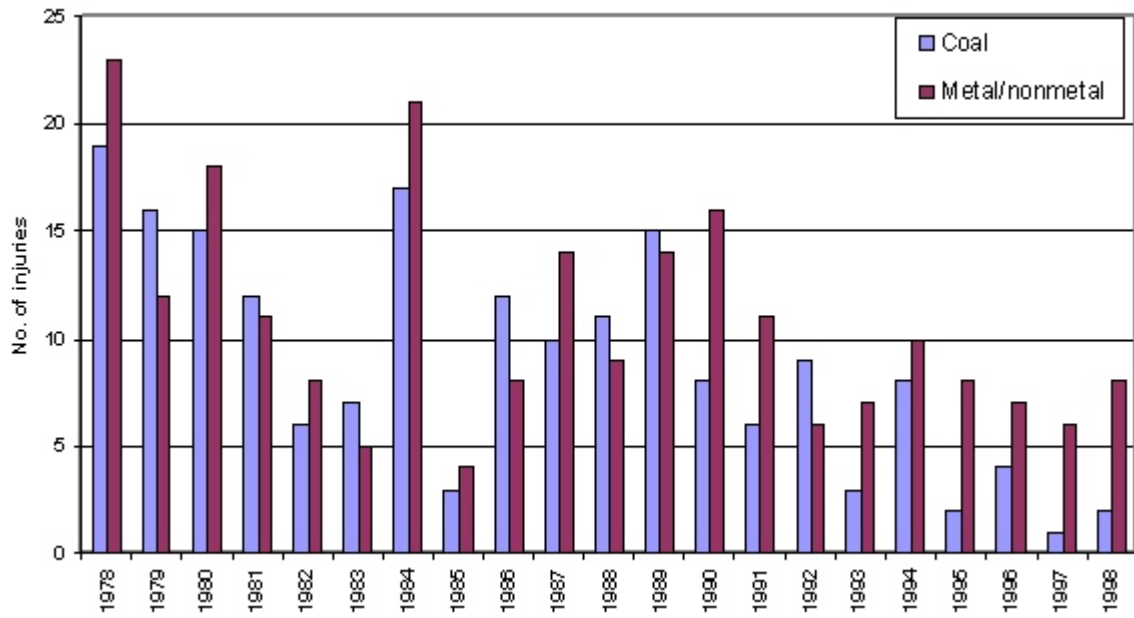
Figure 1. Blasting injuries in surface mines, 1978 - 1998

Forty-five fatal injuries were caused by explosives in surface mines between 1978 and 1998. Coal mines accounted for 19 (42.2%) of the fatalities; metal/nonmetal 26 (57.8%). A total of 367 nonfatal injuries occurred during the same period, averaging about of 17.5 injuries per year. Coal mines accounted for 167 (45.5%) of the injuries; metal/nonmetal 200 (54.5%). Table 2 and figure 1 show the annual distribution of fatal and nonfatal injuries for surface blasting in the coal and metal/nonmetal sectors. During the 21-year period from 1978 to 1998, the mean yearly injuries (fatal and nonfatal) for coal mines was 8.86 (95% CI: 6.38 -11.33), and for metal/nonmetal mines 10.76 (95% CI: 8.39 - 13.14).

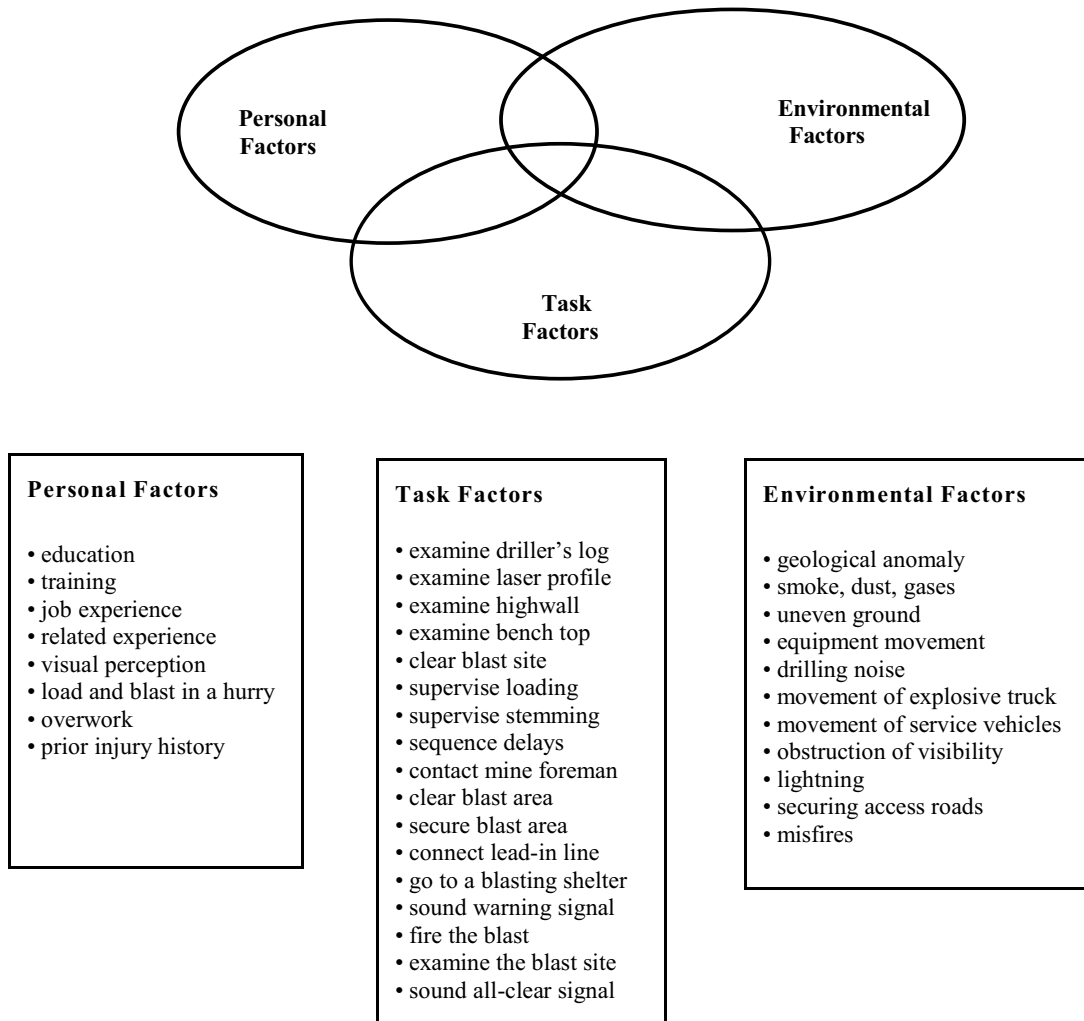
Figure 2. List of factors involved in blasting

Although the circumstances of each incident varied, some important similarities were observed. Deficiency or lack of attention to personal, task, or environmental factors has the potential to cause injury. Figure 2 provides a list of factors which play a role in successful blasting.
