# Diagnosing and Controlling Moisture-Sensitive Roof in Coal Mines

*NIOSH-Pittsburgh Research Laboratory, Pittsburgh, PA*

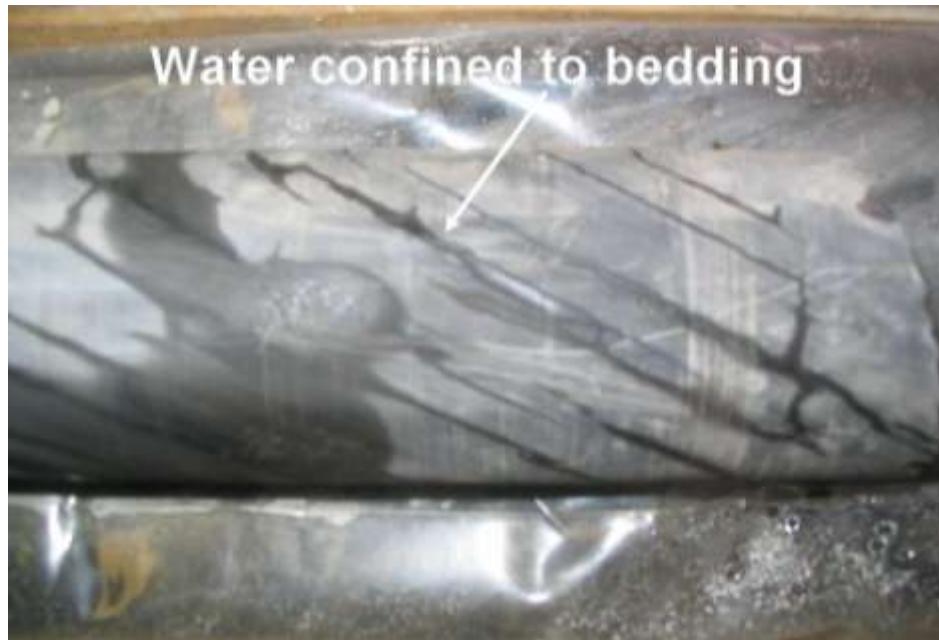
**Figure 6:** Water moves more readily along bedding than across bedding.

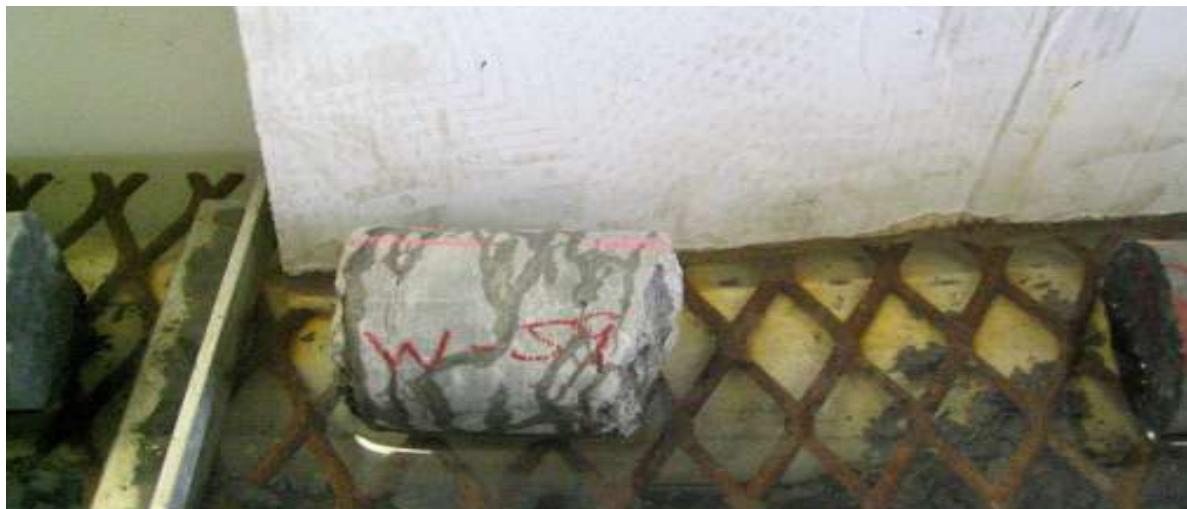
**Figure 8:** Fireclay showing disturbed bedding and water moving easily on bedding.

across bedding (Figure 8). The bedding of roof rock samples was classified as “irregular” or “flat” and plotted against the average moisture-sensitivity of each bedding type. Figure 9 shows that samples with irregular bedding were, as a group, more moisture-sensitive than flat-bedded samples. This progressive infiltration of moisture through irregular bedding may allow for the exposure of swelling clays and begin the deterioration of the rock mass. Rock then falls between bolts and prevents load transfer to the bolts.

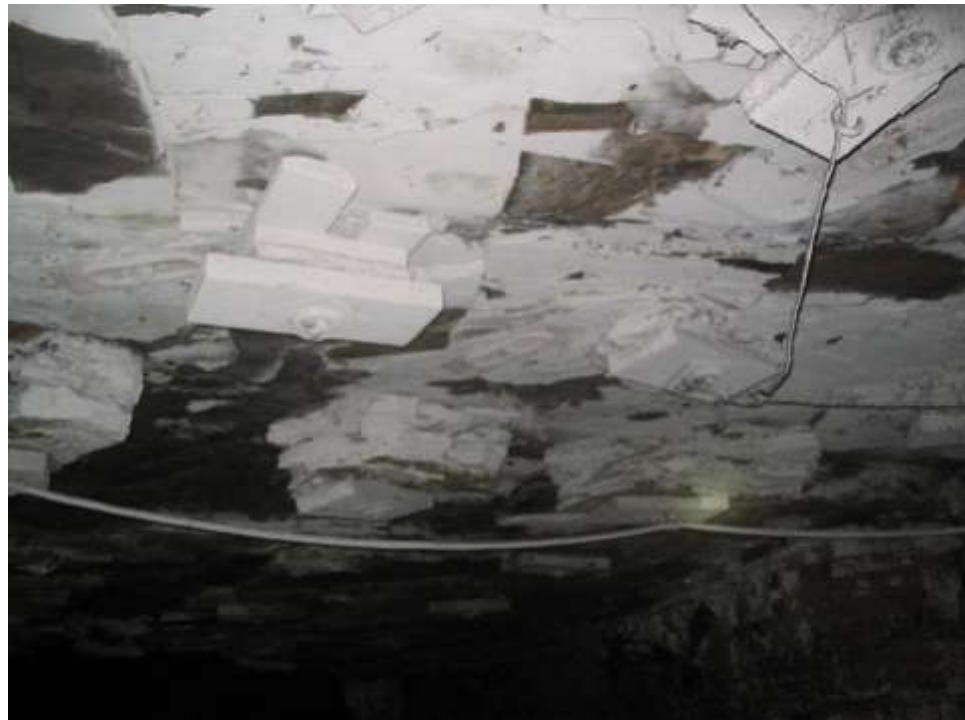
**Figure 14:** Pinchout of black shale leaves moisture-sensitive gray shale exposed.

Between crosscuts #61-65 the roof begins to transition back to the gray shale. Roof falls occur in this transition, and the roof gets dramatically worse as the black shale feathers out to gray shale (location C). Twelve inch roof pots become common with some extending to 24 in high. Weathering is extreme and the roof drips in the summertime due to high humidity (Figure 14). The mine air remains humid until about crosscut #120 when the air loses its moisture and is finally tempered. The gray shale, if wet, deteriorates in a matter of weeks. If kept dry it will last a few months, but then eventually will also deteriorate.

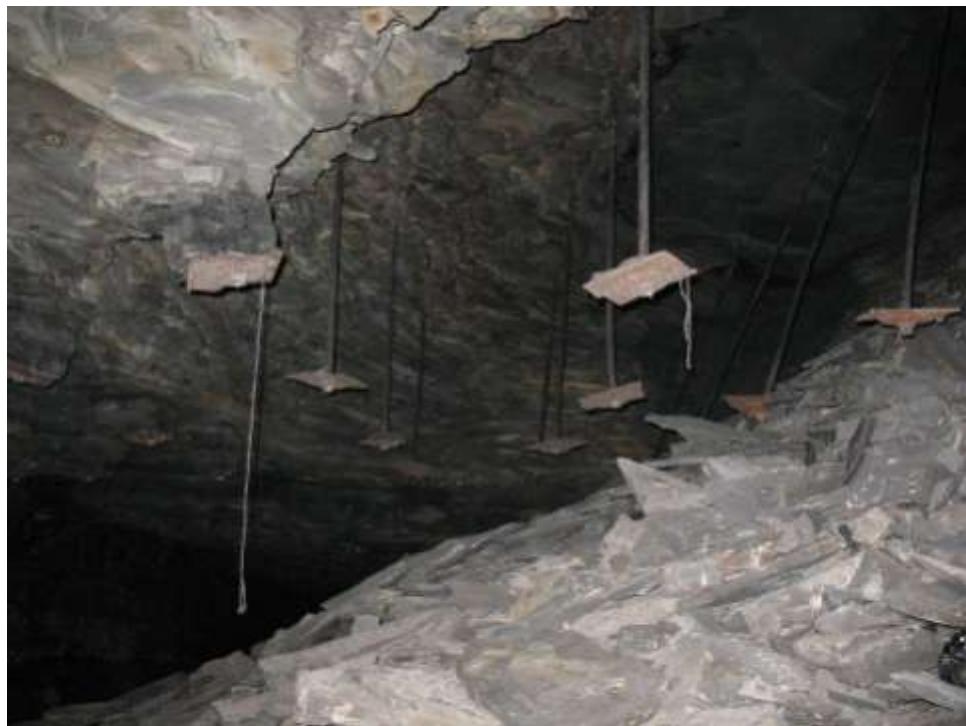
**Figure 15:** Extreme roof deterioration in moisture-sensitive shale at an Illinois coal mine.

The laminated shale averages 89.1%, and the gray shale 91.4% on the Weatherability index. The laminated shale begins to deteriorate within weeks after mining and can be easily broken by hand. Extreme roof potting and deterioration has occurred in an area near the intake shaft after 4 years exposure (Figure 15). This area is currently impassable due to roof and rib deterioration. This roof was not screened for operational reasons. Immediately adjacent to this area is roof that is 14 years old but was screened on cycle. The screen is heavily loaded, but the roof has stayed intact and the entry is passable (Figure 16). The effects of aging and extreme weathering of the roof have been mitigated by roof screen.

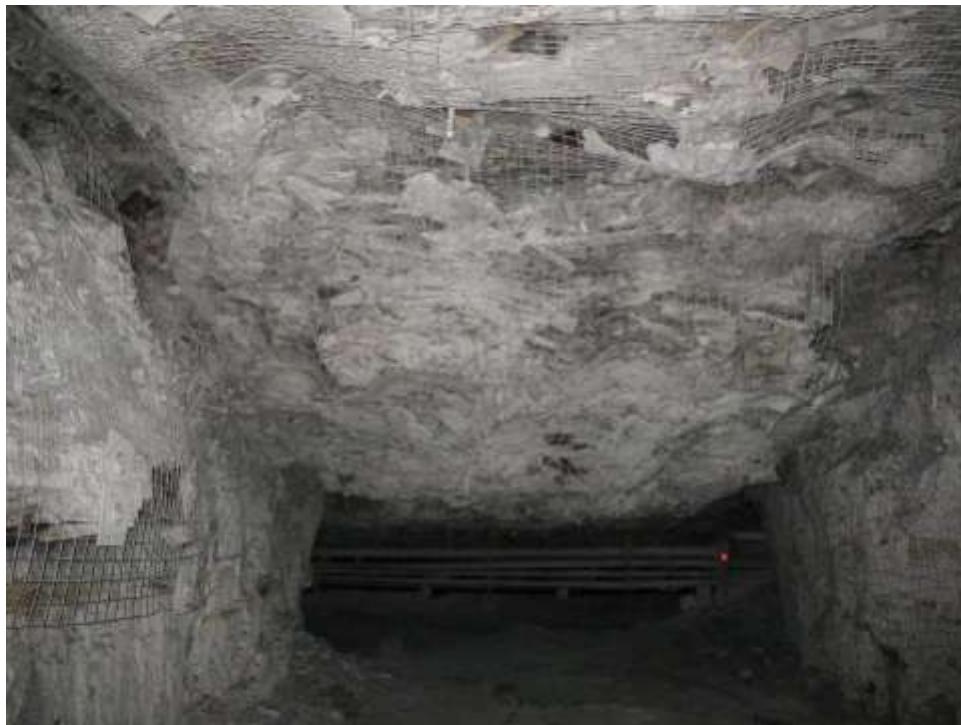
**Figure 16:** Heavily loaded roof screen preserves roof integrity.

Because of the extreme moisture-sensitivity of the immediate roof rock, the roof is screened rib to rib.

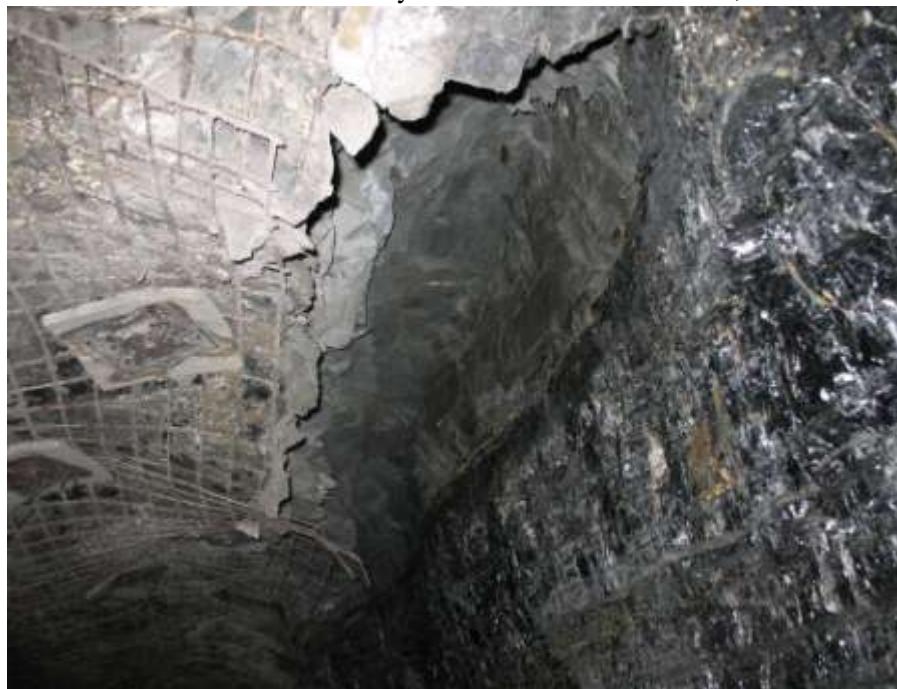
**Figure 17:** Exposed corners in wide entries can lead to guttering and eventually roof fall.

This preserves the roof-rib corner from cutting and progressive guttering. Where the entry is inadvertently cut wide or the rib sloughs, the corner is exposed beyond the reach of the screen. Once exposed, the corner begins to gutter and unravel (Figure 17). This corner failure has lead to roof falls. The mine has solved this problem by extending roof screen around the corner and down the rib (Figure 18). Since the inception of roof screening in 1994, the mine has dramatically cut injuries due to rock fall (Figure 19).

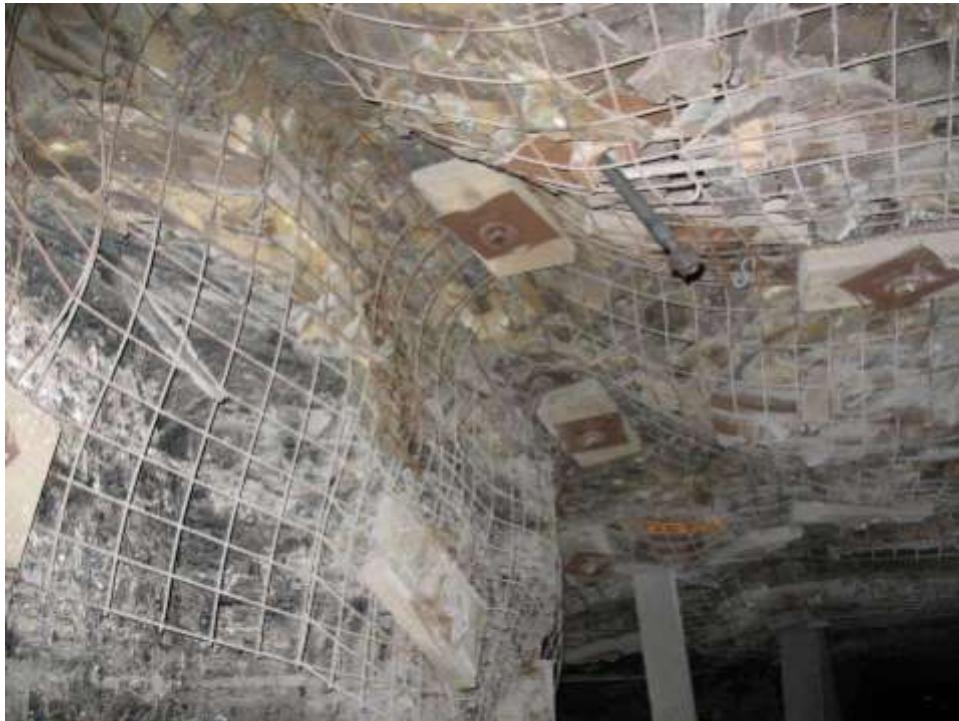
**Figure 18:** Full screening down the rib protects exposed corners and prevents rock falls.

This case study provides an example of where screen may provide a support benefit other than surface control. Much like the skin of a pillar provides confinement and strength to the pillar core, steel screen may act to confine roof layers and prevent the progressive delamination which can lead to a massive roof fall. Once rock has loosened and begins to load the screen, the weight of the rock is then transferred to the roof bolts providing active support, instead of falling out between bolts.
