THE INTRODUCTION OF ROOF BOLTING TO U.S. UNDERGROUND COAL MINES (1948-1960): A CAUTIONARY TALE

Christopher Mark, *Chief, Rock Mechanics Section*
National Institute for Occupational Safety and Health
Pittsburgh Research Laboratory
Pittsburgh, Pennsylvania USA

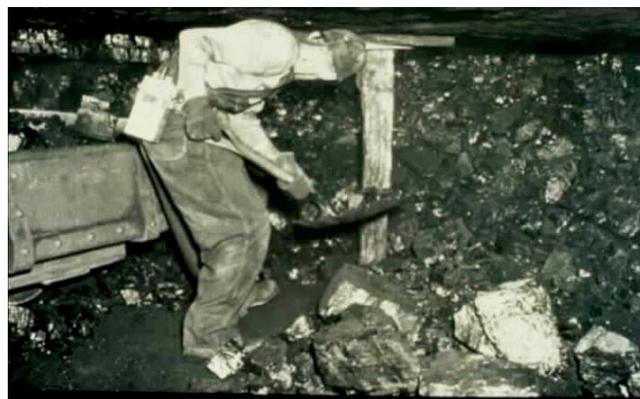
Figure 4. Hand loading with a safety post.

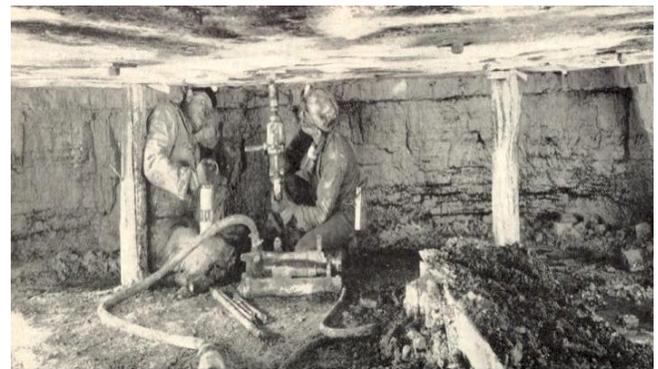
Figure 10. Installing roof bolts with a hand-held stopper drill.

The first roof bolts were installed in Mine No. 7 using hand-held stopper drills (figure 10). The anchors were expansion shells “similar to those used to support trolley wire”, though slot-and-wedge type anchors like the ones “ordinarily used in the metal mines” were also employed. A section of channel iron was used as a plate. The DC air compressor was powered by a trailing cable and mounted on a truck. Two men constituted the bolting crew.³⁶

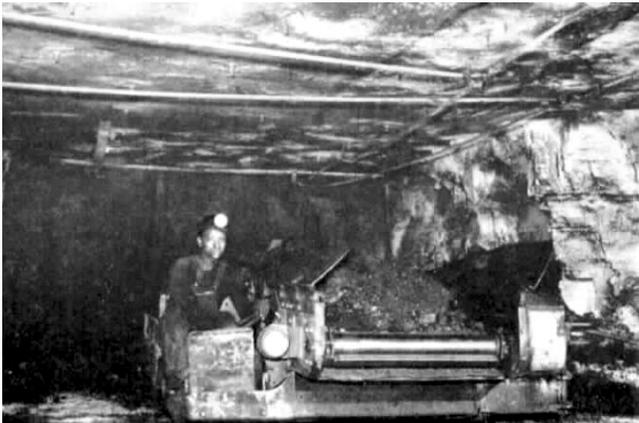
Figure 13. Shuttle car haulage with roof bolts.

Between 1949 and 1955, numerous case histories of the successful application of roof bolting from all over the coalfields were reported in the mining press (figures 13 and 14). An early article reported that three northern West Virginia mines of the Christopher

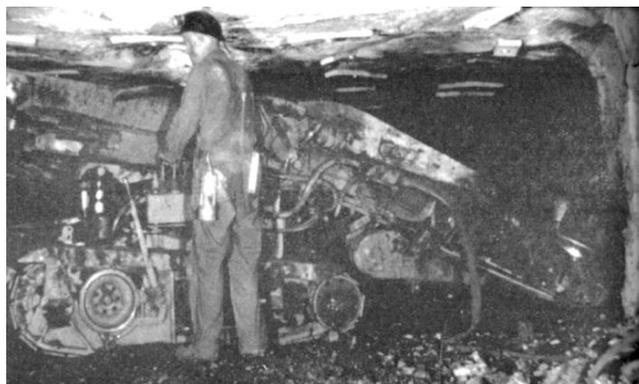
Figure 14. Machine loading with roof bolts.

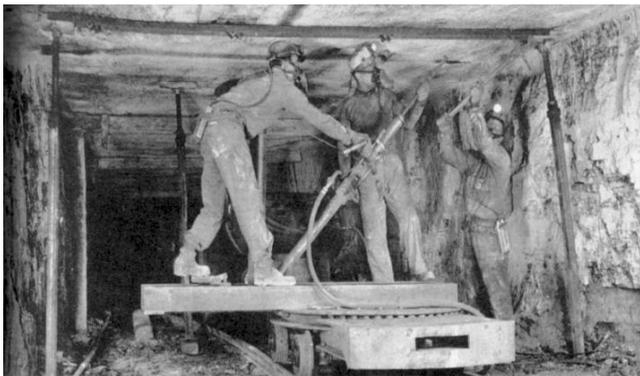
Figure 17. Dry drilling using respirators for dust protection.

The Bureau publicized research that showed dry drilling, with either pneumatic stoper or electric rotary drills, could result in silica dust concentrations up to 200 times the recommended level of 5 million particles per cubic ft of air. Such concentrations were a serious menace to not just the drill operators, but also anyone working downwind in the return air. Wet drilling, on the other hand, was found to result in acceptable levels of dust.⁸⁵
