# INNOVATIVE SAFETY INTERVENTIONS

Feasibility of using intelligent video for machinery applications

BY TODD M. RUFF

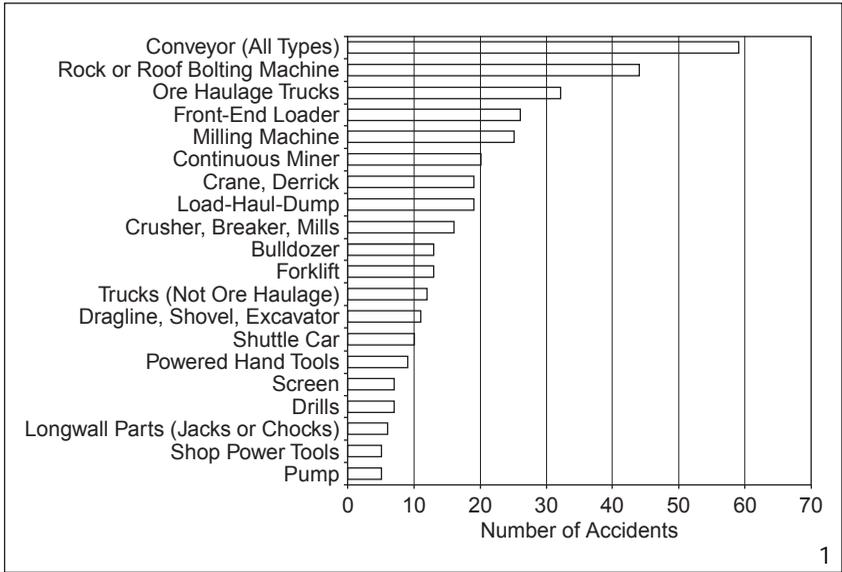
Mining machinery involved in severe accidents, 2000–2005,  $n = 438$  (top 20 machines).

severe accidents at mining operations. Figure 1 shows the top 20 machine types involved in these accidents, with conveyors listed most often (13%). The activity of the worker during the accident was also of interest (Figure 2), with a significant portion of injuries and fatalities occurred during maintenance and repair of machines (24%). Also of interest was that, in approximately 40% of the fatalities involving stationary equipment such as conveyors and crushers, lockout/tagout procedures either were not followed or were not adequate for the particular machine involved [7].

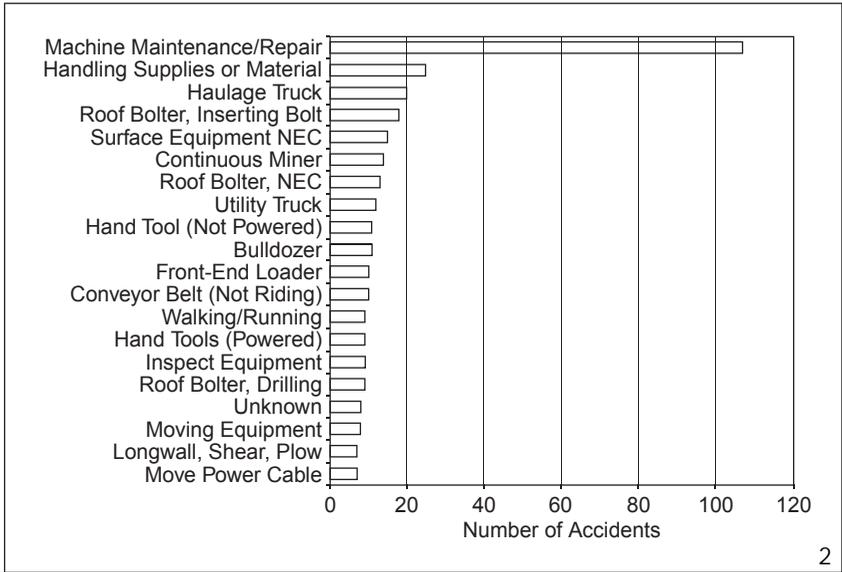
Worker activity at the time of the accident, 2000–2005,  $n = 438$  (top 20 activities).

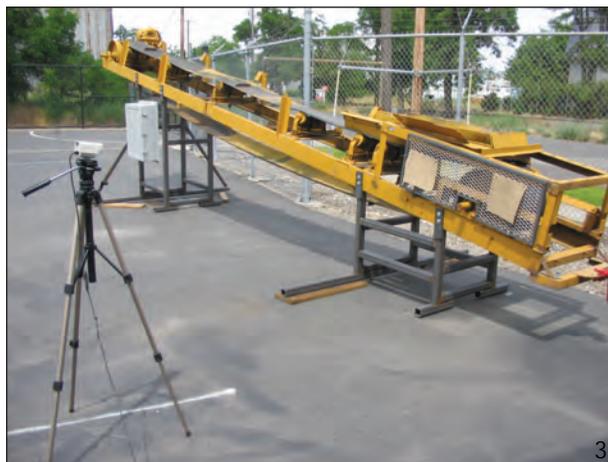
The test conveyor at NIOSH Spokane Research Laboratory.

A preliminary evaluation of intelligent video technology was conducted by NIOSH researchers during a 2007 pilot project. A small rock conveyor was used as a test platform (Figure 3). An eight-channel IVS manufactured by Artec Vision Systems and three different types of outdoor cameras were purchased for evaluation. Several different scenarios were tested: perimeter protection to detect the presence of a worker near the conveyor; monitoring small areas on the conveyor to detect the presence of fingers, hands, and arms in hazardous areas; monitoring the removal of machine guards or enclosure lids; and detecting a worker lying motionless on the ground. The tests described here were primarily conducted using an inexpensive outdoor color camera (420 lines of resolution, 4.3 mm lens).

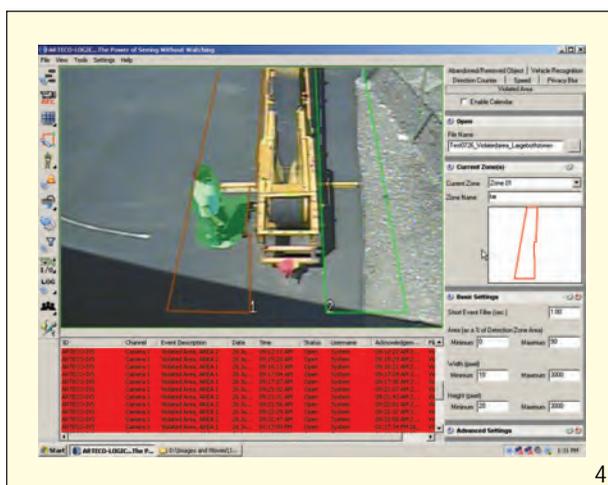
The detection zones for whole-body detection tests.

The detection zones were drawn by simple point-and-click actions to define the corners of the detection area in a particular camera's video window. These zones are indicated by green boundaries (Figure 4). If a person entered a zone, the boundary turned red, indicating an alarm event. At the same time, an audible alarm was activated, and a control signal was generated by using a relay interface. The tests were conducted in the morning (9:00 a.m.) and again just after noon (1:00 p.m.) to observe the effect of different sun positions and resulting shadows. Each test was conducted with the same test subject, first in light-colored clothing and then in dark-colored clothing to determine the effects of differing clothing contrasts against the asphalt background. The test subject entered the zone several times and at several different locations for each test. The IVSs also remained activated between the morning and afternoon tests to see if false alarms were generated.

With high-sensitivity settings, the system reliably detected a person entering either the left or right zone (Figure 4), regardless of clothing color. No missed detections

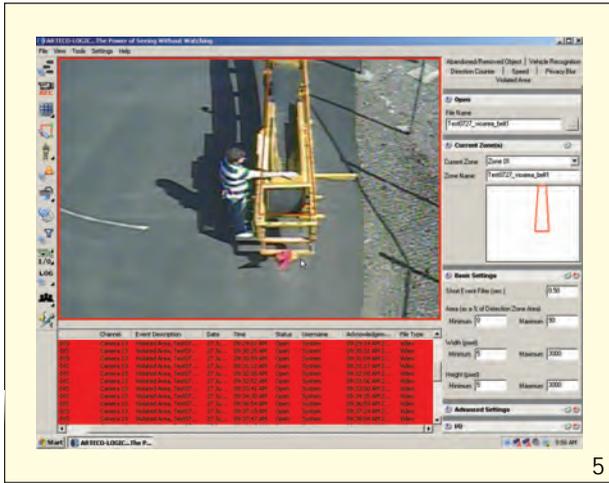
The tail pulley zone for appendage detection tests.

The next test was to determine the reliability of the video system in detecting smaller portions of the body encroaching on critical areas of the conveyor, e.g., the belt and pulley areas. Figure 5 shows the detection zone drawn over the tail pulley area. This detection analytic could only be active when the conveyor was not running—the moving material and belt would constitute constant changes within the detection perimeter and would result in false alarms. Thus, the detection and alarming would be activated during maintenance, when the conveyor was motionless. If a worker's hand, arm, or body was detected in this scenario, an alarm control signal would be provided to the main-conveyor controls to prevent start-up. In this way, the system could not be restarted if a worker was performing maintenance or if maintenance was completed but not all personnel were clear of the area. The false alarms in this scenario could be tolerated. The tests showed that the false alarms were short in duration and the cause was evident in the video, allowing quick correction and resulting in only short delays in the execution of machine start-up.

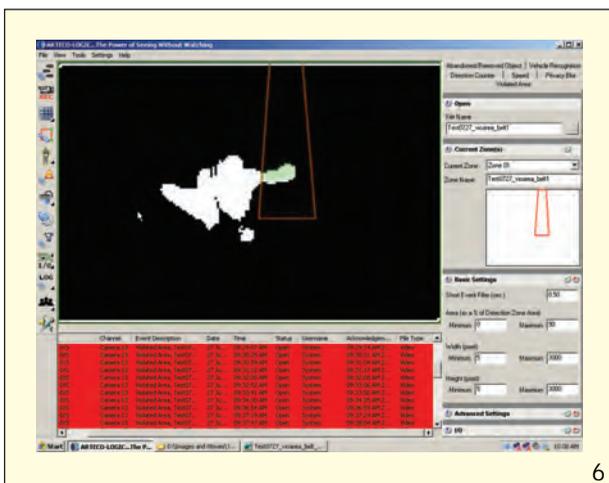
The corresponding blob view after processing.

The tests were conducted in the morning and afternoon at several different locations along the detection area. The sensitivity settings were set high to detect small objects in the detection zone. The tests were run to detect fingers, a hand (to the wrist), an arm (past the elbow), and head/shoulders leaning over the belt (Figure 5). For each body part, ten detection tests were conducted in the morning and ten in the afternoon. The fingers were detected with 80% reliability in the morning test and 60% in the afternoon. A hand was detected with approximately 60% reliability in the morning and afternoon (sporadic detection occurred at some locations but was considered unreliable detection for these calculations). An arm over the belt, or head/shoulders leaning over the belt, was detected 100% of the time in both tests. Figure 6 shows the blob view that the computer is analyzing during the arm detection test. In this view, black indicates areas that have not changed from the baseline, whereas white areas indicate new features or changes in the scene.
