ROCK MASS BEHAVIOR AND SUPPORT RESPONSE IN A LONGWALL PANEL PRE-DRIVEN RECOVERY ROOM

Dr. Stephen C. Tadolini
Dr. Thomas M. Barczak
National Institute for Occupational Safety and Health

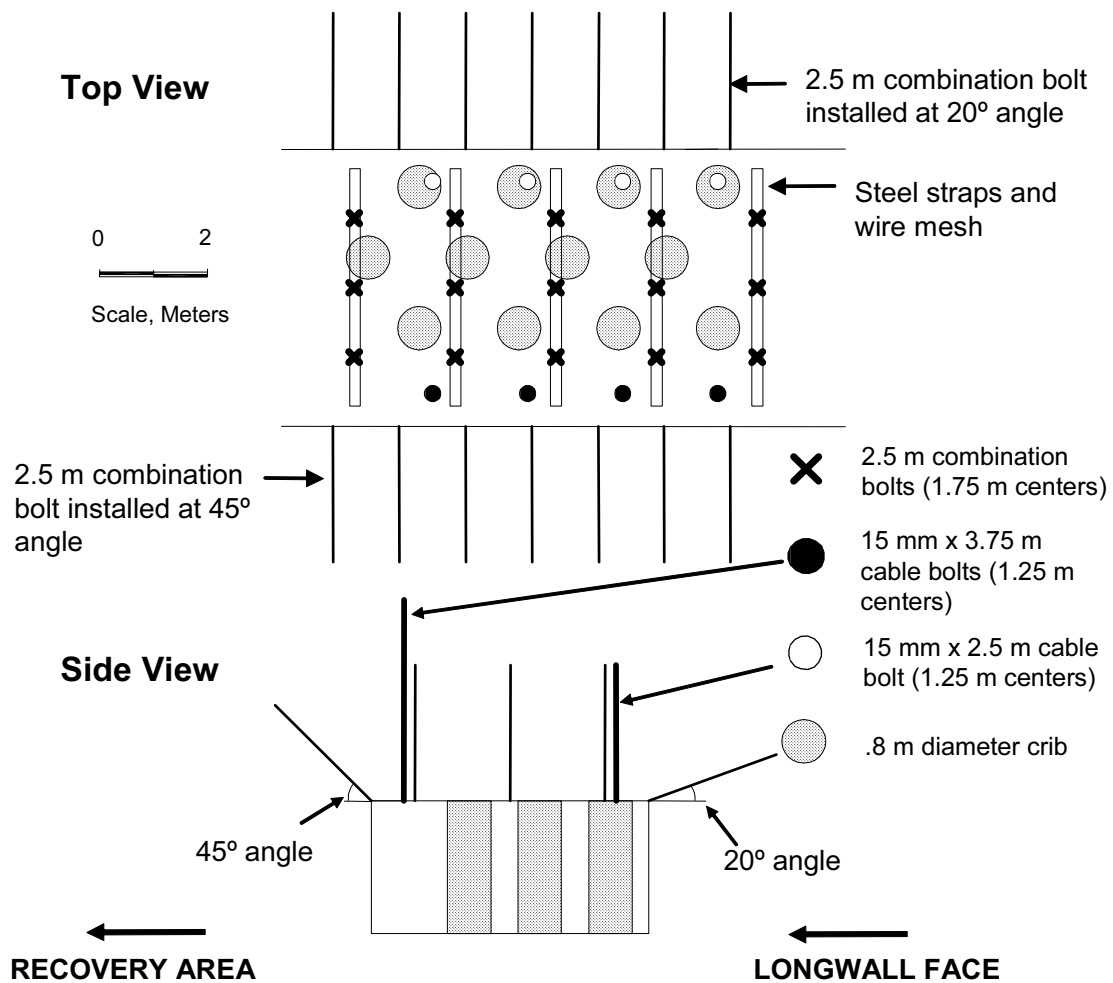
Figure 1 shows the support design for the recovery room. The recovery room was supported with 2.5-m (8-ft), grade 75, combination bolts. Combination bolts were also angled over the longwall panel and the outby pillar ribs to provide additional support as the face cut into and then widened the recovery room. Two and a half meter (8-ft) cable bolts on 1.25-m (4-ft) spacing were installed 62.5 cm (2 ft) from the panel rib to help support the roof when the first row of cribs were cut out, and 4.8-m (12-ft) cable bolts on 1.25-m (4-ft) spacing were installed 62.5 cm (2 ft) from the pillar rib to reinforce the roof from possible shear/tension fractures. The roof was glued with polyurethane resin (PUR) on the outby (pillar) side to strengthen the roof in the area adjacent to the pumpable cribs. The mine chose not to use PUR on the inby side, as was done on the previous panel, to facilitate caving of the immediate roof once the shields entered the room.

Three rows of 0.8-m (30-in) diameter pumpable roof supports were utilized in the recovery room as shown in figure 1. These were Calcium-Sulfo-Aluminate (CSA) grout filled supports that are identical to the supports used for the longwall tailgate except the spiral metal wire in the bag was replaced with a fiberglass wire that could be more easily cut by the longwall shearer. The performance characteristics of this support, as measured in the laboratory through full-scale testing in the NIOSH Mine Roof Simulator, indicate the pumpable support is very stiff with peak load occurring at less than 12.7 mm (0.5 in) of displacement. The support sheds load rapidly during yielding as the bag acts to provide confinement and maintain a residual loading capacity.

Figure 1. Support design for the longwall recovery room.

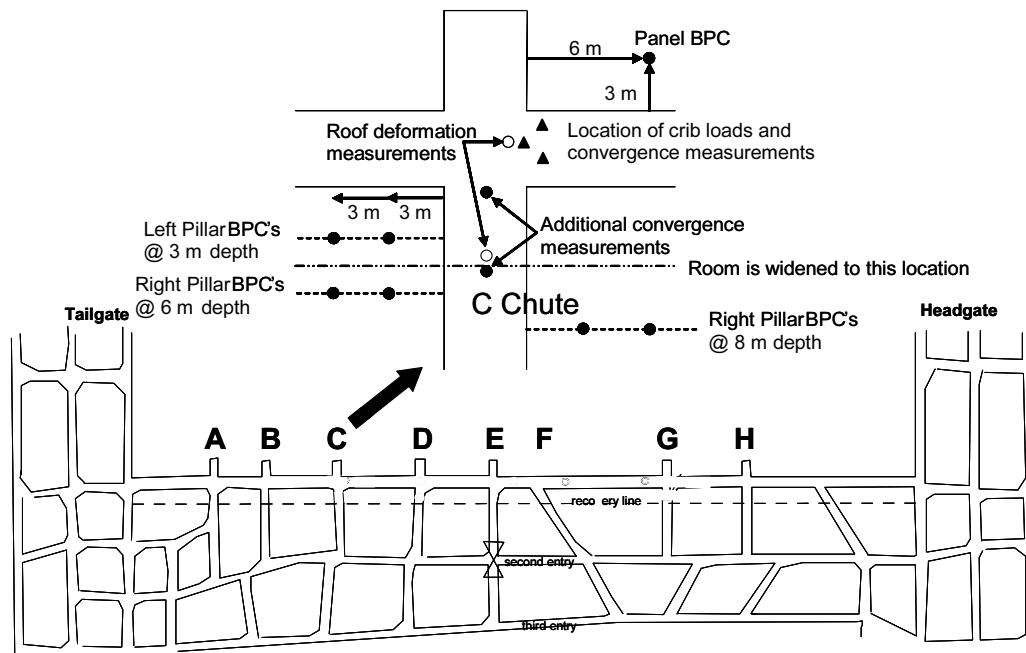
A diagram depicting the approaching longwall panel, predriven recovery room and outby pillar configuration is shown in figure 2. The instrumentation for this study was clustered in areas near Chutes C, F, and G and included:

- Borehole Pressure Cells (BPCs) were used to measure panel and outby pillar stress development in the C chute area. Figure 2 depicts the location of the cells. One cell was installed in the panel 3.1-m (10-ft) from the recovery room to measure yielding of the panel fender as the longwall face approached, two cells were installed in the outby pillars at a depth of 3.1-m (10-ft) and two other cells 6.2-m (20-ft) from the from the outby edge of the recovery room to measure load transfer from the panel to the outby pillars. Two more cells were installed 8.1-m (26-ft) from the outby edge of the recovery room in the adjacent pillar of the C chute location, again to measure load transfer from the longwall panel as the fender yielded.

Figure 2. Diagram showing instrumentation in the longwall recovery room.

The shield leg pressures provide further insight into the loading mechanisms associated with the panel fender yielding. The panel stress measurements are located adjacent to the C Chute location and shield number 175 (see figure 2), which is about 312.5 m (1,000 ft) from the headgate on this 453 m (1,450 ft) long

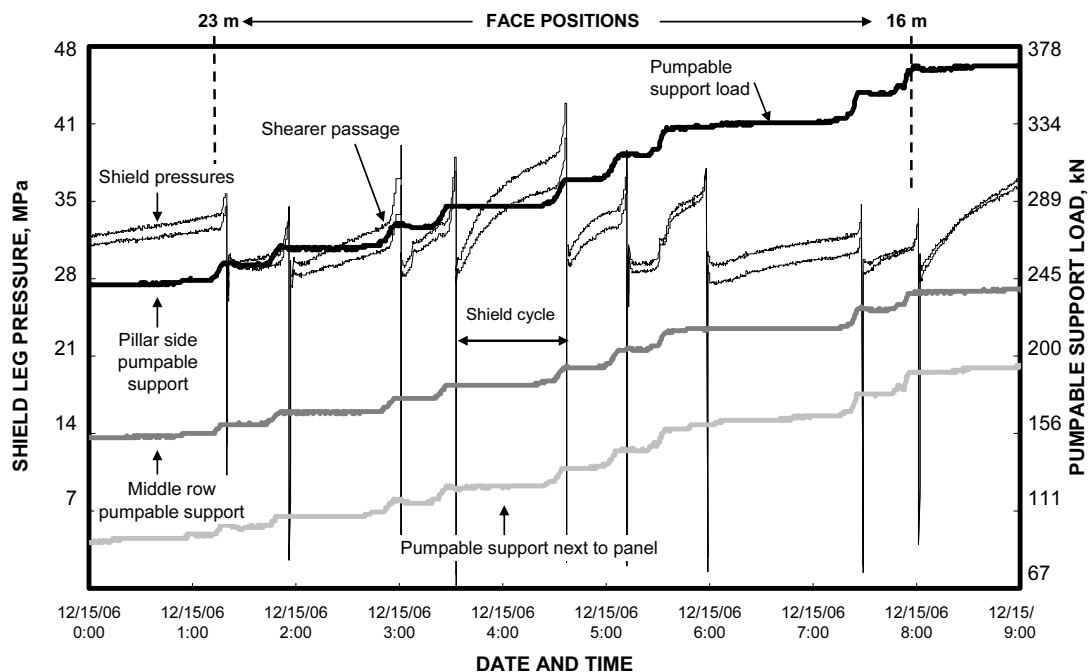
An interesting discovery was revealed concerning the development of the pumpable support loading in response to the panel mining. The pumpable support loads were well correlated to the shield cycles even when the face was 31.2 m (100 ft) away from the recovery room. The support loading increased rapidly as the shearer passed the face location adjacent to the support location in the recovery room, with very little load increase during the remainder of the shield cycle although the leg pressures were increasing significantly throughout the shield cycle. As expected, the shields are responding to the immediate roof and the main roof activity while the recovery room supports at this juncture are seeing the main roof activity. Figure 3 shows an example for shield number 175 (adjacent to Chute C in the recovery room) as the face advanced from a location 23.4 m (75 ft) away to 15.6 m (50 ft) away the recovery room. As the face advanced closer than the 15.6 m (50 ft) location, the pumpable supports began to increase in loading during the full shield cycle, but the majority of the load increase continued to be consistent with the shearer passage and a step-type function in the load development continued.

Figure 3. Correlation between pumpable support load and #175 shield cycles showing load increase during shearer passage.

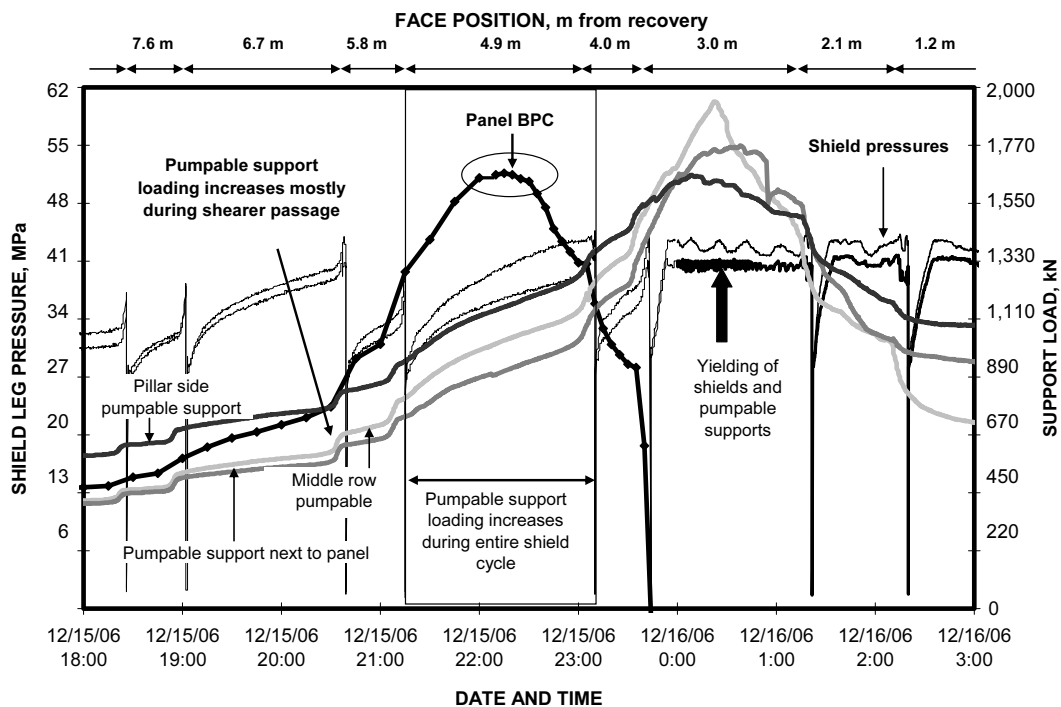
face. For bidirectional cutting, the shield cycles are likely to alternate between short and long cycles since the support is located away from the center of the panel where the shield cycle time differential would be minimized. As shown in figure 5, the panel fender yielded during a long cycle (114-minute duration) as the shearer had to move to the headgate and back to complete the loading cycle. It was somewhat surprising to observe that the peak BPC stress occurred not when the shearer passed by this location, but when the shearer was over 312.5 m (1,000 ft) away at the headgate, particularly given the close proximity of the longwall face to the stress cell (approximately 1.9 m (6 ft) away). This could be the result of the time dependent properties of the coal, in which the highly stressed coal will continue to deform (strain) even under static load conditions. The unloading rate is also nearly the same as the loading rate during this shield cycle. The detail of the loading is magnificent as exemplified by the temporary stop in load shedding as the shearer passes back in front of the pressure cell (see figure 6).

Figure 5. When the longwall face was approximately 5 m (16 ft) inby the recovery room, the pumpable support loading increased during the full shield cycle.

- **Yielding of the shields and pumpable roof supports** The pumpable roof supports in the recovery room continue to develop load as the panel and pillar BPCs shed load as previously described (shown in figure 5). The pumpable supports yield two shield cycles after the panel BPC yields and one cycle after the pillar BPC shed load, putting the yield of the supports at a face position of approximately 3.1 m (10 ft). The shields also yield during this cycle. Again, the nature of the shield loading provides insight into the load mechanics. After being set, the shield-loading rate is significantly higher than on previous shield cycles and the shields quickly reach their rated capacity and begin to yield. They continue to yield even though the shearer is moving away from the shields toward the headgate in a long shield cycle.

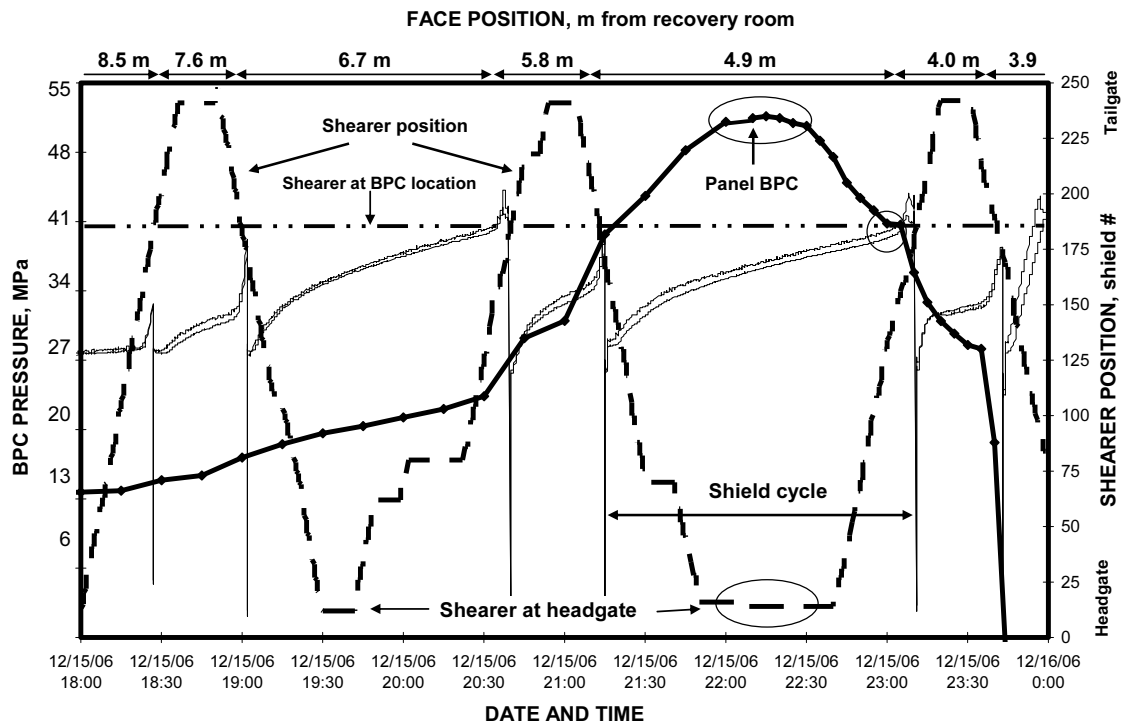
Figure 6. Yielding of panel BPC occurred when the longwall shearer was approximately 302 m (1,000 ft) away from the cell location.

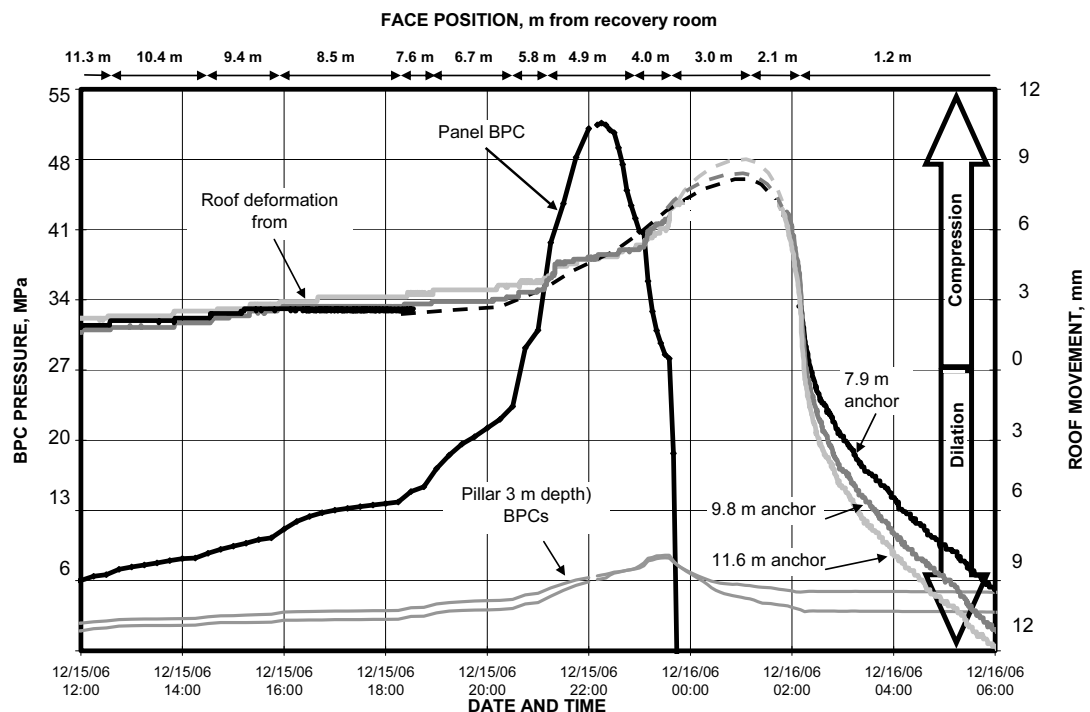
The yielding of the pumpable supports trigger roof movements and convergence in the recovery room before the face even gets there. The pumpable roof supports are very stiff supports, capable of developing over 1,775 kN (200 tons) of load capacity in less than 12.7 mm (0.5 in) of displacement. Prior to the yielding of the pumpable supports, the roof remained intact as a composite structural unit without additional separation among rock layers. As the pumpable supports began to rapidly increase load while the panel fender was yielding, the data indicate that the roof was moving slightly “upward”, as shown in figure 7. This apparent “upward” movement is most likely compression of the immediate roof structure or closing of preexisting fractures along bedding planes or elsewhere within the first 8.1 m (26 ft) of roof. Since the support requires compression to build load, it is also possible that the floor ahead of the panel fender in the recovery room was also moving upward (heaving) as the panel fender yielded.

The roof-to-floor convergence also increased dramatically with the yielding of the pumpable supports. By the time the face mined into the recovery room, the convergence measured from the middle row support displacement reached 12.7 cm (5 in), while the roof deformation at this time was approximately 3.7 cm (1.2 in). This indicates that about 75% of

Figure 7. Roof initially is compressed during yielding of panel fender and then begins to deform downward into the recovery room.

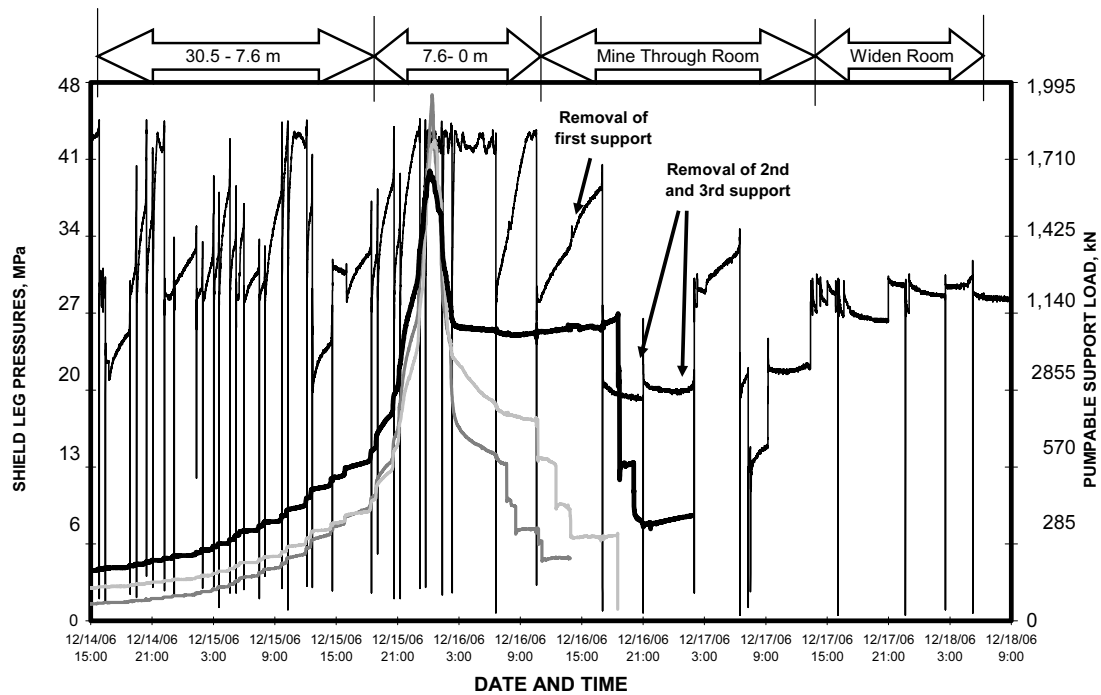
The next phase of the mining operation was to cut out the pumpable supports and advance the face to the pillar line to prepare for widening of the face. During this phase, no coal was being mined, however since the pumpable supports were helping to control the roof span and deformation process, the removal of the supports can be critical to the stability of the recovery room. At the C chute location, the shield loading decreased as the supports were extracted and the face advanced toward the pillar line (see figure 8). As the first row of supports was being extracted, the shield loading remained high but below the yield rating. As the second row of pumpable supports was being extracted, the shield loading did not change much after being set and this condition remained throughout the advancement through the pre-driven recovery room. The pillar stress, as measured by the cells at both the 3.1- and 6.2-m (10- and 20-ft) locations from the edge of the recovery room, remained fairly constant during this process. The roof continued to deform slightly in the chute as measured by a three-point extensometer in the center of the entry located 5 m (16 ft) from the outby edge of the pre-driven recovery room, but the deformations were nearly an order of magnitude less than that seen in the recovery room. An additional 25.4 mm (1 in) of closure occurred for a distance of about 6.2 m (20 ft) in the C chute crosscut as measured by electronic closure meters measuring roof-to-floor displacement.

Figure 8. Shield loading decreased as the pumpable supports were extracted from the longwall recovery room.
