FIELD VERIFICATION OF THE ROOF FALL RISK INDEX: A METHOD TO ASSESS STRATA CONDITIONS

Anthony T. Iannacchione, Acting Geotechnical Engineering Section Chief
Gabriel Esterhuizen, Senior Service Fellow
NIOSH-Pittsburgh Research Laboratory
Pittsburgh, PA, USA

ABSTRACT

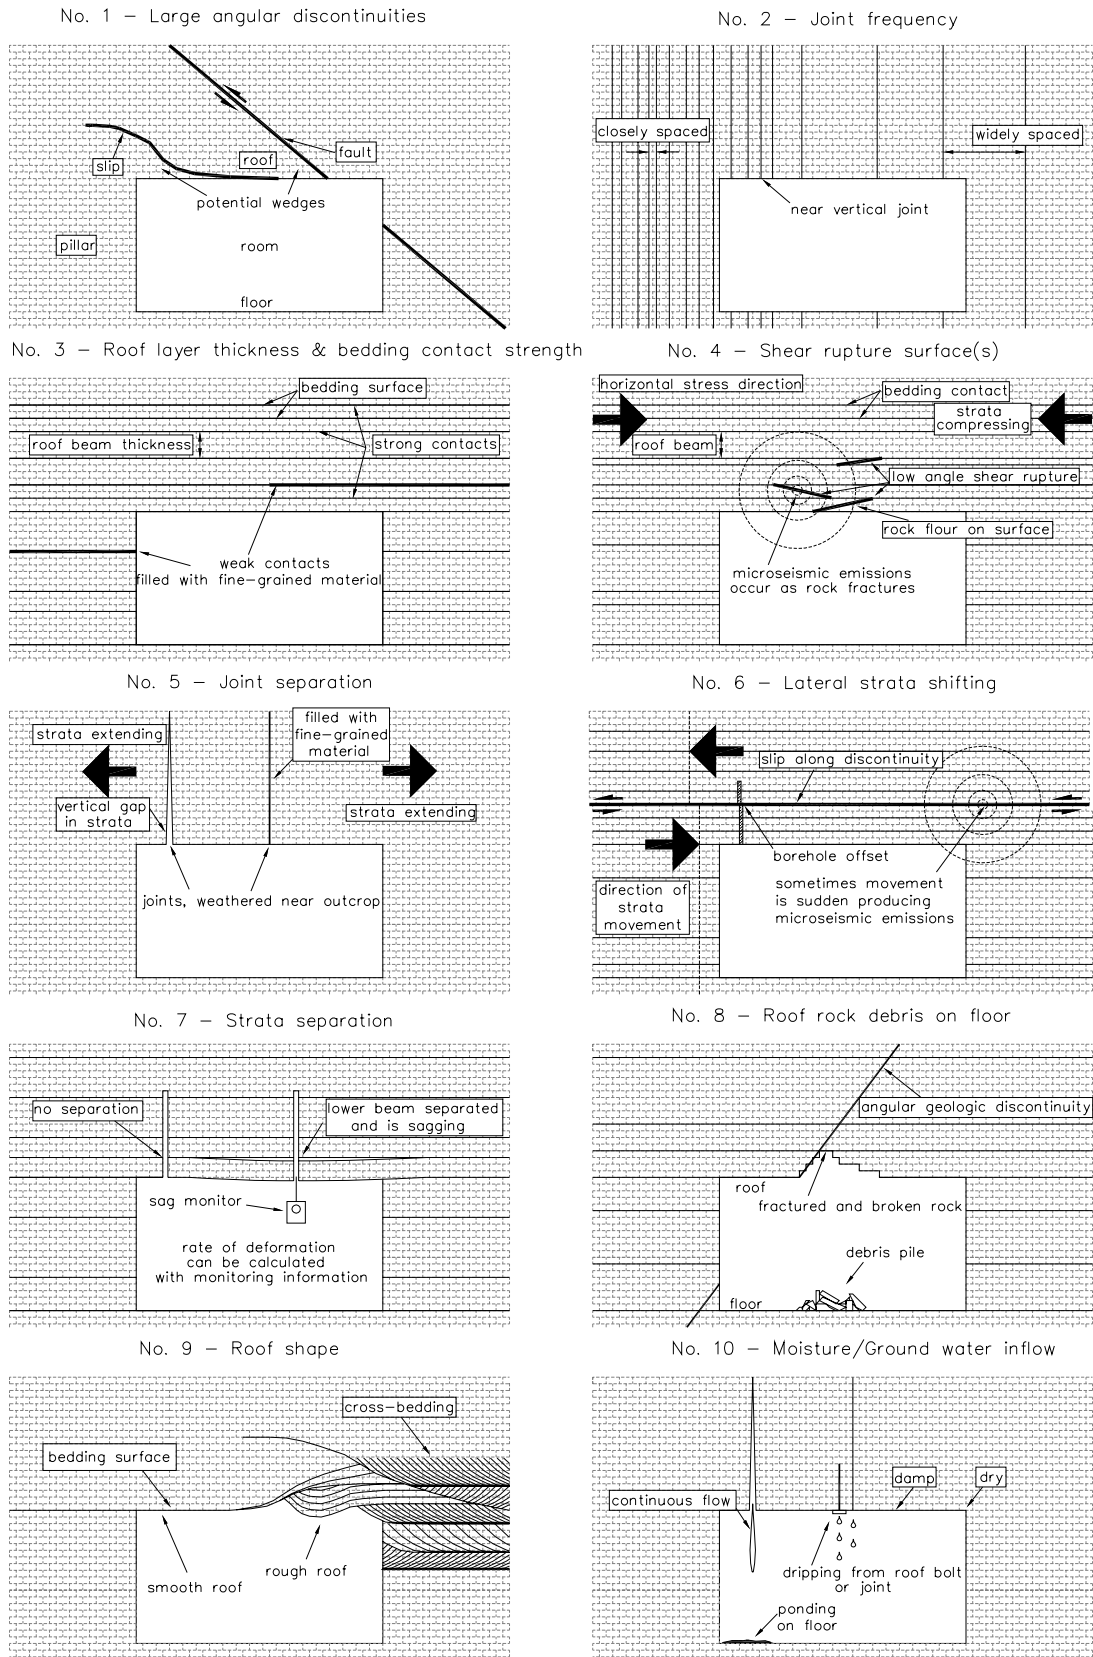
Figure 1. Sketch of parameters associated with the ten defect categories.

- Category 1 (Large Angular Discontinuities) notes the occurrence of significant geologic structures such as faults and slips that cut the roof rock at angles from 10 to 70 degrees from horizontal (Figure 1, No.1). These discontinuities act to weaken competent roof rock and can be zones where displacements are initiated (mobilized). The influence of angular discontinuities on roof strata stability is documented by Lagather (1977) and Moebs (1977). If these parameters are non-existent, then an AV of 1 is assigned. An AV of 5 is assigned to roof strata with a significant angular discontinuity, containing weak (low strength) contact. Typically strong contacts are comprised of sharp surfaces with relatively rough profiles while weak contacts are comprised of smooth surfaces that are either polished or filled with fine grained material.

- Category 2 (Joint Frequency) focuses on the importance of joint frequency on roof stability (Krausse et al., 1980). Joints refer to the steeply inclined (nearly vertical) fractures that often naturally occur in rock formations (Figure 1, No.2). Joint frequency is comprised of several parameters that help define the frequency or spacing of joints. Typically, the joints will occur in preferential orientations that can cluster in one or more groupings. It is recommended that the cluster with the lowest average distance between joints be used to evaluate this parameter (table 1). Widely spaced joints yield an AV of 2, while closely spaced joints have an AV of 5.

- Category 4 (Shear Rupture Surfaces) considers the influence of shear rupture surfaces, typically caused by buckling of roof layers less than 1 m thick (Figure 1, No.4). When excessive levels of horizontal stress are present, a roof layer can buckle, producing a low angle shear rupture surface with a powder-like residue (Gale et al., 2001; Iannacchione et al. 2003). The shear failure or roof cutters are typically comprised of a concentrated zone of defects. They are typically assigned an AV of 5 but if present in very small lengths (< 1 m) are given an AV of 3.

- Category 5 (Joint Separations) takes into account the separation of vertical fractures or joints. This type of defect occurs only when the strata loses compression in the direction perpendicular to the joint orientation (Figure 1, No.5). Joint separation signals that strata extension has occurred. Because most underground stone mine roofs have some level of vertical jointing and horizontal bedding plane contacts, most roofs are comprised of block segments of varying size that are supported by the confining stresses in the immediate roof beam. When strata extension occurs, the roof blocks are no longer confined and can fall to the ground under the forces of gravity. If no joint separation is observed, then the AV is 1. Because separation is a severe defect, any noticeable or measurable separation of a vertical joint is assigned an AV of 5.

- Category 6 (Lateral Strata Shifting) examines defects associated with lateral strata shifting where roof layers move in opposing directions along bedding contacts (Figure 1, No.6). While it is difficult to directly link this category with roof falls, it is commonly recognized as an unstable condition (Zhang and Peng, 2001). In some mines, lateral strata shifting are associated with large-scale movement along a fault plane or a large angular discontinuity (Iannacchione et al., 1981). The level of strata offset on either side of the shifting surface can be an indication of the magnitude of movement. If no lateral strata shifting occur, then the AV is 1. If less than 2cm of offset is observed where the surface intercepts the mine roof or rib, then the AV is 3. If the offset is greater than 2cm, the AV is 5. Many of these lateral offsets do not intercept the mine roof or rib and can be hidden from view within the immediate roof. A proven technique to detect these surfaces is to drill vertical boreholes into the roof on a regularly spaced pattern. This technique has been used in coal mining to successfully determine the magnitude and direction of strata shifting (Mucho and Mark, 1994).

- Category 7 (Strata Separation) encompasses the vertical strata separation caused when roof layers separate from one another and sag into the mine entry (Figure 1, No.7). The association of roof layer deflection with roof falls is well established and has been a subject of many investigations (Parker, 1973; Maleki and McVey, 1988; Iannacchione and Prosser, 1998). While strata separation can be determined by many methods, a basic requirement is a vertical borehole drilled into the roof and some means to observe and locate separations and determine their magnitude. Often, this is accomplished with devices such as a simple scratch tool, a bore scope, or a roof deflection monitor. If no separations exist in the immediate roof, then the AV is 1. If the separation is barely detectable or open, then the AV is 3. If the separation is easily detectable (>0.5cm), then the AV is 5.

- Category 8 (Roof Rock Debris on the Floor) assesses the amount of defects in the roof strata by estimating the amount of roof rock deposited on the mine floor (Figure 1, No.8). It is vitally important that this information be retained by the mining operation in some manner. If the floor is cleaned after debris has fallen from the roof and not recorded, then this information needs to be inferred. Debris from blasting and scaling the roof and ribs must be differentiated from roof rocks that have fallen. If no roof rock debris is observed, then the AV is 1. Increasing amounts of debris produce a higher AV. An AV of 5 is typically associated with a pile of broken rocks that obstructs or hinders walking in that portion of that mine entry.

- Category 10 (Moisture/Ground Water Inflow) appraises the amount of defect damage by moisture/ground water inflow characteristics (Figure 1, No.10). Different AV's are assigned as the conditions change from dry (AV=1), to damp (AV=2), to dripping (AV=4), and finally to the steady flow of water from the roof (AV=5).

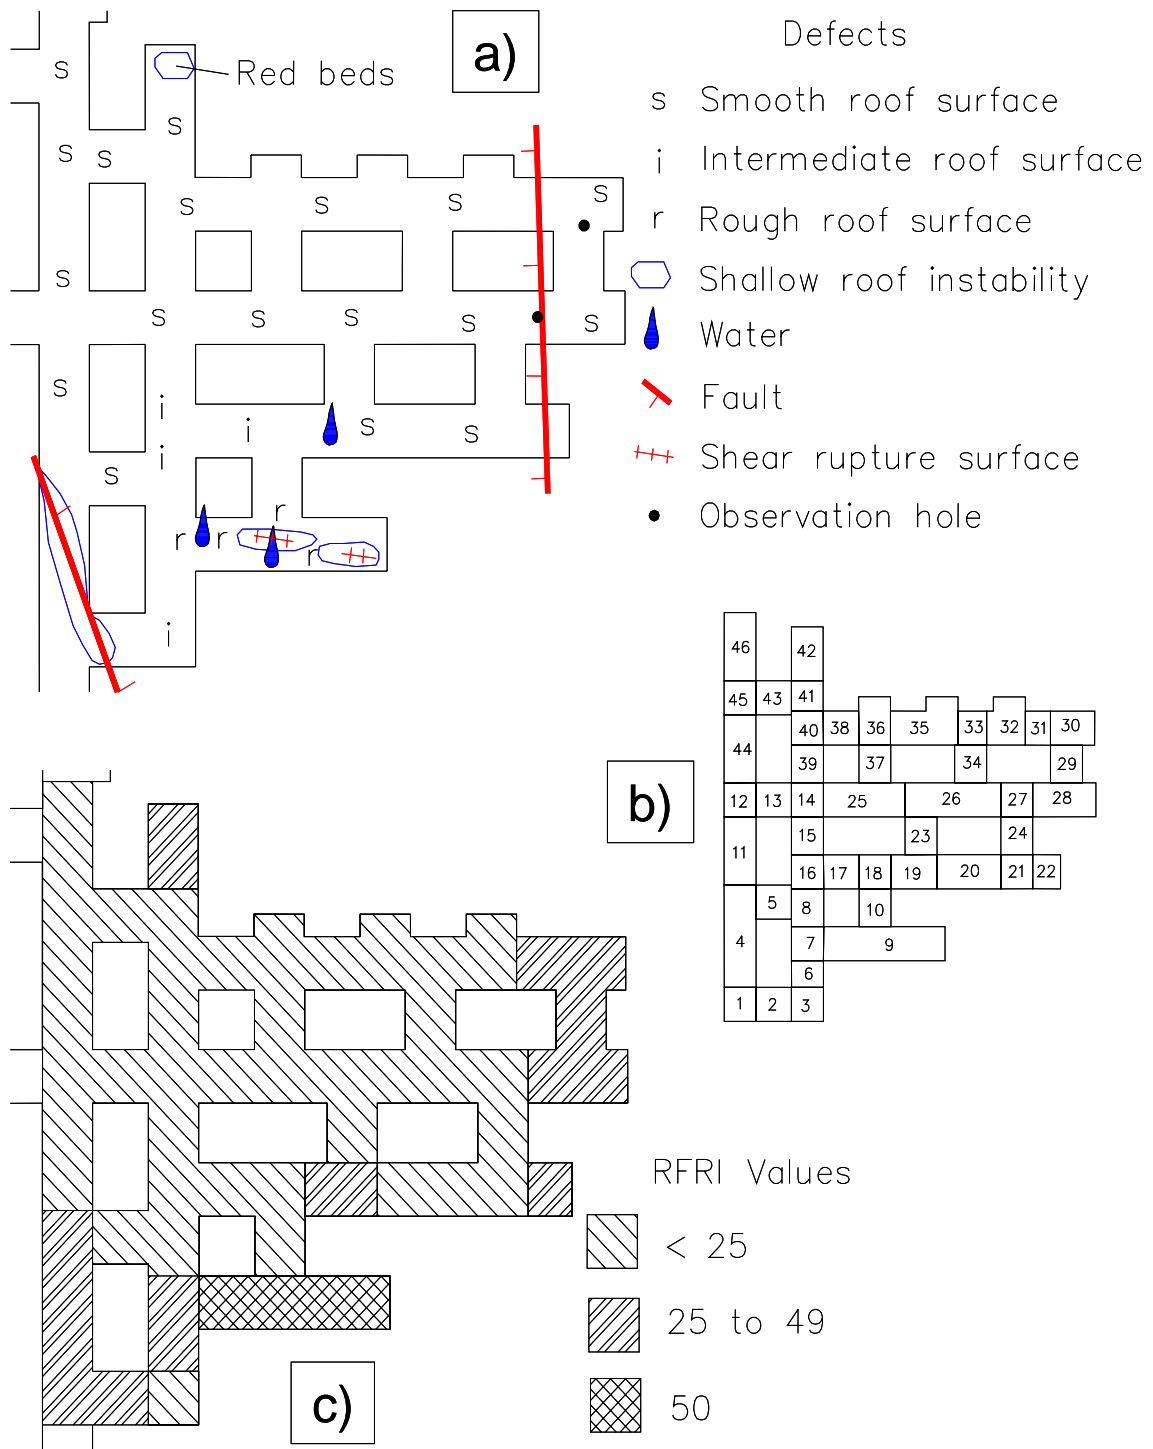
Figure 2. The first field verification site measurement region: a) defects map, b) 46 measurement areas, and c) roof fall risk map displaying the individual RFRI values over the measurement region.

Collection of defect information from the mine: During one mine visit, a total of 3 hours was spent mapping the new 4-entry development. The geologic, stress and mining related defects were observed and placed on a mine map (Figure 2a). The mapped region was then divided into 46 measurement areas (Figure 2b). A general summary of the AV for the most important Defect Categories used to determine the RFRI for typical measurement areas at the first site are as follows:

Analysis of RFRI values: The RFRI values in the measurement region ranged from a low of 19 to a high of 58 (Figure 3). A roof fall risk map was constructed from the 46 RFRI measurements (Figure 2c). The highest percentage of these values occurred at the lowest RFRI indicating that most of the mine's roof in this section had low concentrations of defects. In fact, 591 m or 69 % of the measured mine entries had an RFRI < 25. Approximately 25 % or 220 m had an RFRI between 25 and 50. The main factor for the elevated RFRI values in these areas was faults. Small increases in the percentage of RFRI values from 30 to 35 and 45 to 50 were caused by faults (Figure 3), the latter were faults with some vertical strata separation and rough roof conditions.

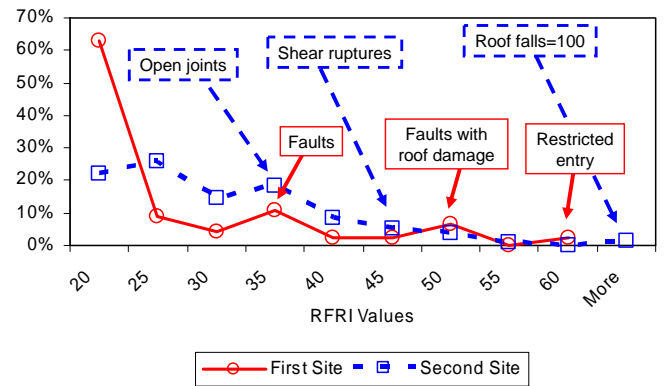
Figure 3. Percentage of RFRI values collected from the two field verification sites.

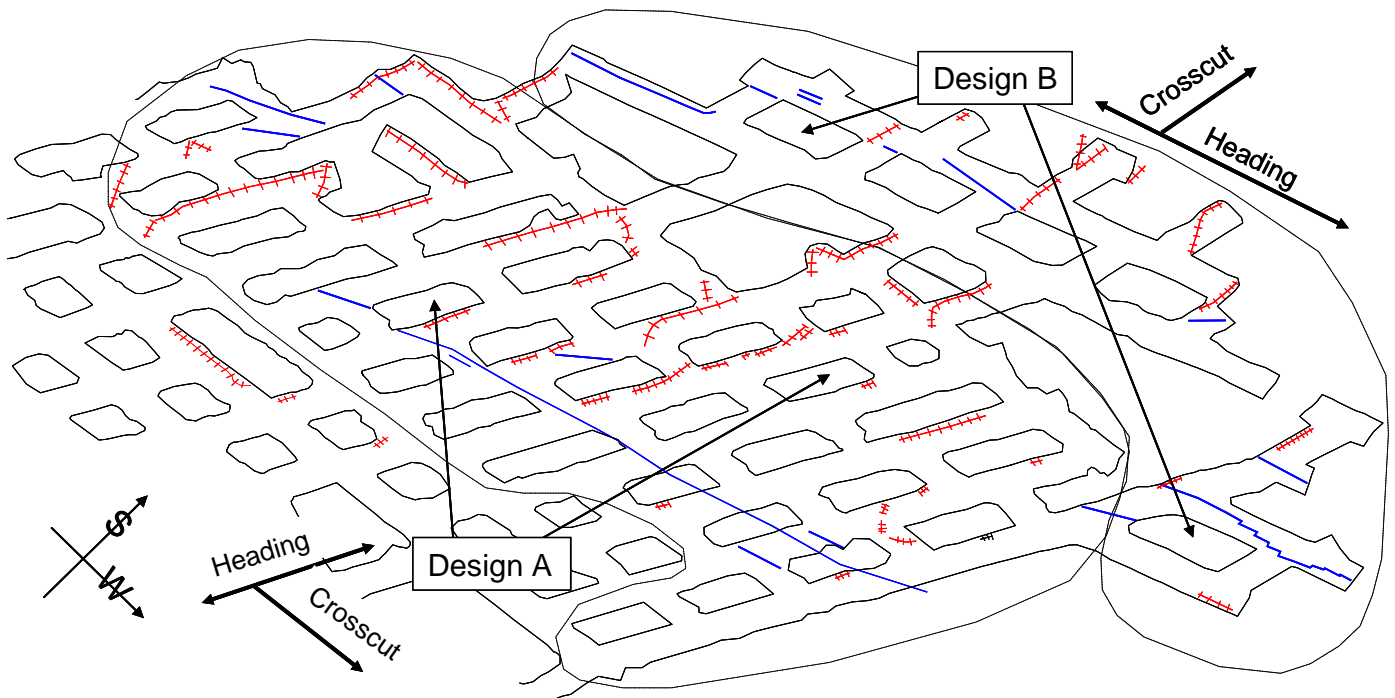
Figure 4. The second field verification site measurement region showing the two mine layout designs. Major defects are also shown where shear ruptures are drawn as tracked features and open joints are drawn as solid lines.

At the second field verification site, two mine layout designs were implemented to improve roof conditions. The first, Design A, used headings (entry paralleling the main direction of mine development) developed in the S30W direction and crosscuts (entry between headings) developed in the S80W direction (Figure 4).

Collection of defect information from the mine: During two mine visits, 10 hours were spent mapping a portion of the mine that contains parts of the two distinct mine layouts (Figure 4). The geologic, stress and mining related defects were observed and placed on the mine map. The mapped region was then divided into 226 measurement areas. Each measurement area generally encompassed one of three mine entry characteristics: headings, crosscuts and 3-way intersections. The length of these different measurement areas ranged from 12 to 66m. In this study, the measurement areas are equivalent to distinct segments of mine entries. This facilitated analyzing the influence of mine layouts on RFRI. A general summary of the AV for the most important Defect Categories used to determine the RFRI for typical measurement areas at the second site are as follows:

At the second verification field site, these very conditions were observed. Shear ruptures occurred in orientations that cluster around S20E as shown by the tracked pattern on Figure 4. Additionally, a significant number of open fractures exist in the S70W orientation suggesting a highly bi-axial horizontal stress field (see the solid lines on Figure 4). For this reason, the main headings in Design B were laid out along that direction to take advantage of favorable conditions. Conversely, crosscuts were oriented 53 degrees off the S70W bearing (S17W) and offset by rectangular pillars to inhibit the extension of roof cutters in the least favorable mining direction (S20E). The crosscuts at this mine could not be developed in the S20E due to steep dips in that direction. Because the RFRI has produced trends that support the collective knowledge of roof conditions in the mapped region of the study site, this field trial was viewed as a success.

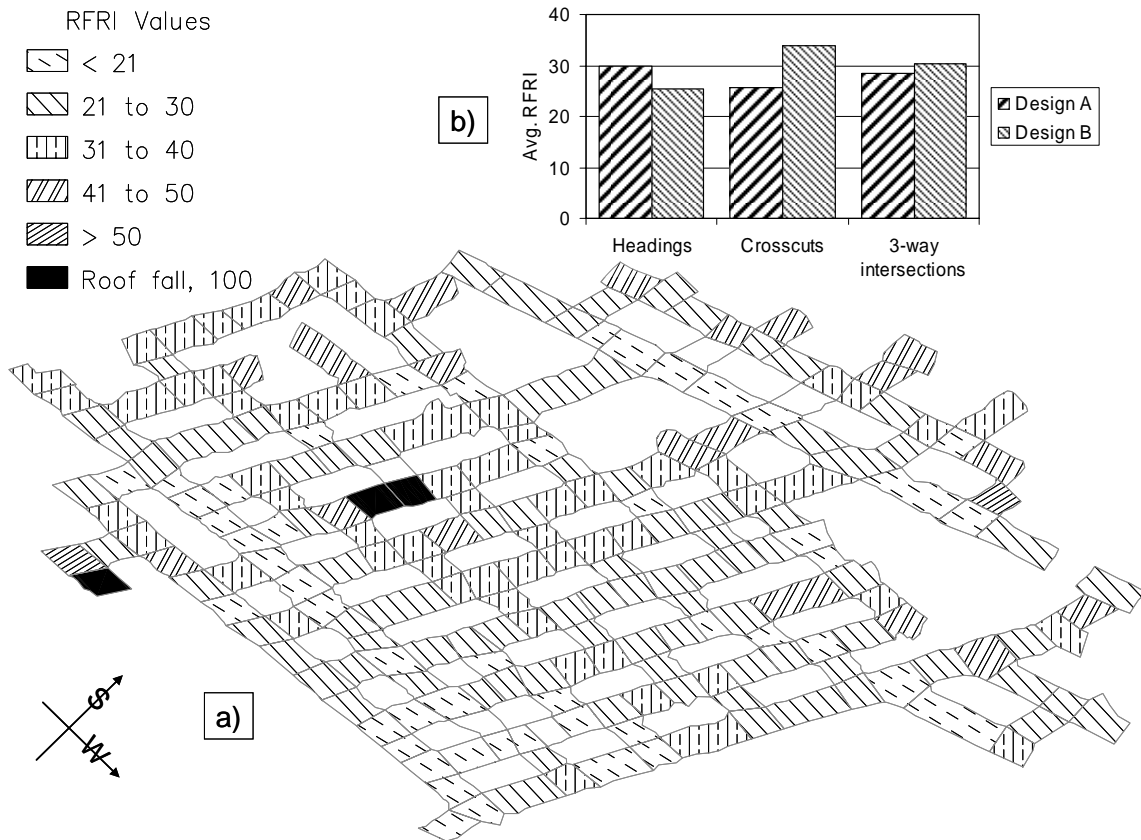
Figure 5. (a) Roof fall risk map displaying the 226 RFRI values over the measurement region. (b) RFRI for different entry characteristics in the Design A and Design B.

Analysis of RFRI values: The distribution of the 226 RFRI values collected from measurement sites is shown in Figure 5. RFRI values ranged from a low of 19 to a high of 53, with the exception of the pre-survey roof fall areas that are assigned an RFRI of 100 (Figure 5a). As would be expected, most of the locations had low RFRI values. For example, 61 % of the measured entry areas had an RFRI less than 30. Twenty-seven percent of the entries had RFRI values between 30 and 40, and were often adversely influenced by open joints and to a lesser extent by shear ruptures and flowing water. Twelve percent of the entries were dominated by shear ruptures.

A roof fall risk map was constructed from the 226 measured RFRI values (Figure 5a). The average RFRI for the different mine designs were calculated and shown in Figure 5b. In general, Designs A and B have similar overall average RFRI (A = 28 and B = 29); however, small, but important, differences are observed when individual entry characteristics are considered. For example, the headings of the Design B had an RFRI of 25 as compared to the 30 for the headings of the Design A. The opposite trend was observed for the crosscuts where Design B had a higher RFRI (26 versus 34). The RFRI for the 3-way intersections was very similar for both designs. This data indicates that Design A had similar concentrations of defects in both the headings and crosscuts, whereas Design B had relative low concentration of defects in the headings and higher concentrations in the crosscuts.
