National Personal Protective Technology Laboratory

Status Investigation Report of Three
Self-Contained Breathing Apparatus
Submitted by the
Pennsylvania State Fire Academy
Lewistown, Pennsylvania

NIOSH Task No. 14292

May 1, 2007

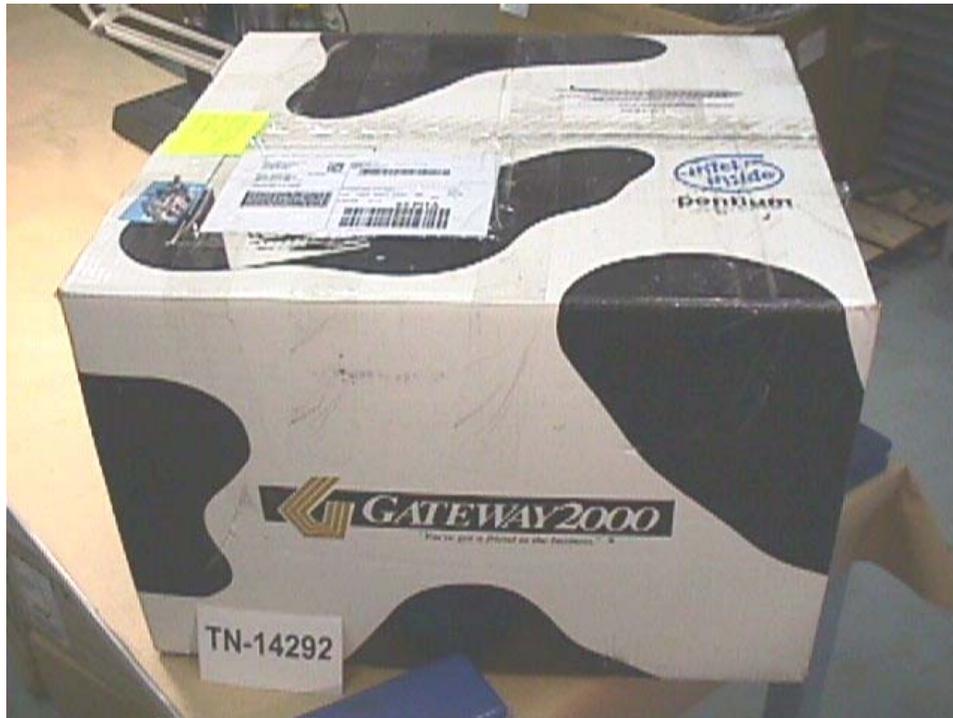
Figure 1 – Unit #1 as Received from the Pennsylvania State Fire Academy

The SCBA was received in a corrugated cardboard box (refer to **Figures 1 through 3 in Appendix III**).

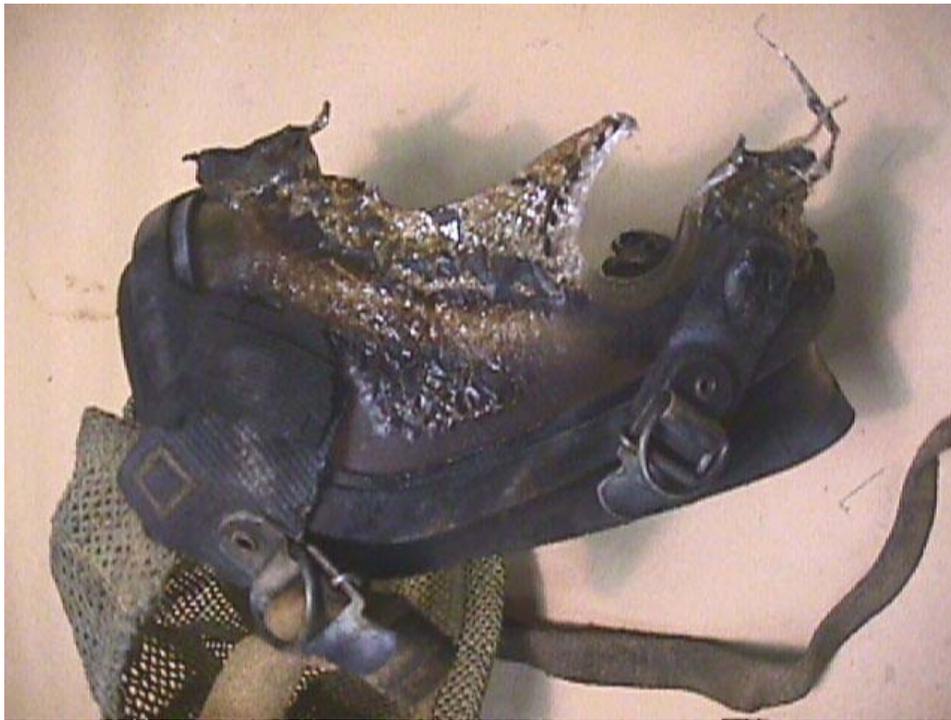
Figure 5 – Side View of Unit #1 Facepiece

1. Facepiece (Refer to Figures 4 through 12 in Appendix III):

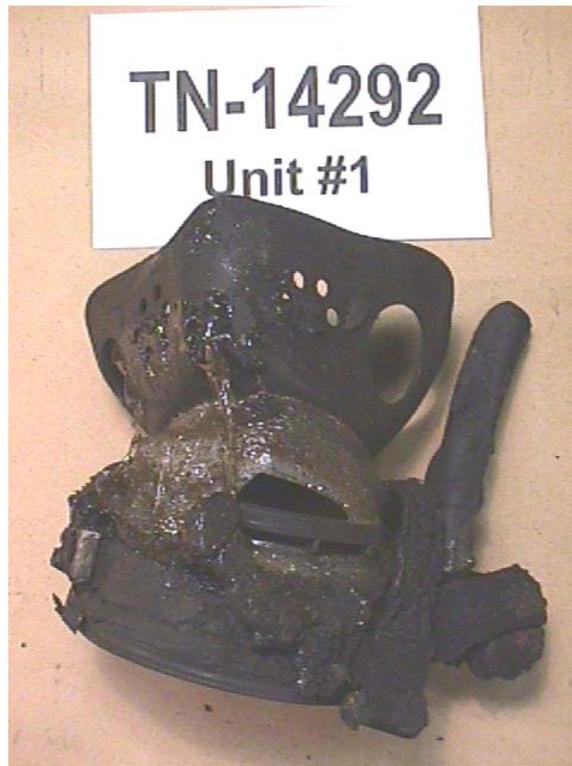
Figure 13 – Unit #1 Regulator with Nosecup and Portion of Lens

2. **Air Pressure Regulator** (Refer to Figures 13 through 18 in Appendix III):

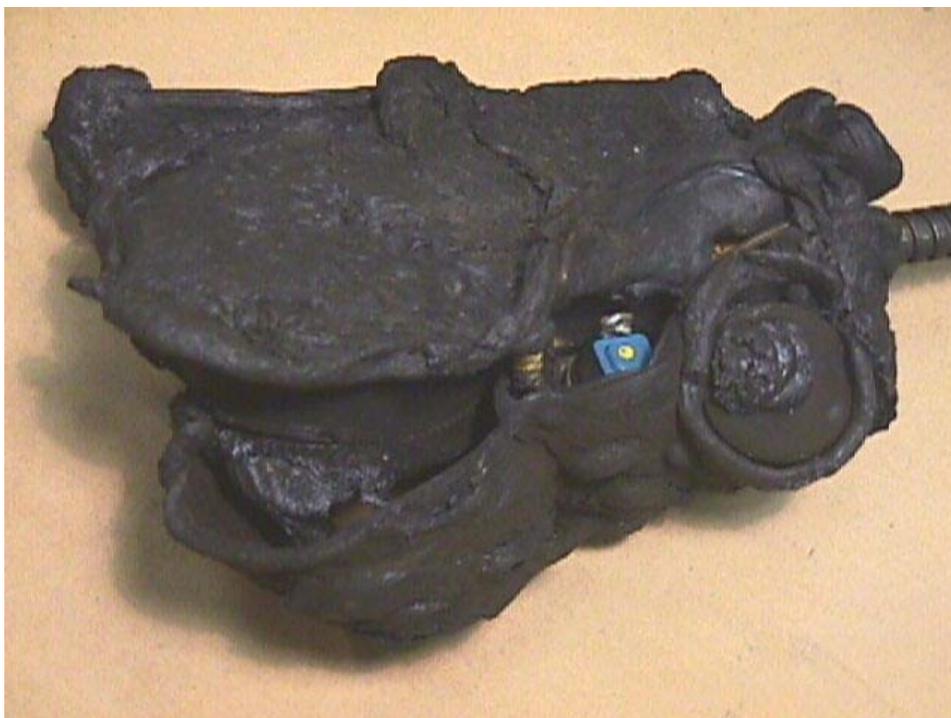
Figure 22 – Rear View of Unit #1 Remote Pressure Gauge/PASS Console

A Personal Alert Safety System (PASS) device was incorporated into the pneumatics of Unit #1. Like other components of the SCBA, it has suffered severe thermal damage and is not functional.

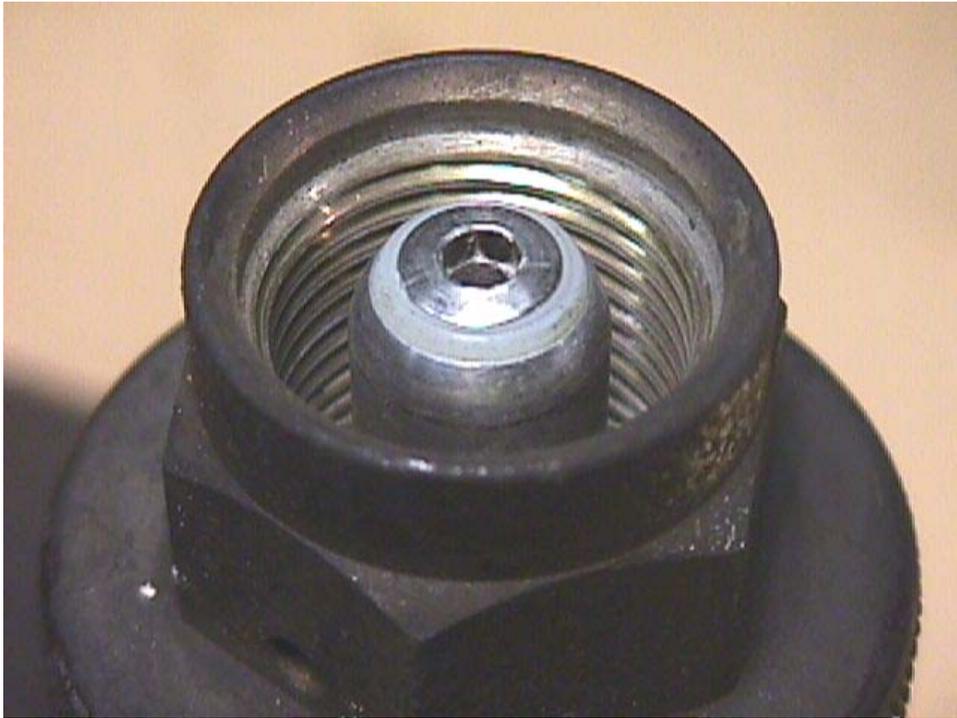
Figure 25 – Unit #1 Cylinder Connector Nut

6. **High Pressure Hose and Cylinder Coupling Nut** (Refer to Figures 24 and 25 in Appendix III):

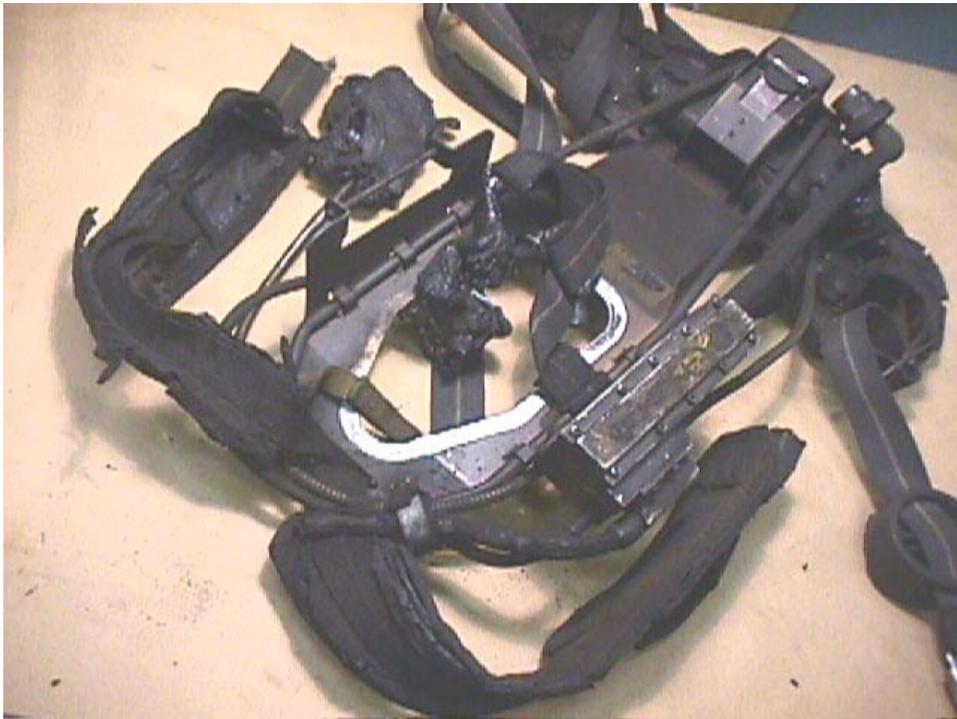
Figure 26 – Unit #1 Backframe

7. **Backframe and Harness Assembly** (Refer to Figures 26 through 32 in Appendix III):

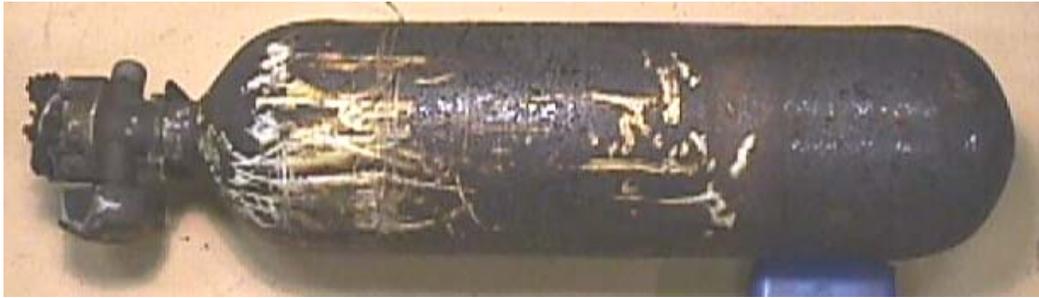
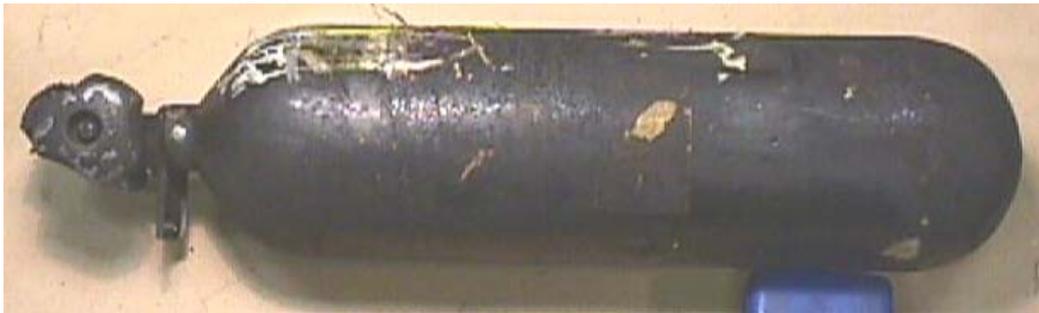
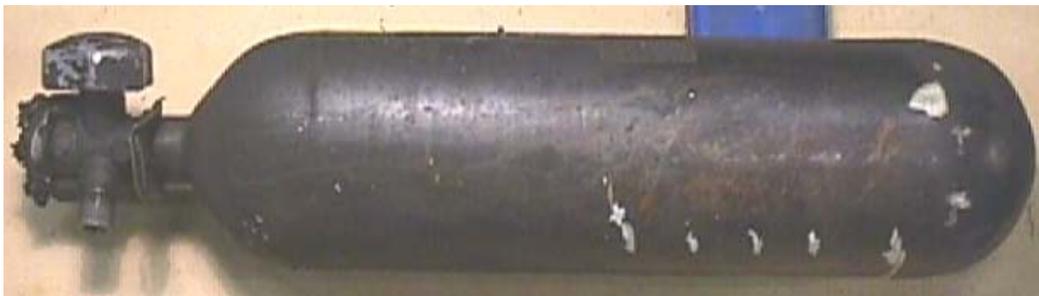
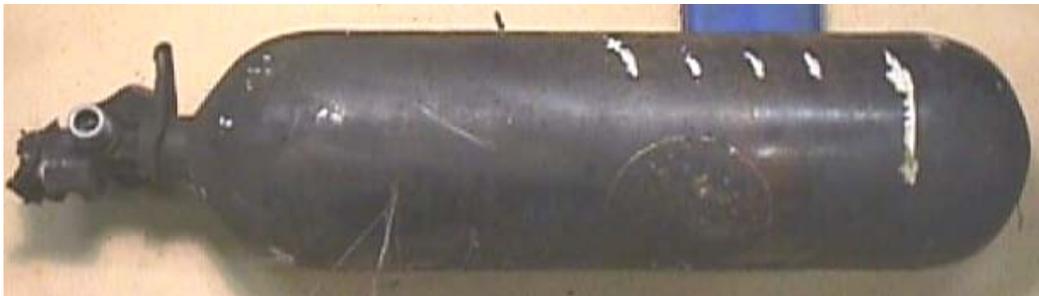
8. Compressed Air Cylinder (Refer to Figures 33 through 40 in Appendix III):

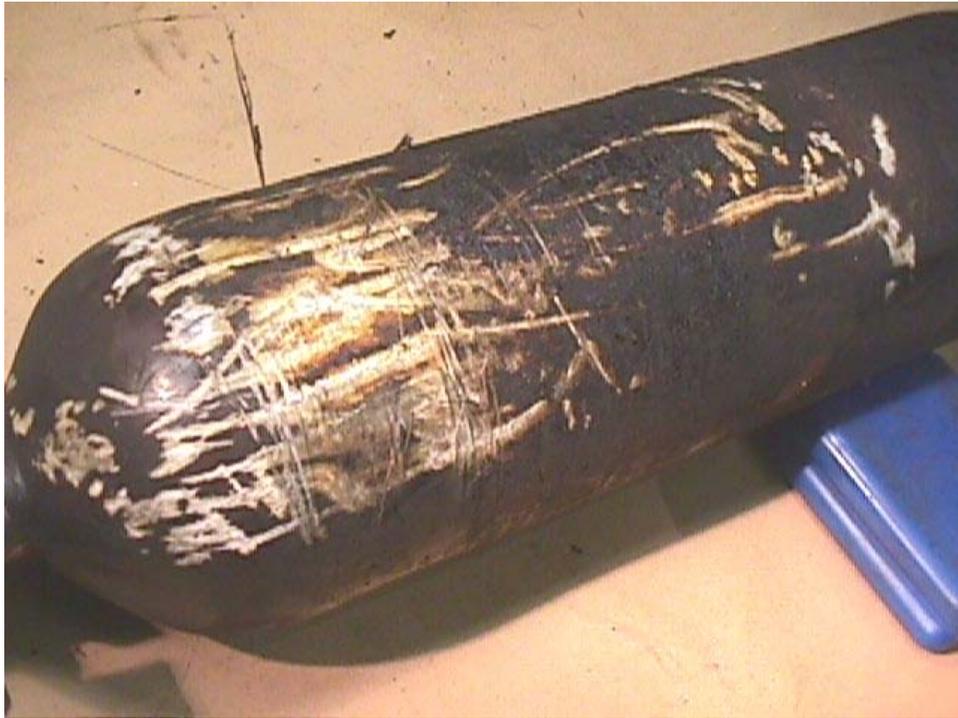
Figure 37 – Scrapes on Unit #1 Cylinder

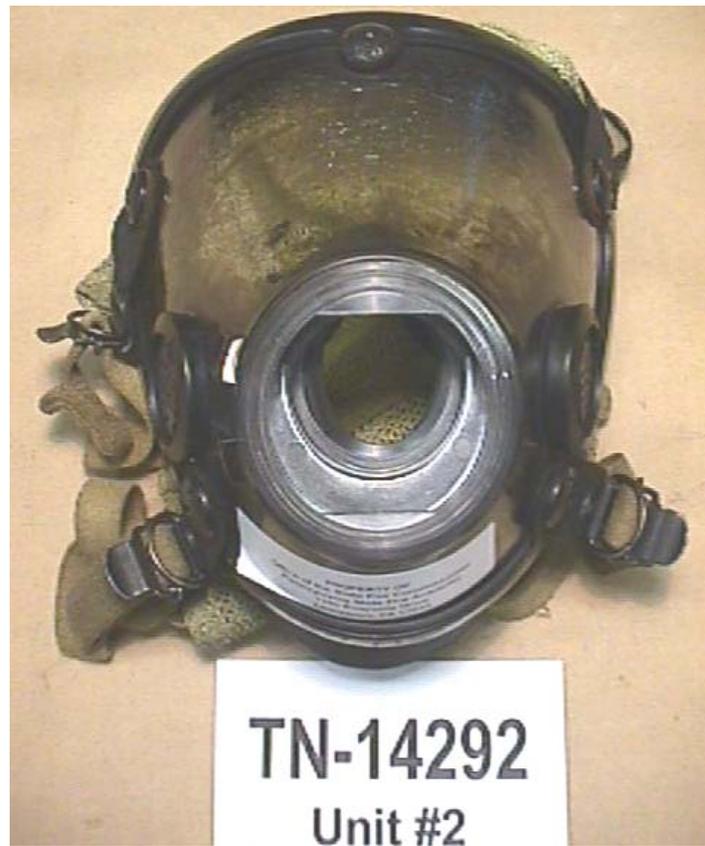
Figure 43 – Unit #2 Facepiece

1. Facepiece (Refer to Figures 43 through 46 in Appendix III):

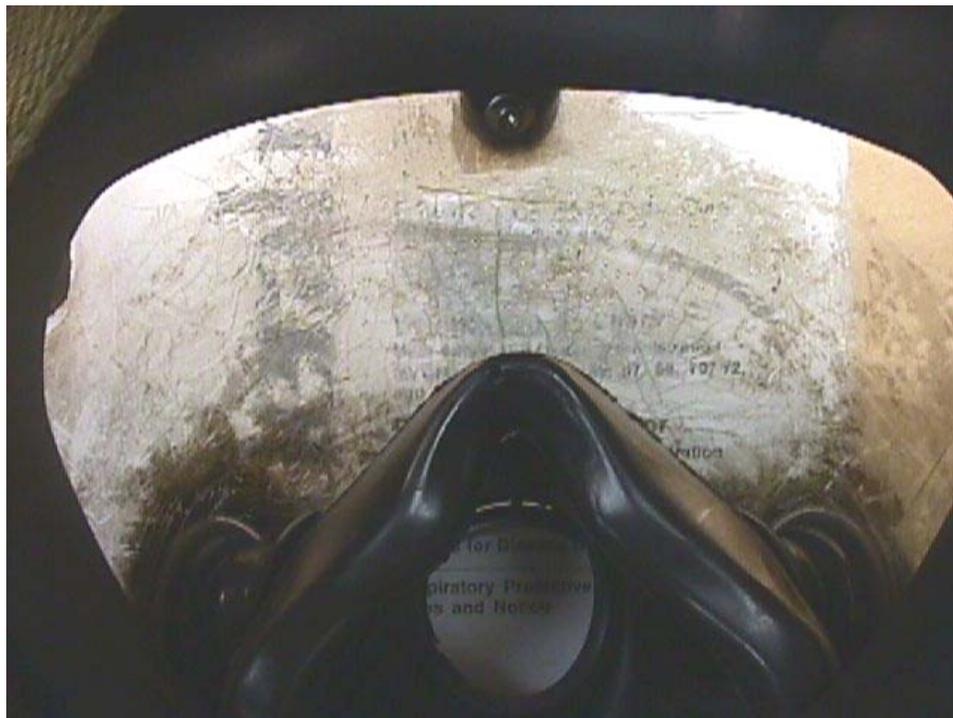
Figure 44 – Visibility through Unit #2 Facepiece

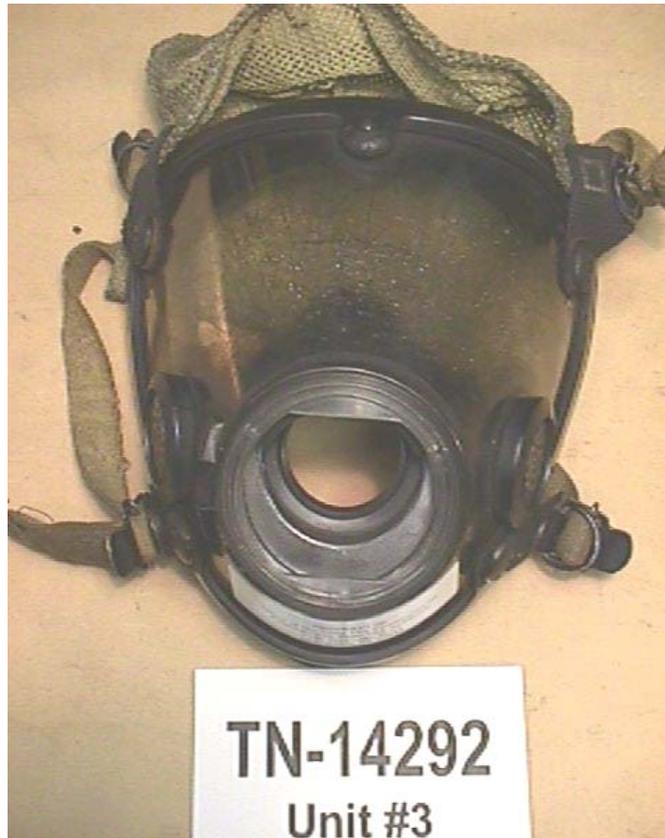
Figure 47 – Unit #3 Facepiece

1. Facepiece (Refer to Figures 47 through 50 in Appendix III):

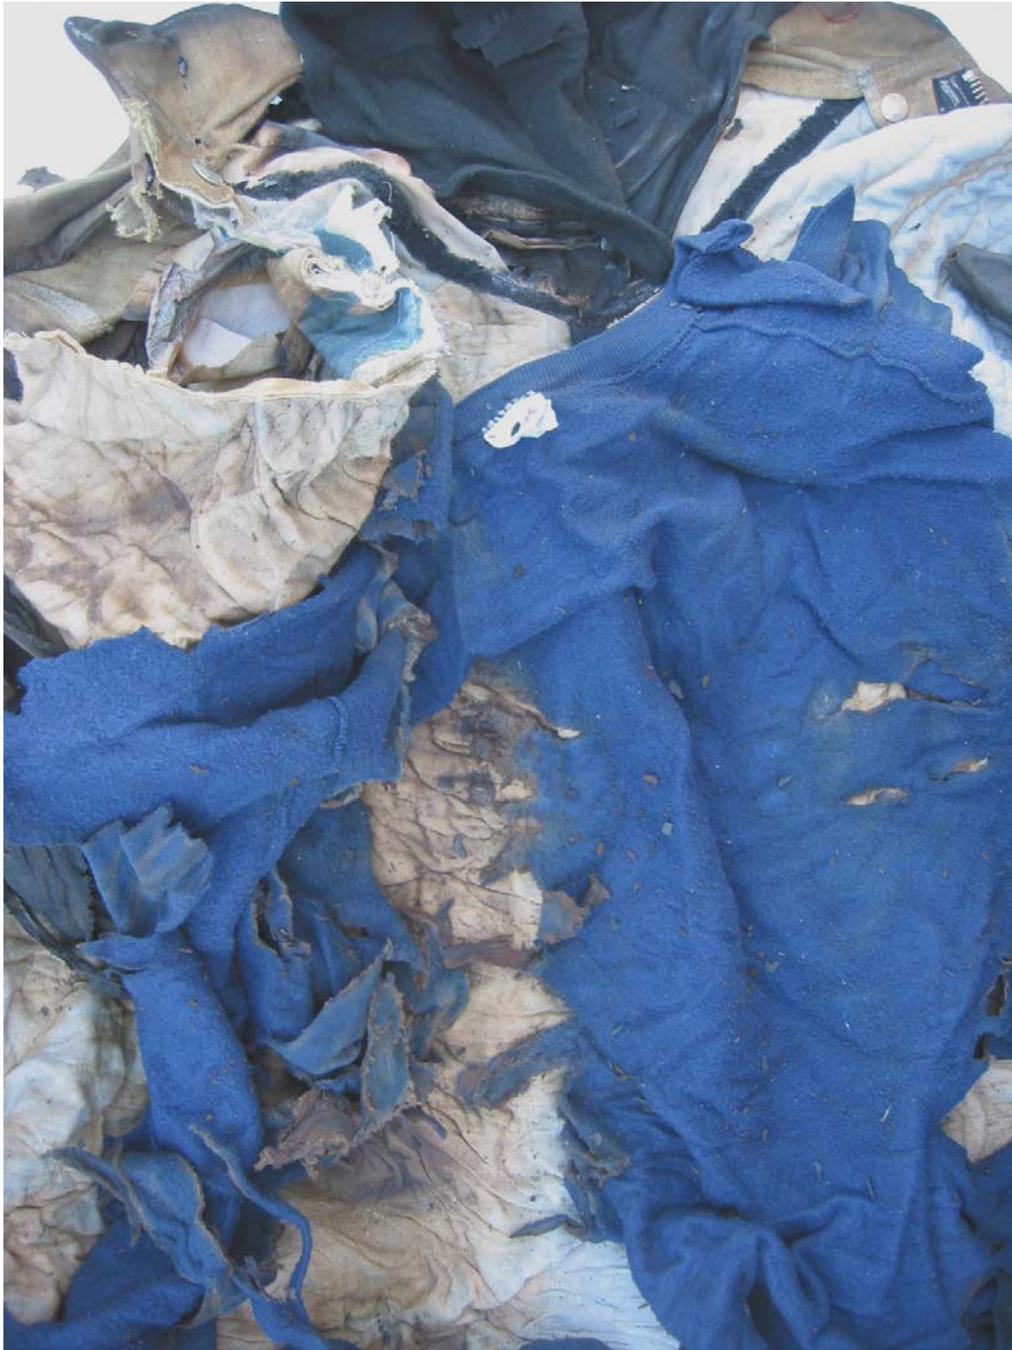
Figure 66 – View of Collar and Upper Part of Turnout Coat

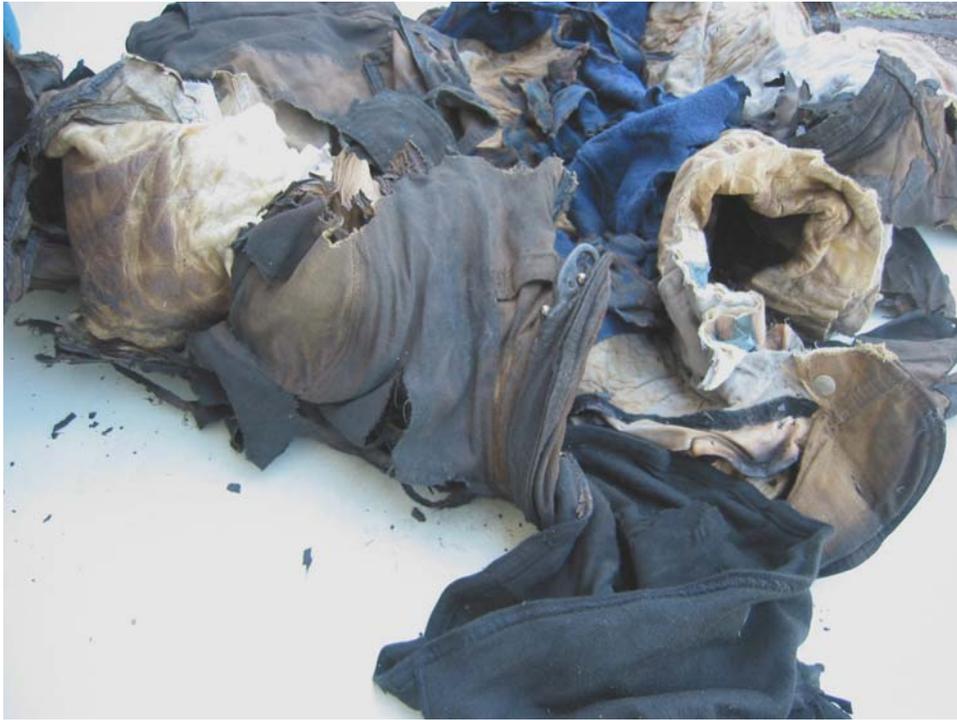
Figure 67 – Plastic Adhered to Front of Turnout Coat

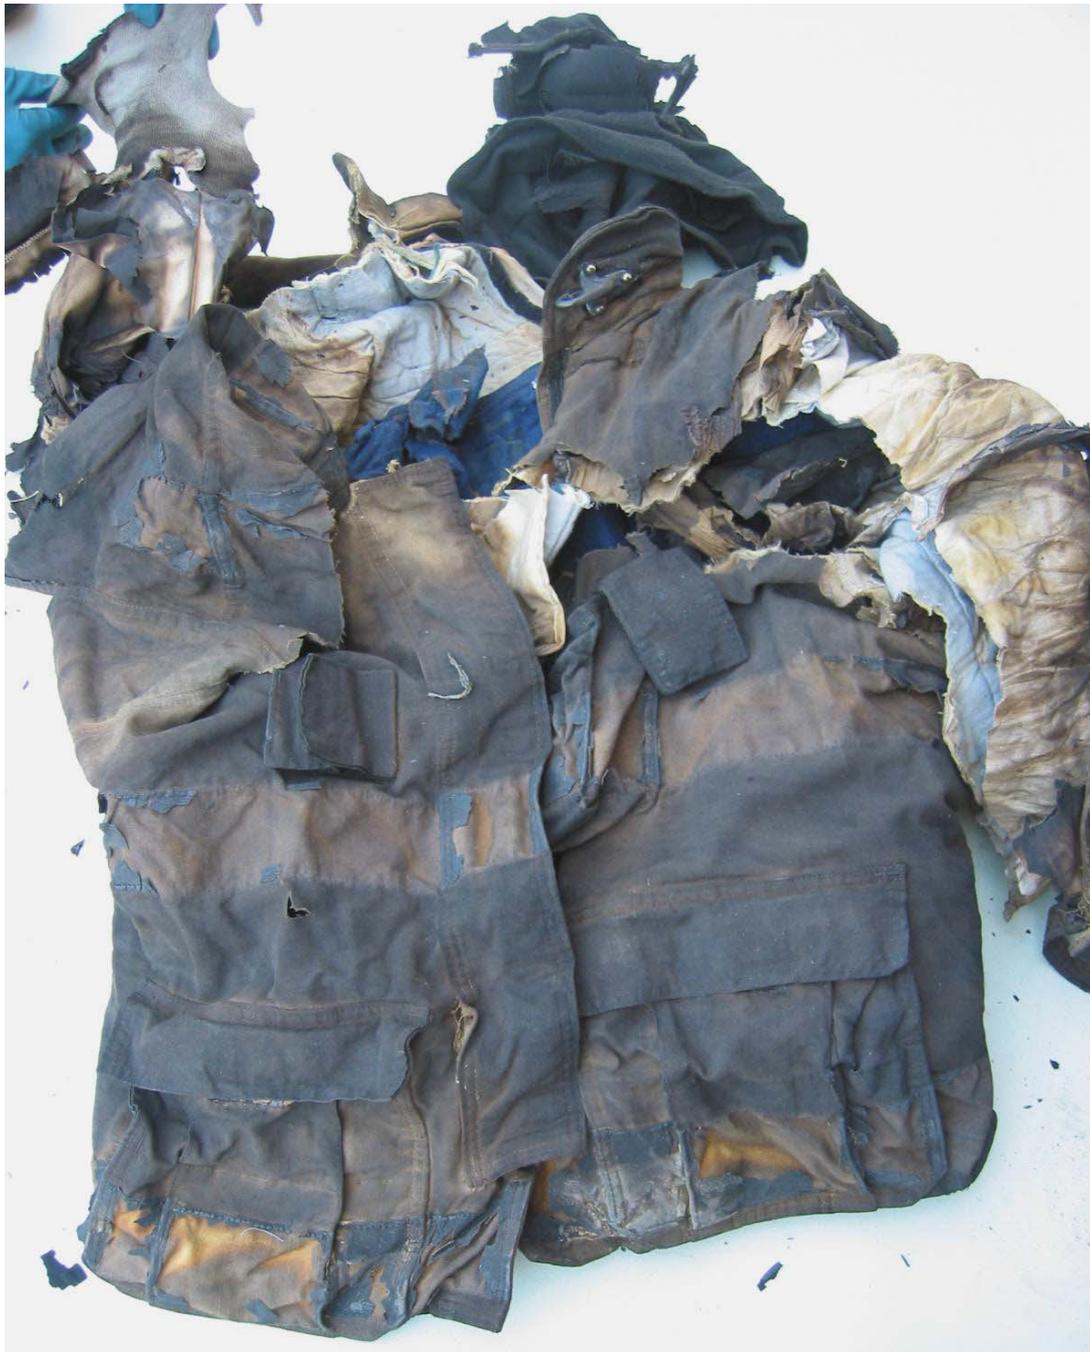
Figure 69 – Damage to Moisture Barrier of Turnout Coat

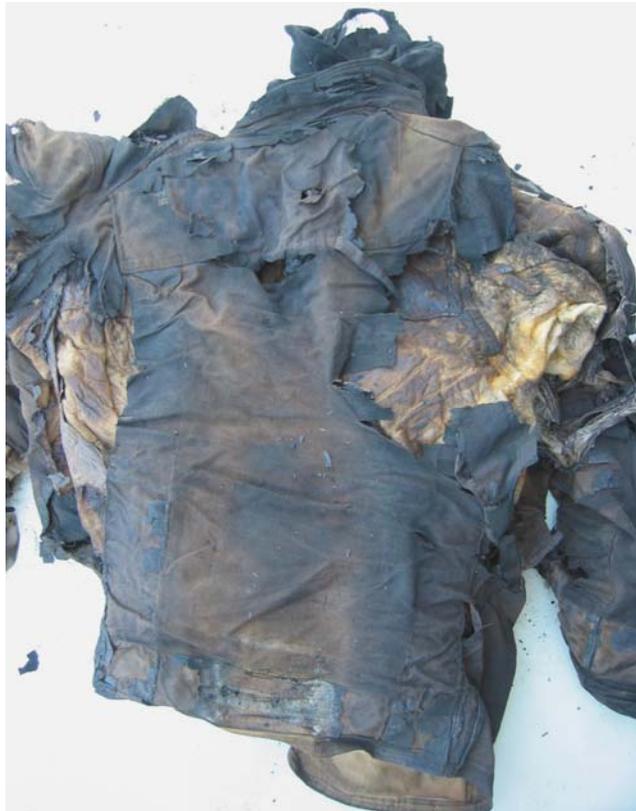
Figure 71 – Rear View of Turnout Coat Hem
