Evaluation of dampness-associated respiratory symptoms with relocation of staff during remediation of an elementary school

*Rachel Bailey, DO, MPH
Ju-Hyeong Park, ScD, MPH, CIH
Rena Saito, PhD
Kathleen Kreiss, MD
Jean Cox-Ganser, PhD*

Health Hazard Evaluation Report
HETA 2009-0172-3124
North Carolina
March 2011

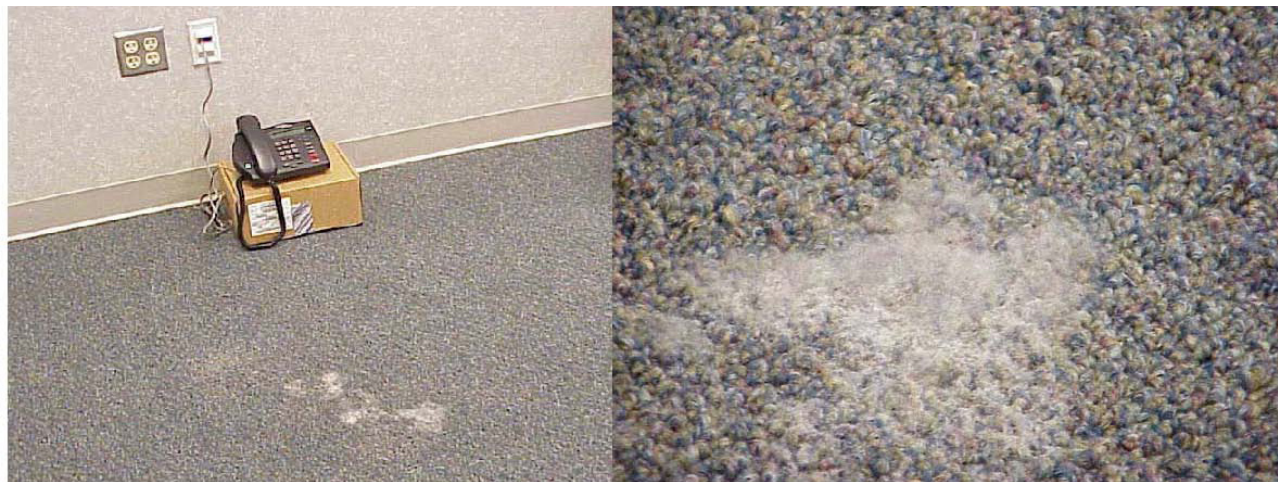
In August 2005, visible mold was also found on carpet in classrooms 427 and 625 (Figure 2), upholstered chairs in the records room (room 109) (Figure 3), and on picture frames in the storage room (room 111) (Figure 4). Later, after the school year began, mold reappeared on some of the books in the temporary media center in classroom 500. Many books were thrown out while others were again cleaned. By the end of August 2005, visible mold had been identified in the k/1 wing (classroom 613, 625), 2/3 wing (classroom 427), 4/5 wing (classroom 500), and the administrative wing (rooms 109 and 111).

Figure 2. Visible mold on carpet in a classroom (room 625), August 2005 (courtesy of building occupant).

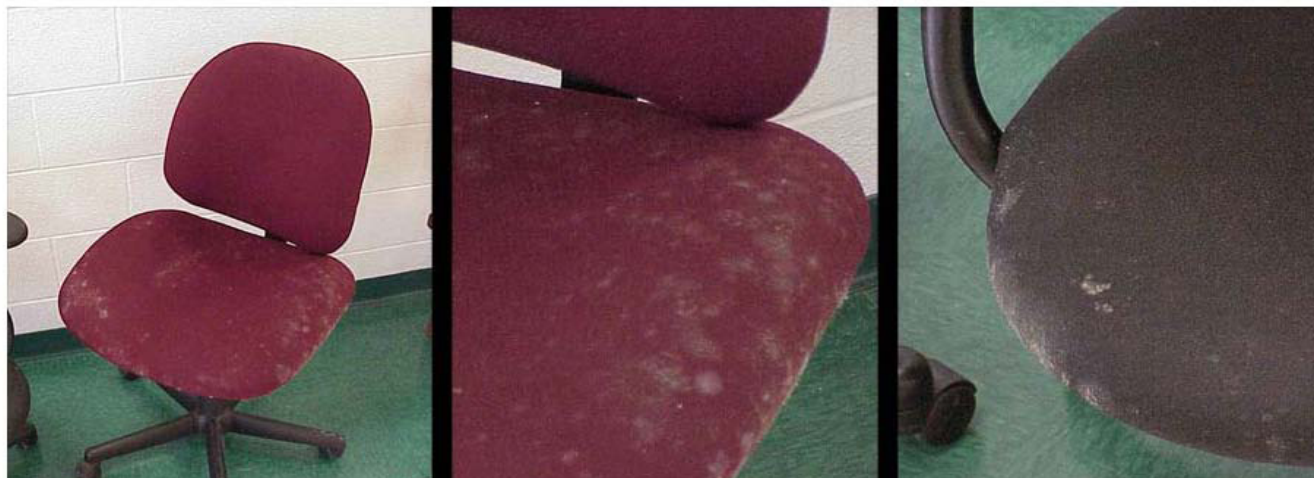
Figure 3. Visible mold on upholstered chairs in the records room (room 109), August 2005 (courtesy of building occupant).

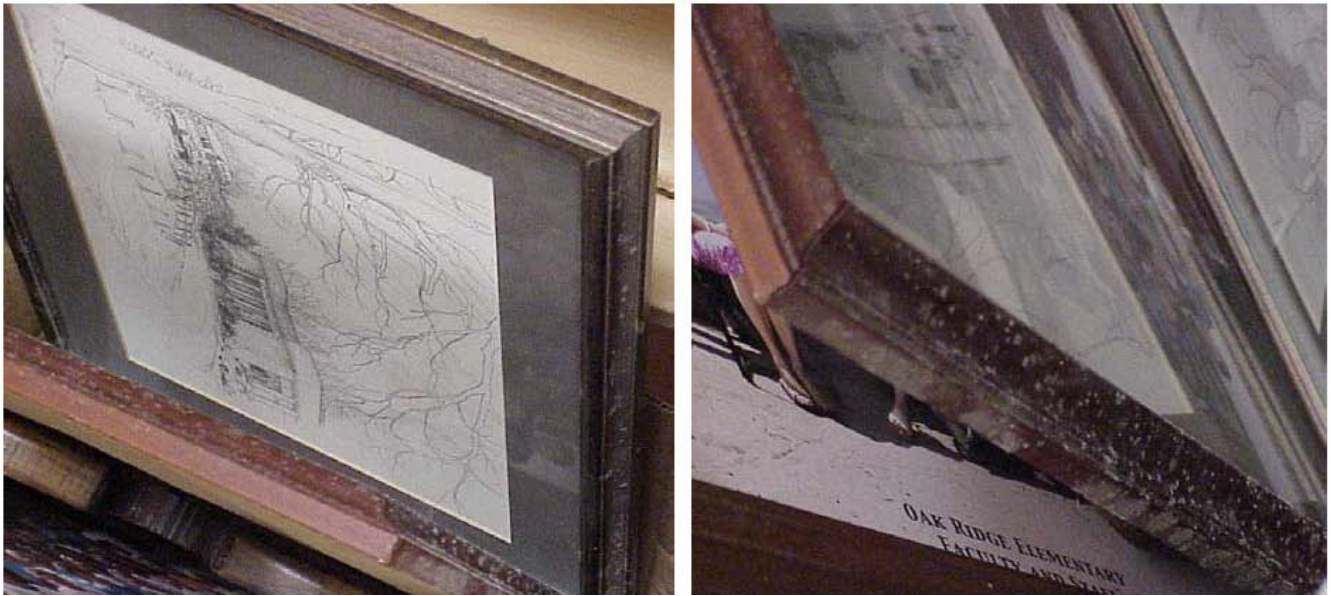
Figure 4. Visible mold on picture frames in the storage room (room 111), August 2005 (courtesy of building occupant).

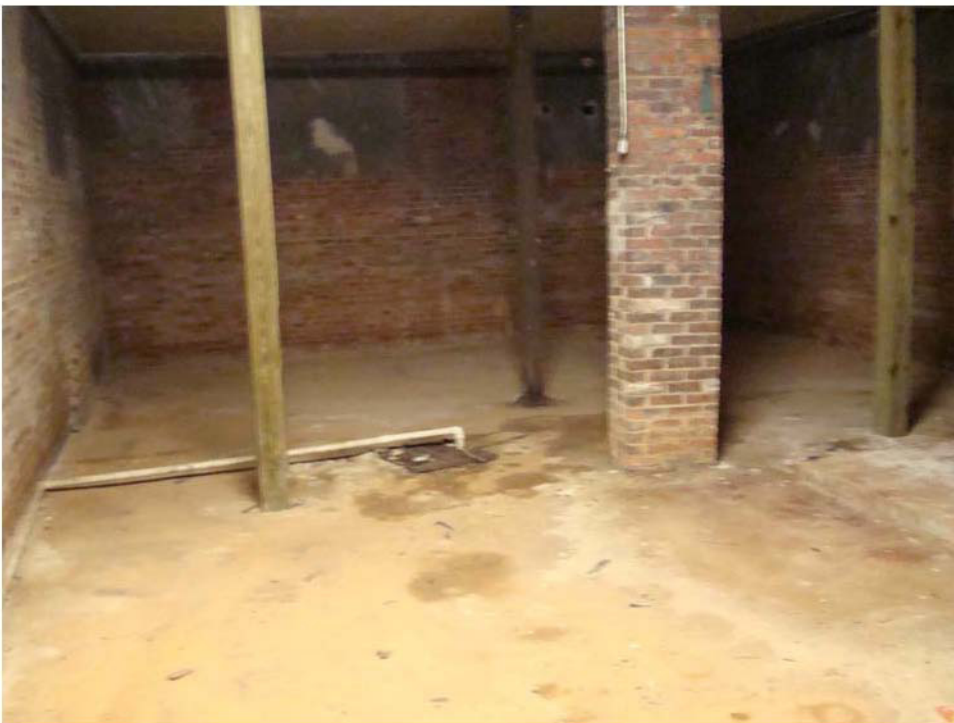
During this visit, we noted a strong musty, moldy odor in the basement (Figure 5) and crawl space under the media center. Lime was observed on the crawl space dirt floor. We also noted a musty smell in the corridor around the media center, particularly near the school museum. Surface water from playgrounds drained towards the classroom wings; it appeared water could puddle near concrete walkways adjacent to classroom wings, especially near the 2/3 and 4/5 wings (Figures 6, 7, and 8). A storm drain outside the media center was blocked, and there was standing water in it (Figure 9). There were multiple locations on the foam roof surface where the roof membrane had been compromised; there were signs of softness and bubbling of the membrane (Figures 10 and 11). There did not

Figure 5. Basement below the media center wing, July 2009.

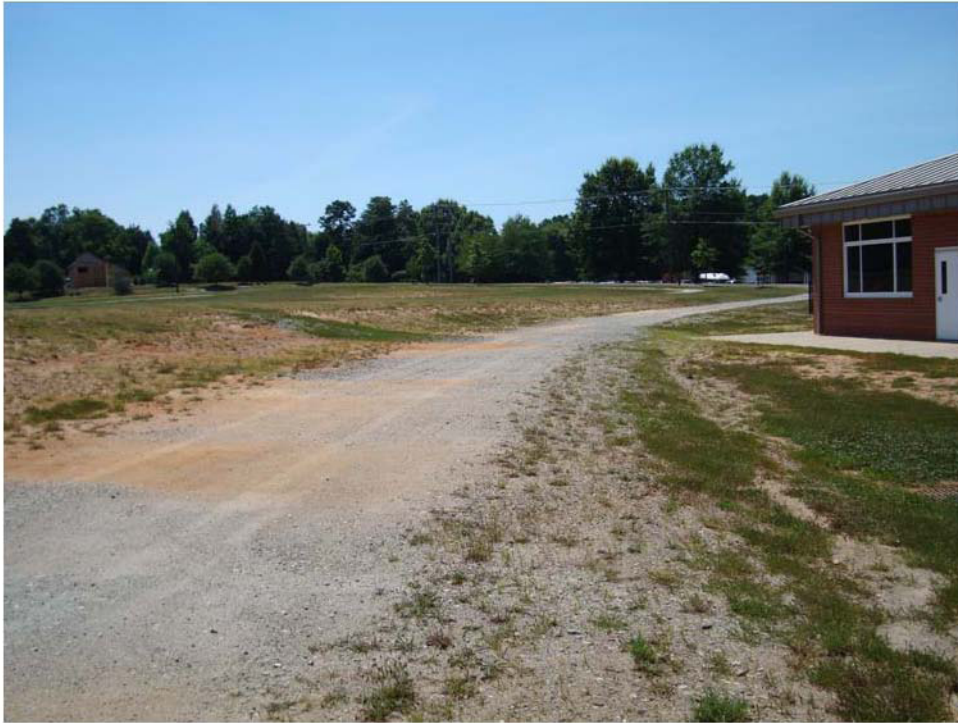
Figure 6. School grounds sloping downward towards classroom wings, July 2009.

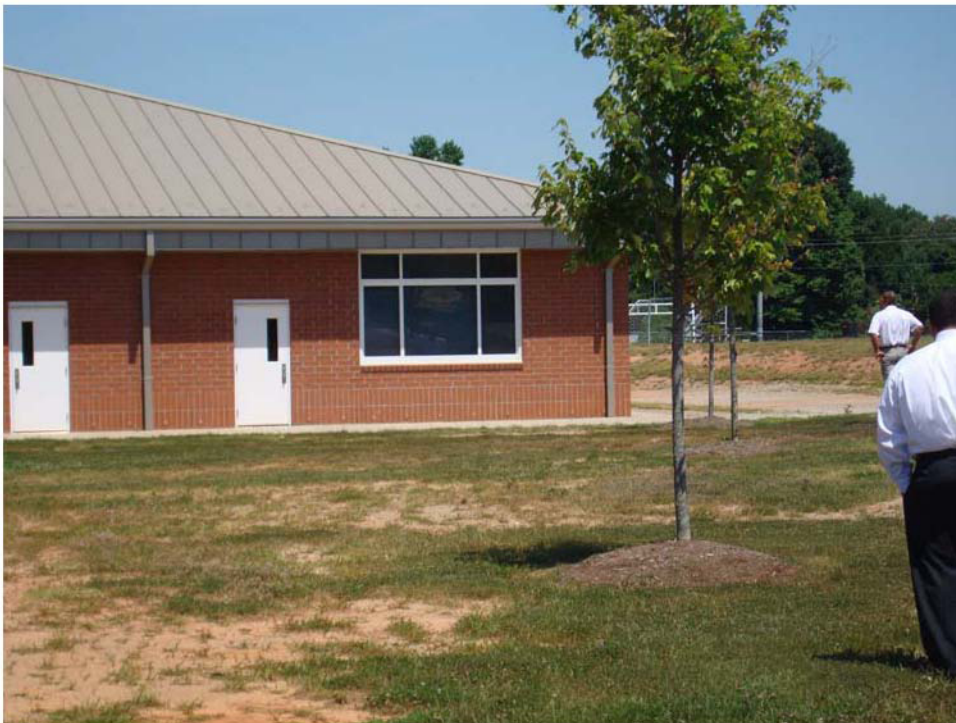
Figure 7. School grounds sloping downward towards classroom wings, July 2009.

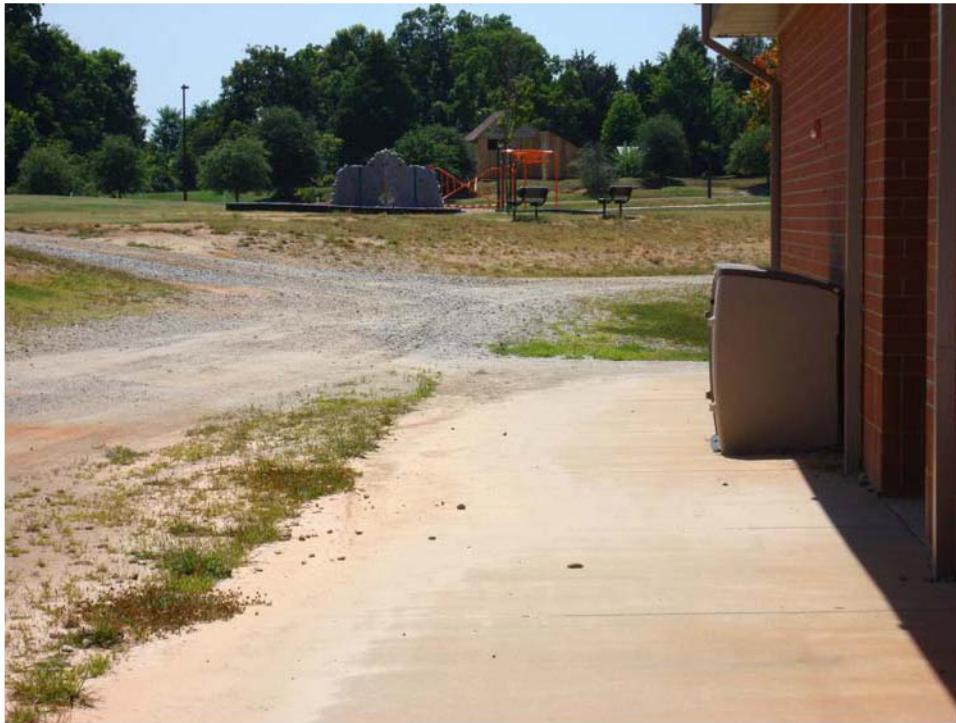
Figure 8. School grounds sloping downward towards classroom wings, July 2009.

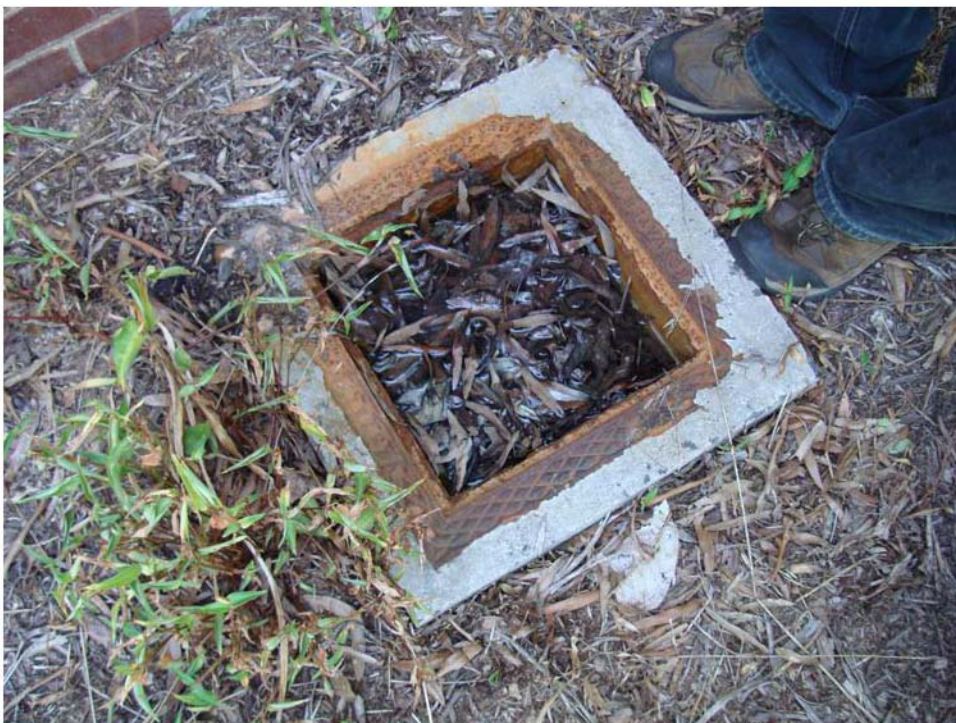
Figure 9. Blocked storm drain outside of the media center, July 2009.

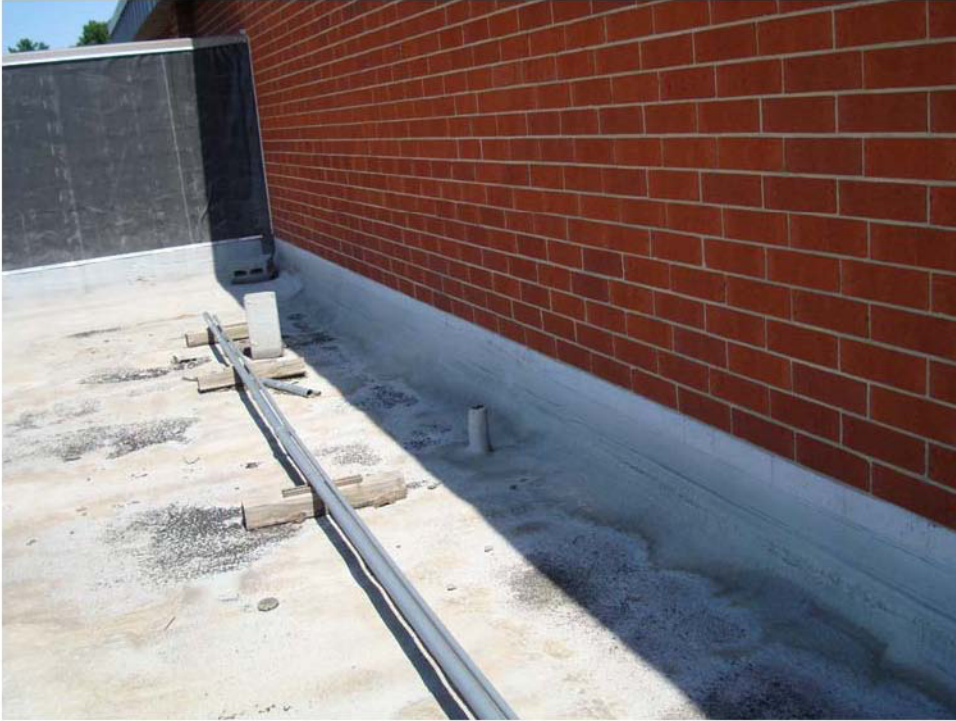
Figure 10. Foam roof adjacent to gym, July 2009.

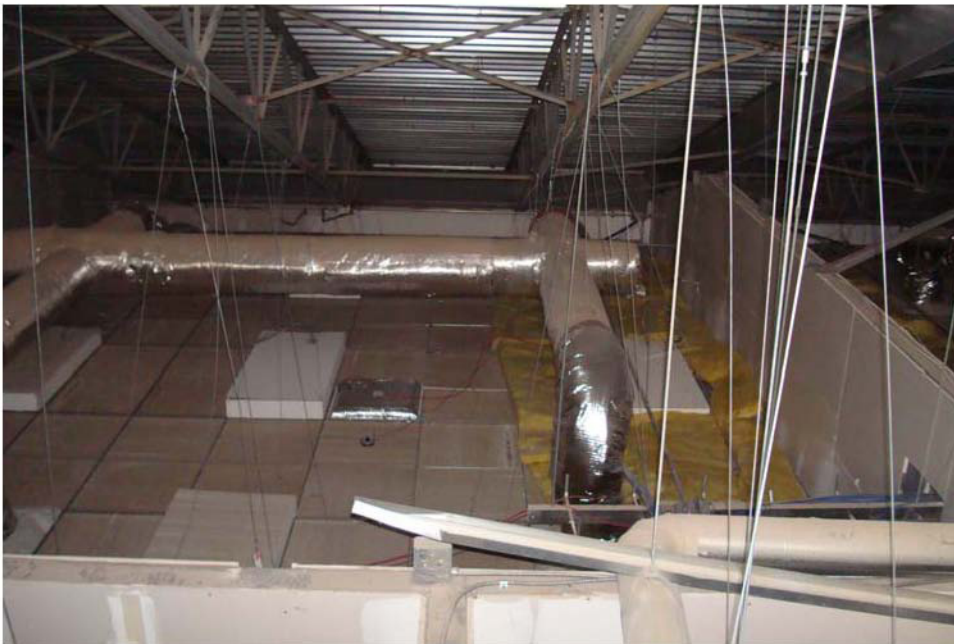
Figure 13. Plenum above classroom ceiling, showing ductwork and dust, July 2009.

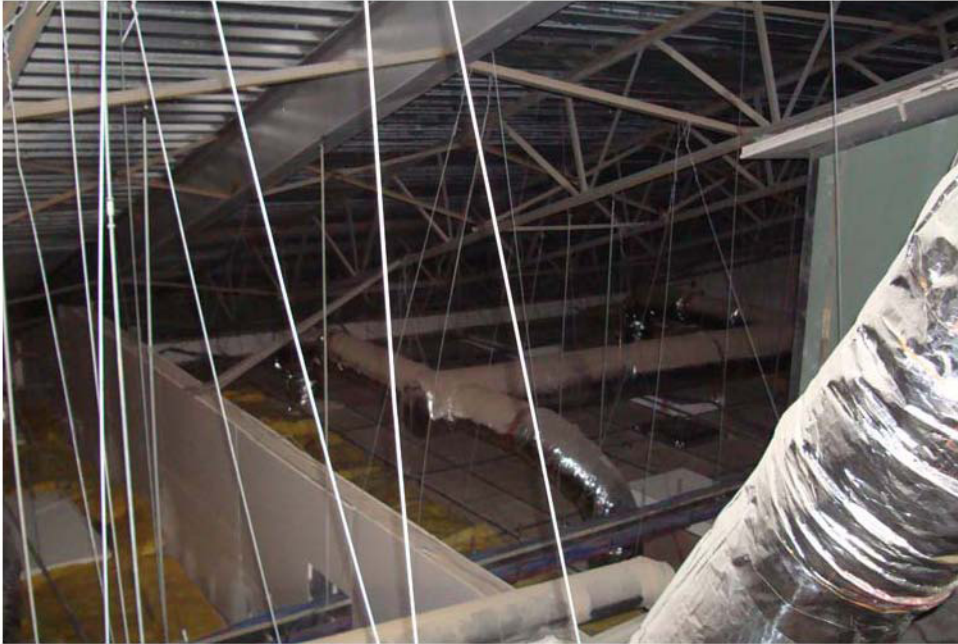
Figure 14. Plenum above classroom ceiling, showing ductwork and dust, July 2009.

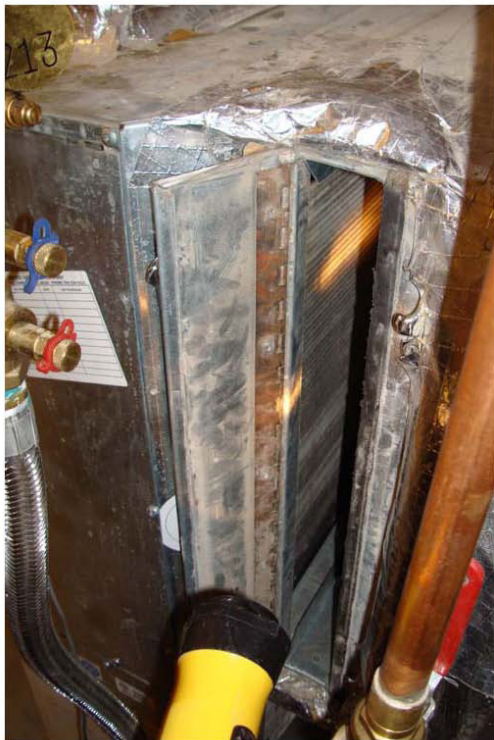
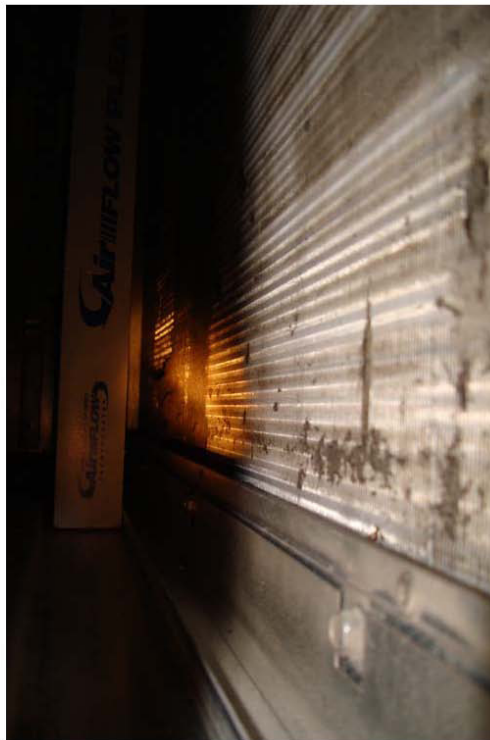
appear to be adequate flashing at the junction of the parapet wall (above room 206) and the gym (Figure 12). Room 206 had stained carpet, wavy baseboards, and walls which appeared to have been newly painted. Inside the school, we noted excessive moisture (with an infrared camera) in the gym's exterior concrete block wall where a leak had been repaired. We also noted that multiple classrooms were under negative pressure instead of positive pressure relative to the corridor. Multiple restrooms were also under positive pressure instead of negative pressure. During the day, the plenum above the classroom ceilings was generally under positive pressure in relation to the exterior of the building. However at night, when the dehumidifier (which served the classroom wings) was turned off, this sometimes resulted in the plenum being under negative pressure in relation to the outside of the building. This allowed outside humid air to enter the plenum through the soffits in the classroom wings. From the mezzanine area, where the dehumidifier was located, we observed dust on classroom ceilings and ducts (Figures 13 and 14). Some of the coils for the HVAC air handlers had residue that may have been mold contamination (Figure 15).

Figure 15. Coils in HVAC air handlers, showing dust and possible mold contamination, July 2009.

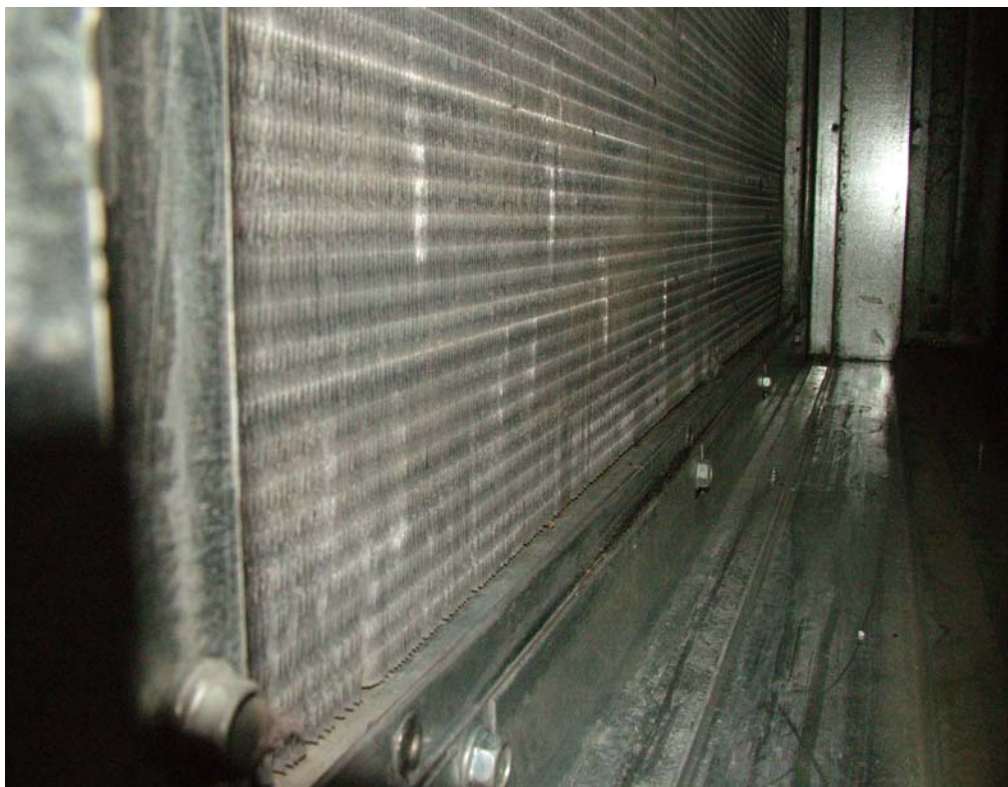
Clean Coil

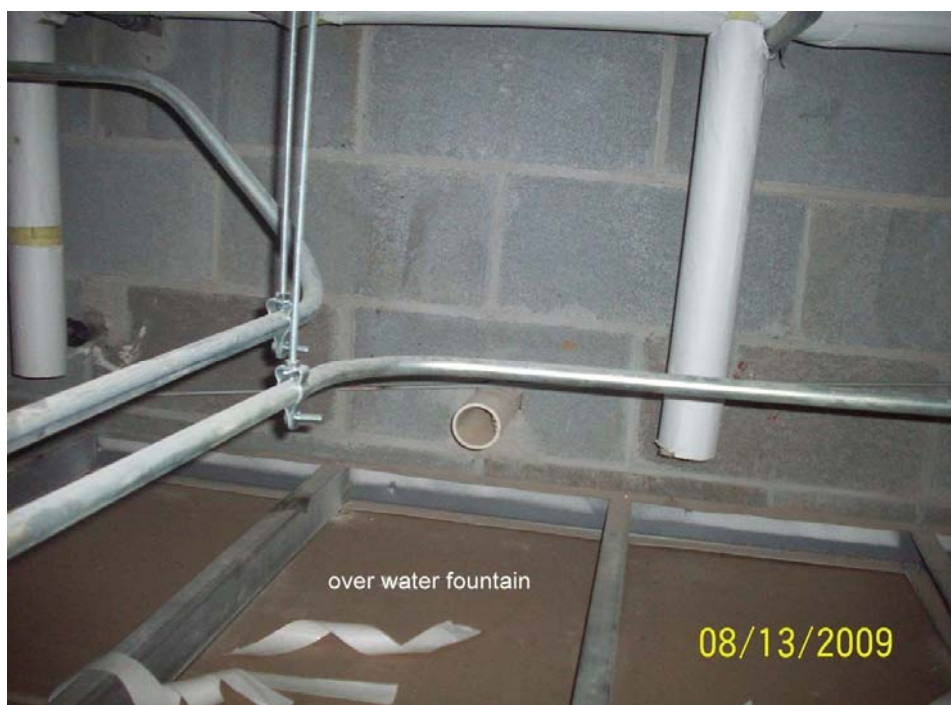
Open Plumbing Vent Lines

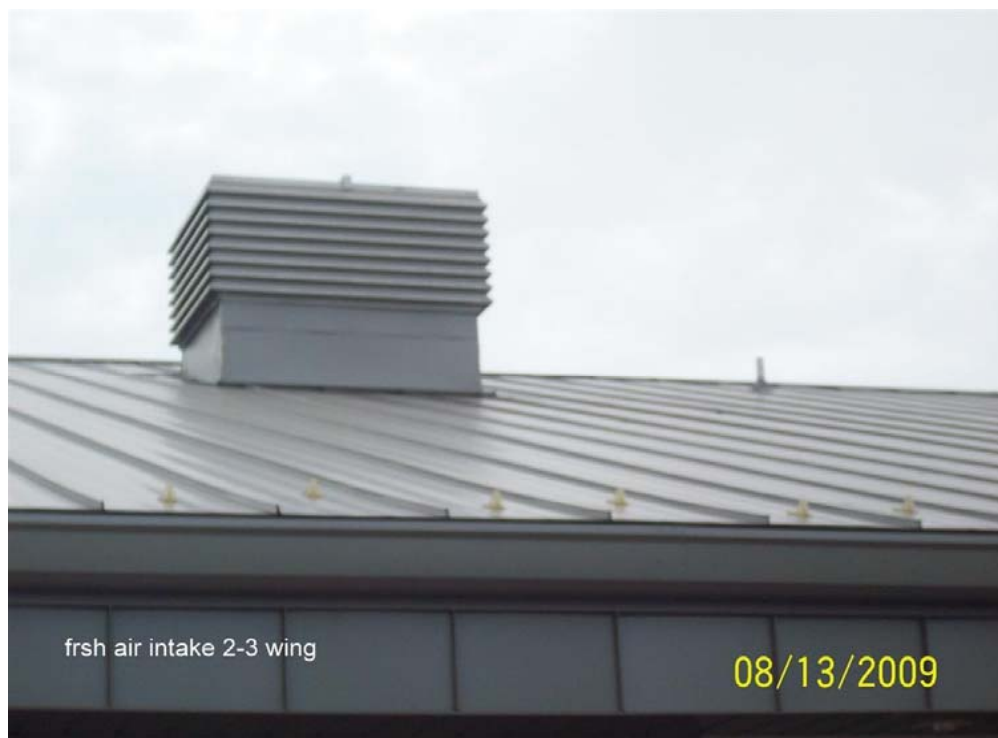
Vent Through Roof And OA Inlet

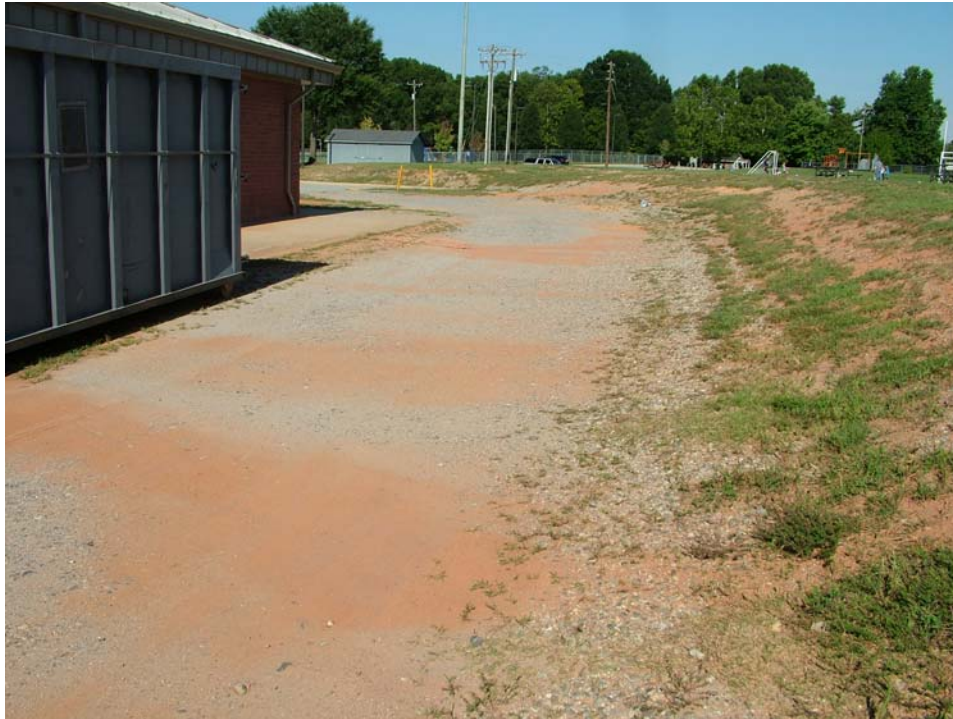
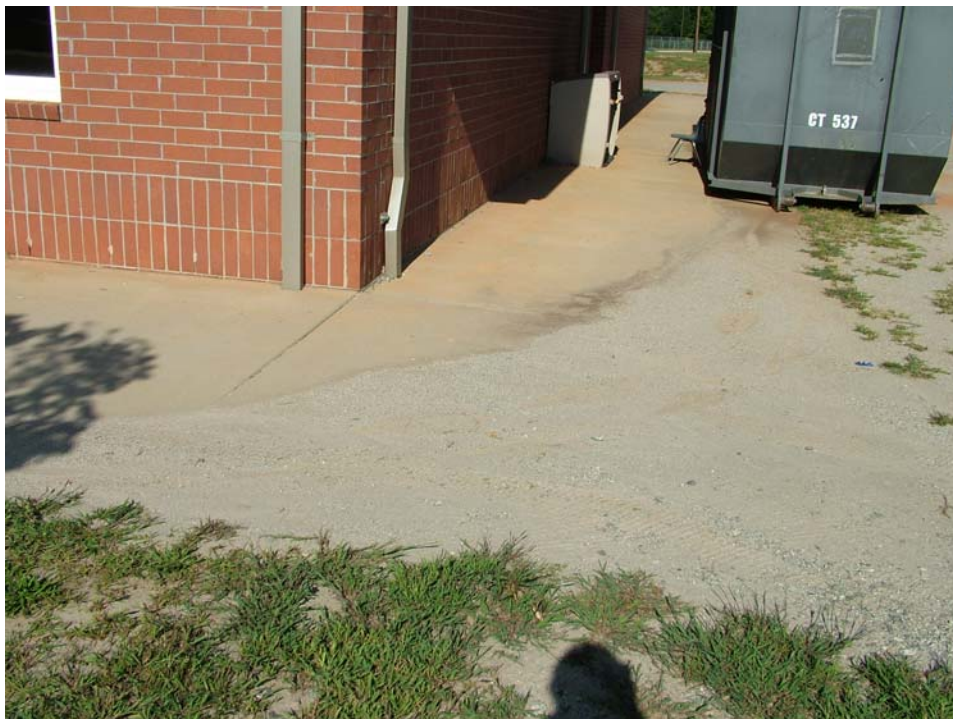
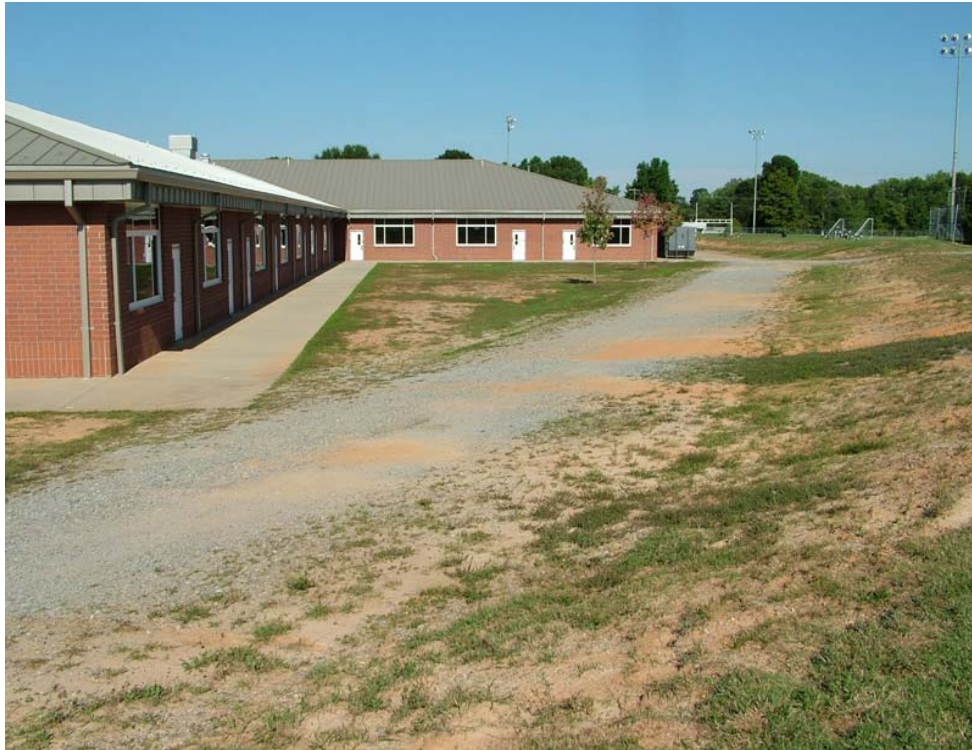
Visual signs of Site runoff

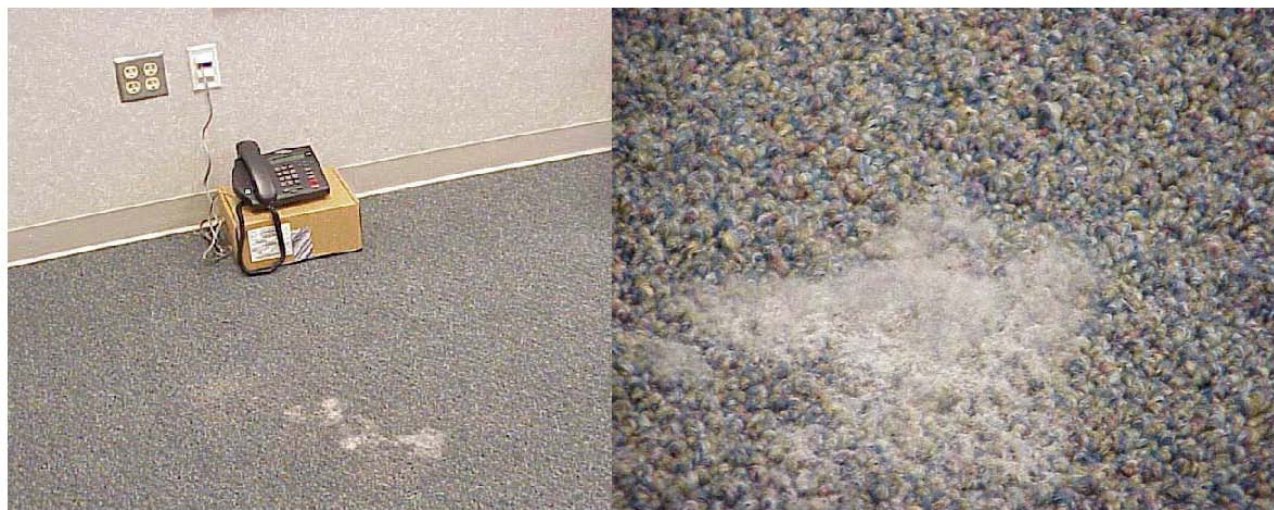
In August 2005, visible mold was also found on carpet in classrooms 427 and 625 (Figure 2), upholstered chairs in the records room (room 109) (Figure 3), and on picture frames in the storage room (room 111) (Figure 4). Later, after the school year began, mold started to grow back on some of the books in the temporary media center in classroom 500. Many books were thrown out while others were again cleaned. By the end of August 2005, visible mold had been identified in the k/1 wing (classroom 613, 625), 2/3 wing (classroom 427), 4/5 wing (classroom 500), and the administrative wing (rooms 109 and 111).

Figure 2. Visible mold on carpet in classroom 625, August 10, 2005 (courtesy of building occupant)

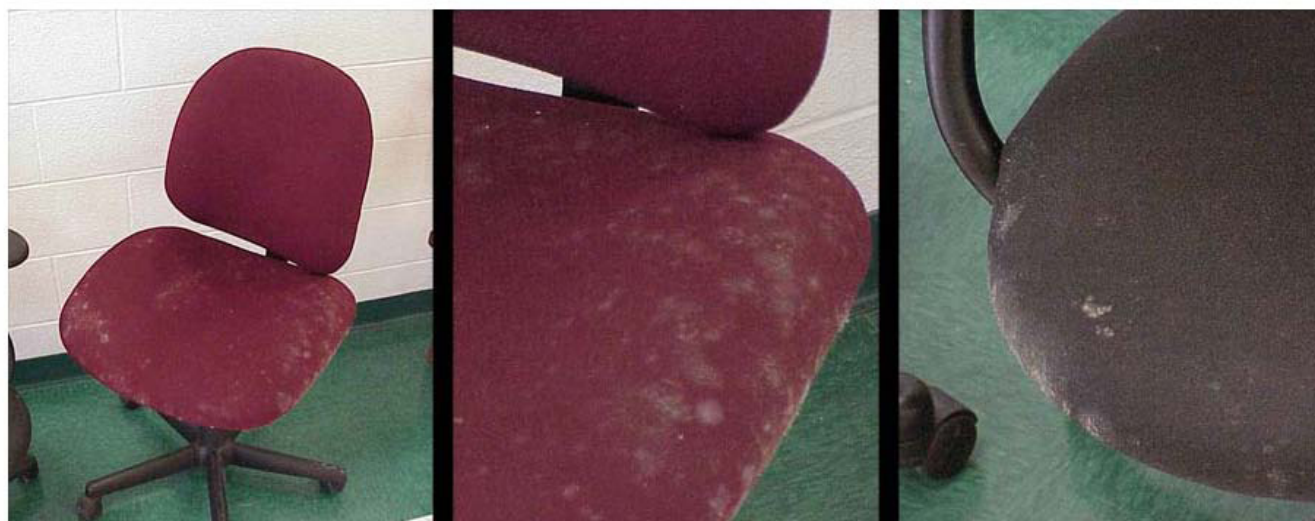
Figure 3. Visible mold on upholstered chairs in the records room (room 109), August 10, 2005 (courtesy of building occupant)

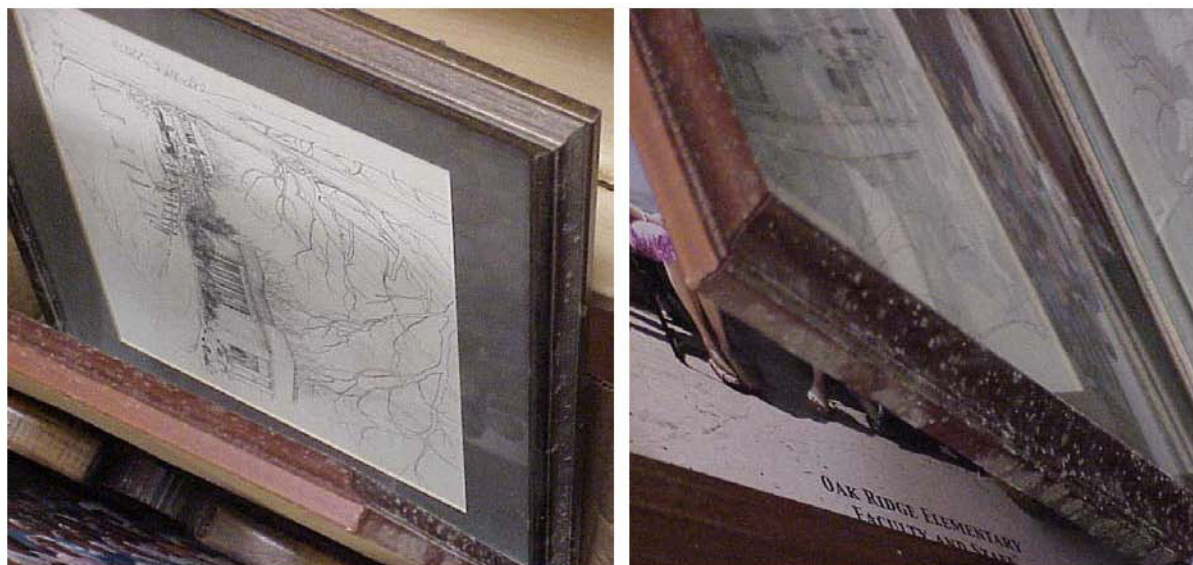
Figure 4. Visible mold on picture frames in the storage room (room 111), August 10, 2005 (courtesy of building occupant)

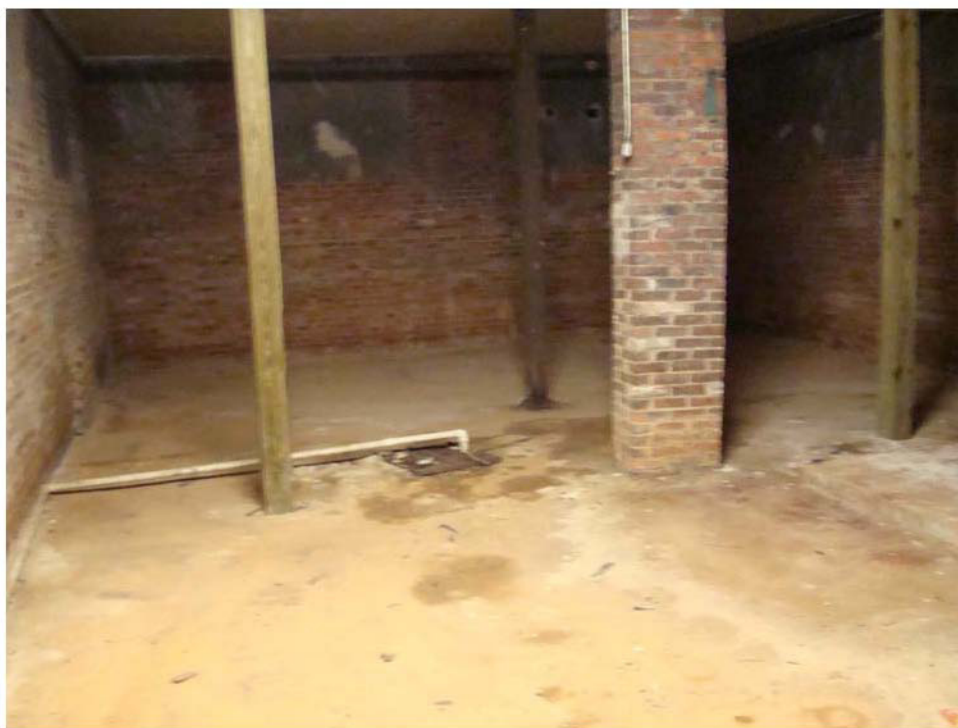
We noted a strong musty, moldy odor in the basement (Figure 5) and crawl space under the media center. Lime was observed on the crawl space dirt floor. We also noted a musty smell in the corridor around the media center, in particular near the school museum. Surface drainage from playgrounds drained towards the classroom wings;

Figure 5. Basement below the media center wing, July 14, 2009

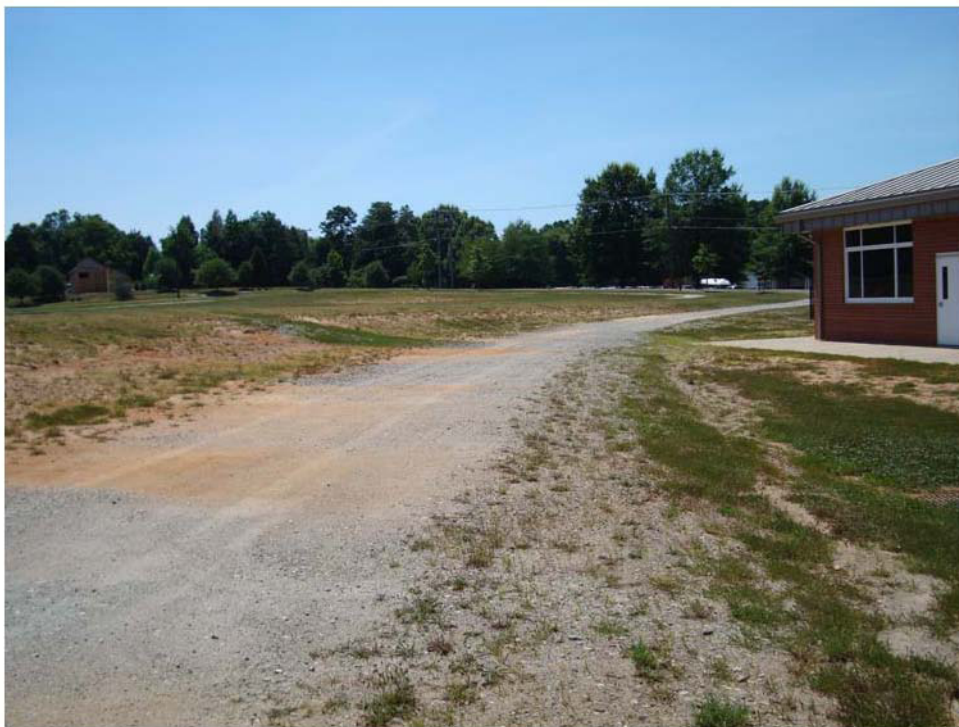
it appeared water could puddle near concrete walkways adjacent to classroom wings especially near the 2/3 and 4/5 wings (Figures 6, 7, and 8). A storm drain outside the media center was blocked with standing water in it (Figure 9). **The foam roof had multiple locations where the surface had been compromised; there were signs of softness and bubbling of the roof membrane** (Figures 10 and 11). There did not appear to be adequate flashing at the junction between the parapet wall (above room 206) and the gym (Figure 12). Room 206 had stained carpet, wavy appearing baseboards, and walls which appeared newly painted. Inside the school, we noted moisture (with the infrared camera) in the gym's exterior concrete block wall in an area where a leak had been repaired. We also noted pressure airflow issues between rooms and spaces. Multiple classrooms were under negative pressure instead of positive pressure in regard to the corridor. Multiple restrooms had positive pressure instead of negative pressure. During the day, the plenum above the classroom ceilings was generally under positive pressure in regard to the exterior of the building. However at night when the dehumidifier (which served the classroom wings) was turned off, this sometimes resulted in the plenum being under negative pressure in regard to the outside of the building. This allowed outside humid air to enter the plenum through the soffits in the classroom wings. From the mezzanine area where the dehumidifier was located, we observed dust on classroom ceilings and ducts (Figures 13 and 14). Some of the coils for the HVAC air handlers had residue that may have been mold contamination (Figure 15).

Figure 6. Downward sloping ground towards classroom wings, July 14, 2009

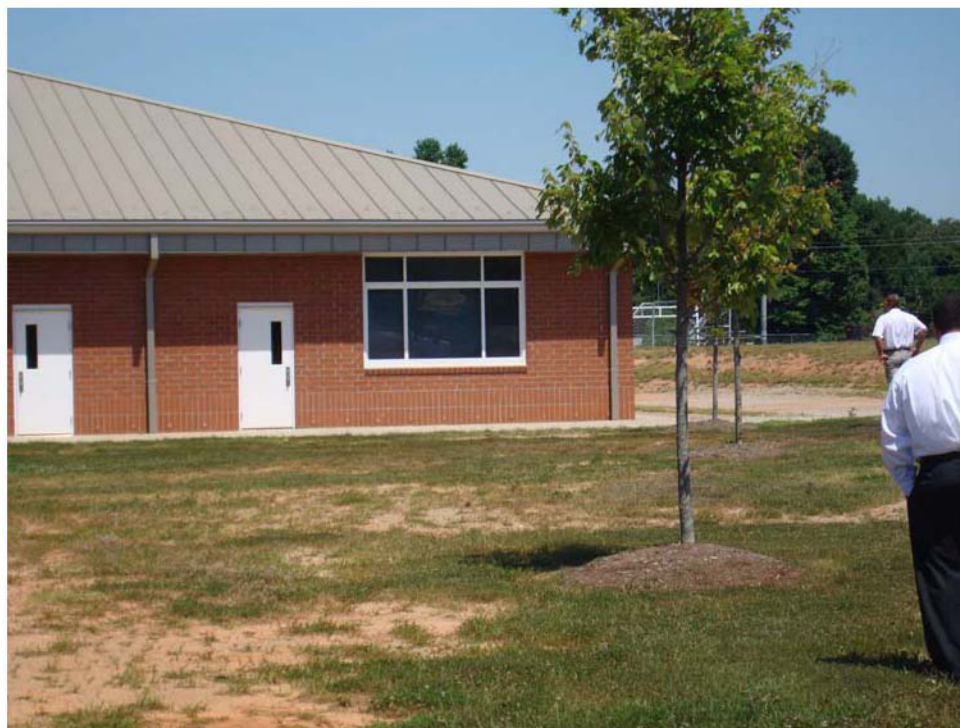
Figure 7. Downward sloping ground towards classroom wings, July 14, 2009

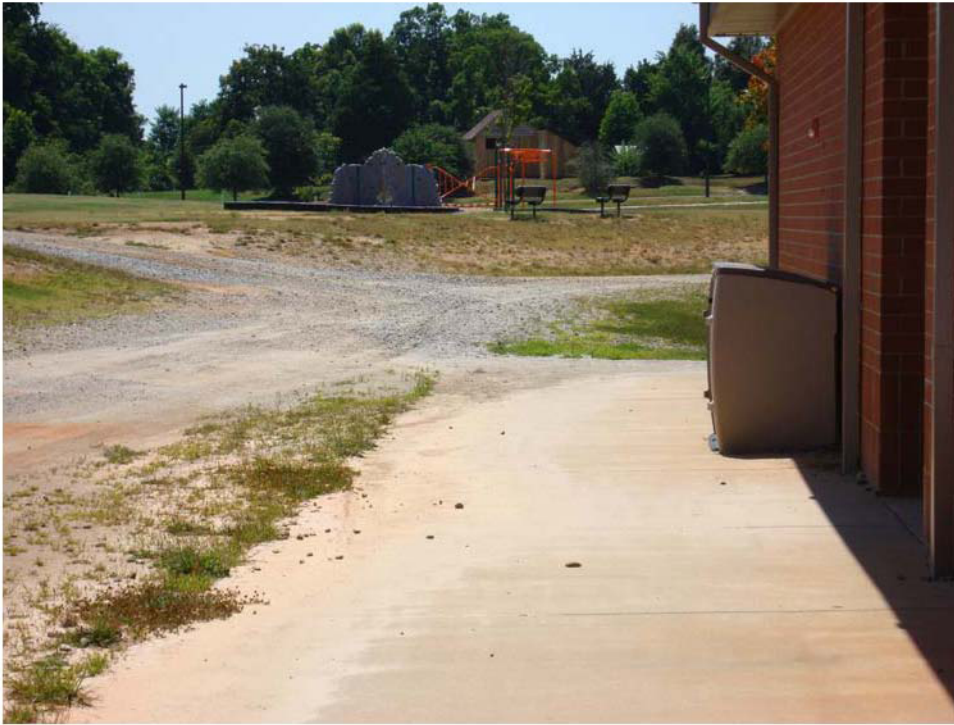
Figure 8. Downward sloping ground towards classroom wings, July 14, 2009

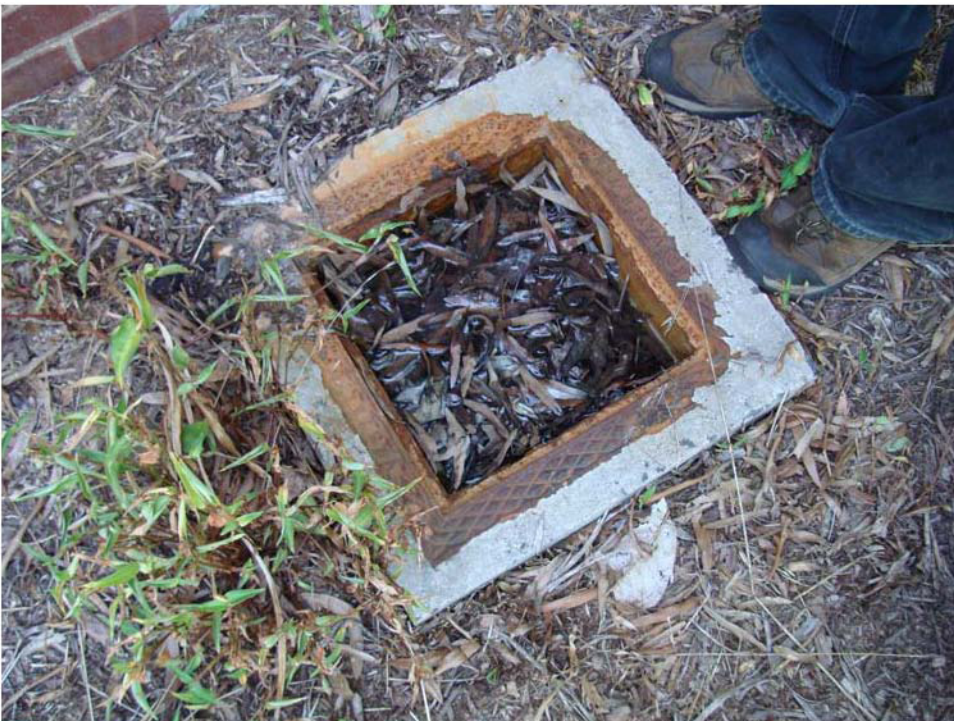
Figure 9. Blocked storm drain outside of the media center, July 14, 2009

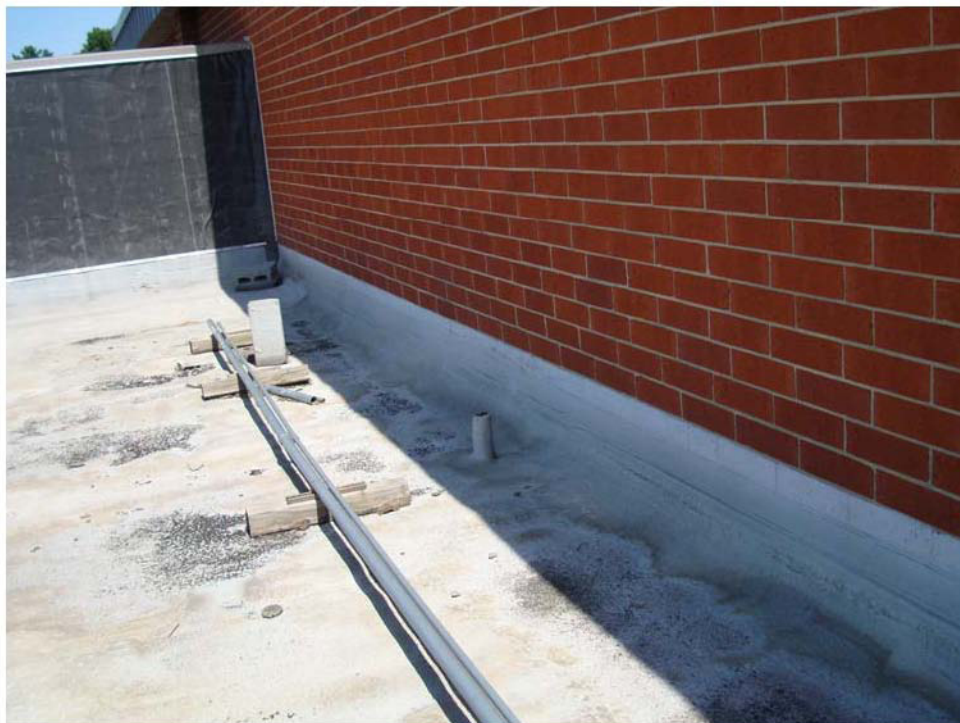
Figure 10. Foam roof adjacent to gym, July 14, 2009

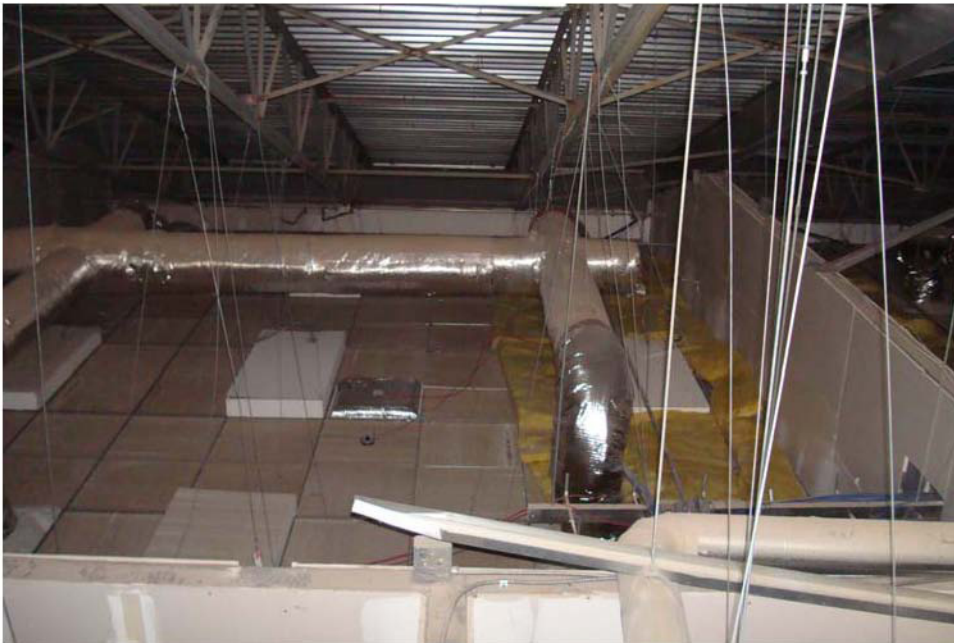
Figure 13. Dust on classroom ceilings and ducts in plenum, July 16, 2009

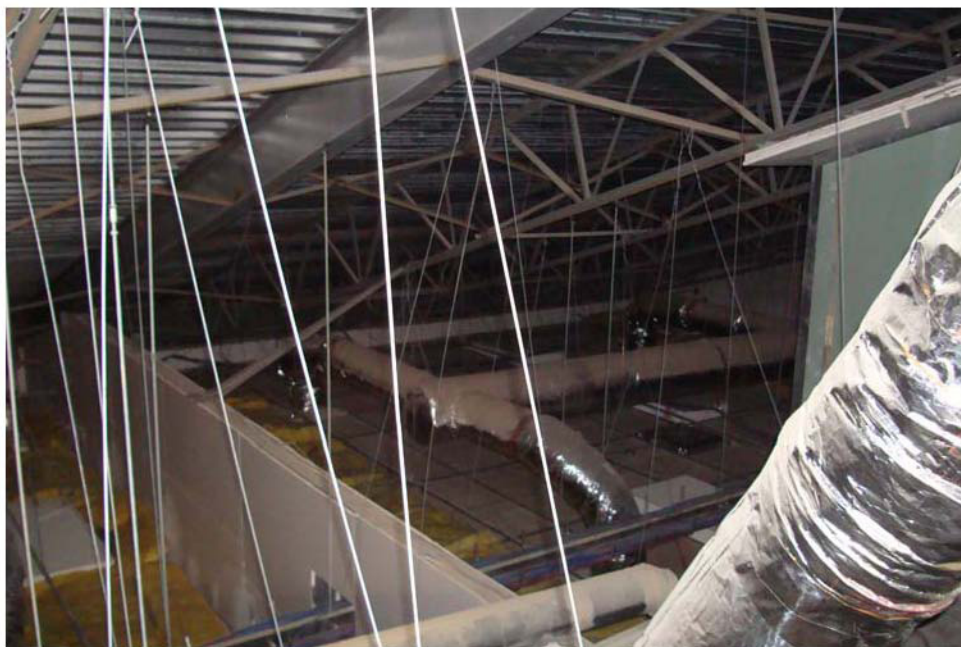
Figure 14. Dust on classroom ceilings and ducts in plenum, July 16, 2009
