Evaluation of dampness-associated respiratory symptoms with relocation of staff during remediation of an elementary school

*Rachel Bailey, DO, MPH
Ju-Hyeong Park, ScD, MPH, CIH
Rena Saito, PhD
Kathleen Kreiss, MD
Jean Cox-Ganser, PhD*

Health Hazard Evaluation Report
HETA 2009-0172-3124
North Carolina
March 2011

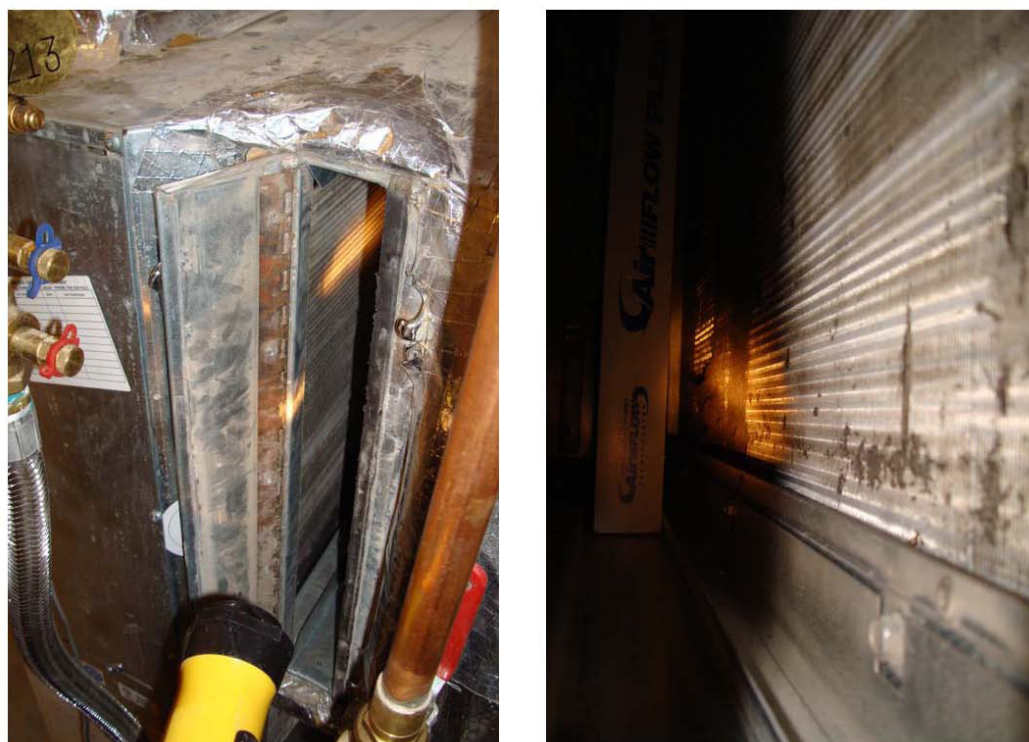
Figure 15. Coils in HVAC air handlers, showing dust and possible mold contamination, July 2009.

it appeared water could puddle near concrete walkways adjacent to classroom wings especially near the 2/3 and 4/5 wings (Figures 6, 7, and 8). A storm drain outside the media center was blocked with standing water in it (Figure 9). **The foam roof had multiple locations where the surface had been compromised; there were signs of softness and bubbling of the roof membrane** (Figures 10 and 11). There did not appear to be adequate flashing at the junction between the parapet wall (above room 206) and the gym (Figure 12). Room 206 had stained carpet, wavy appearing baseboards, and walls which appeared newly painted. Inside the school, we noted moisture (with the infrared camera) in the gym's exterior concrete block wall in an area where a leak had been repaired. We also noted pressure airflow issues between rooms and spaces. Multiple classrooms were under negative pressure instead of positive pressure in regard to the corridor. Multiple restrooms had positive pressure instead of negative pressure. During the day, the plenum above the classroom ceilings was generally under positive pressure in regard to the exterior of the building. However at night when the dehumidifier (which served the classroom wings) was turned off, this sometimes resulted in the plenum being under negative pressure in regard to the outside of the building. This allowed outside humid air to enter the plenum through the soffits in the classroom wings. From the mezzanine area where the dehumidifier was located, we observed dust on classroom ceilings and ducts (Figures 13 and 14). Some of the coils for the HVAC air handlers had residue that may have been mold contamination (Figure 15).

Figure 15. Coils for HVAC handlers showing dust and possible mold contamination , July 16, 2009

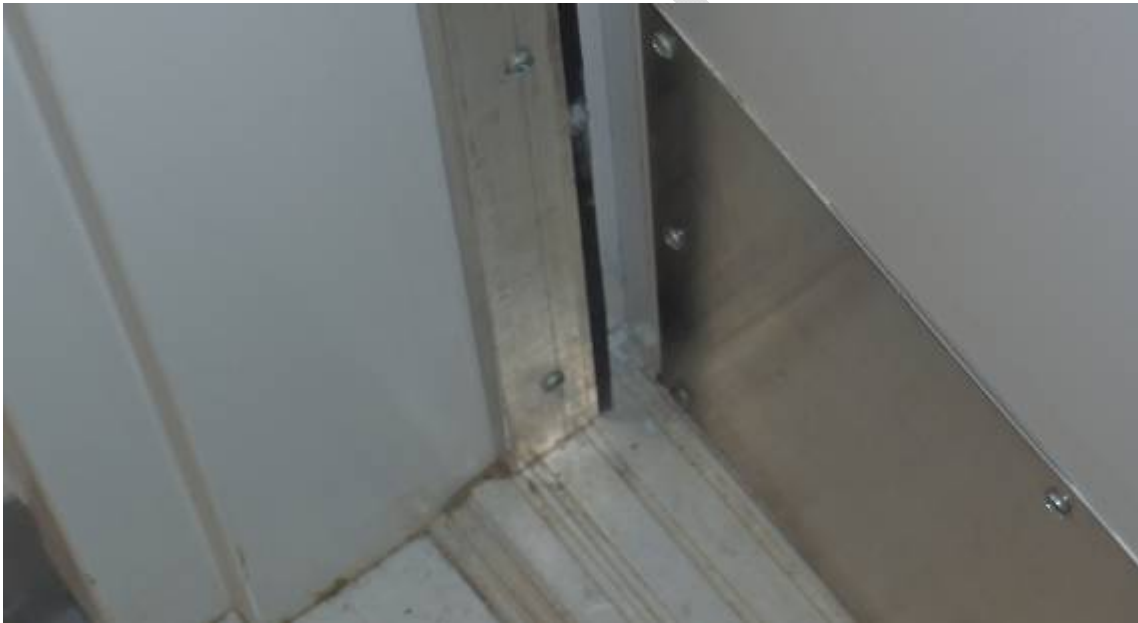
- Figure 7 shows the outside door to classroom 521, and the door frame which has been badly damaged. The resulting misalignment of the door now requires deliberate action to pull the door shut to the point of latching. Figure 8 shows the door sweep and the spot the door is dragging on as a result of the door misalignment. There is a large open area when the door is not pulled shut shown in figure 9, which not only allows conditioned air to escape the room, but also has the potential to allow unauthorized access to the school if the door is not latched.

Figure 8 – Outside door of classroom 521 dragging on threshold

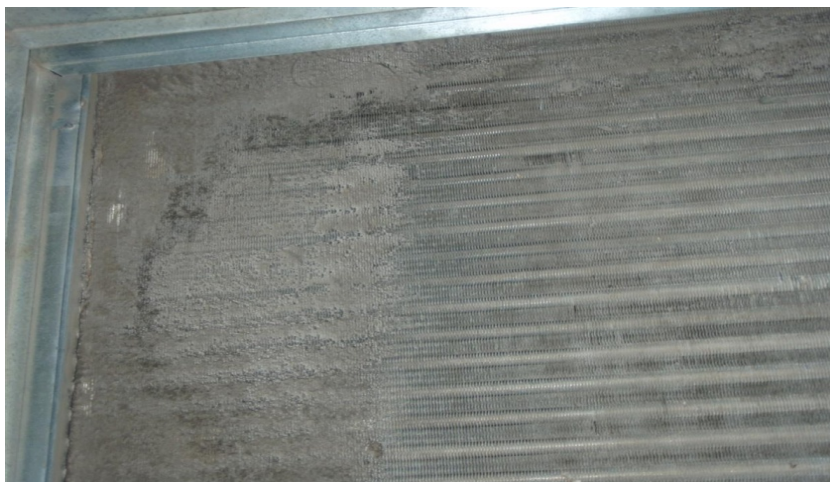
#5

DIRTY COILS

CLEANED COILS

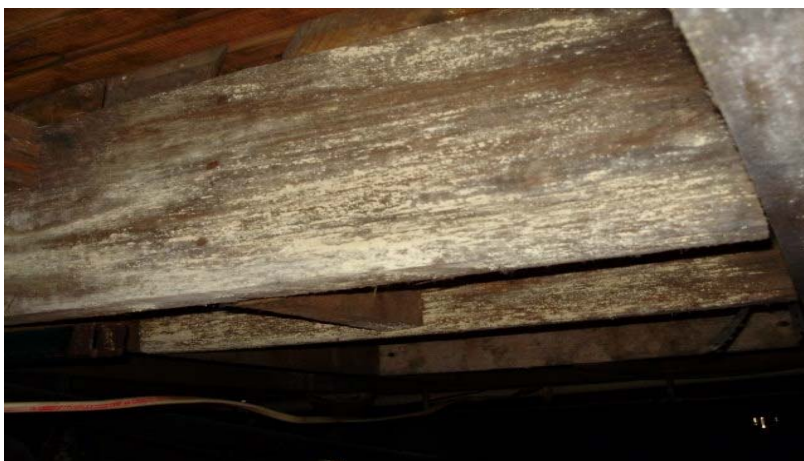
#8

MOLDED FLOOR SYSTEM

**CLEANED FLOOR SYSTEM AND
INSTALLED VAPOR BARRIER**

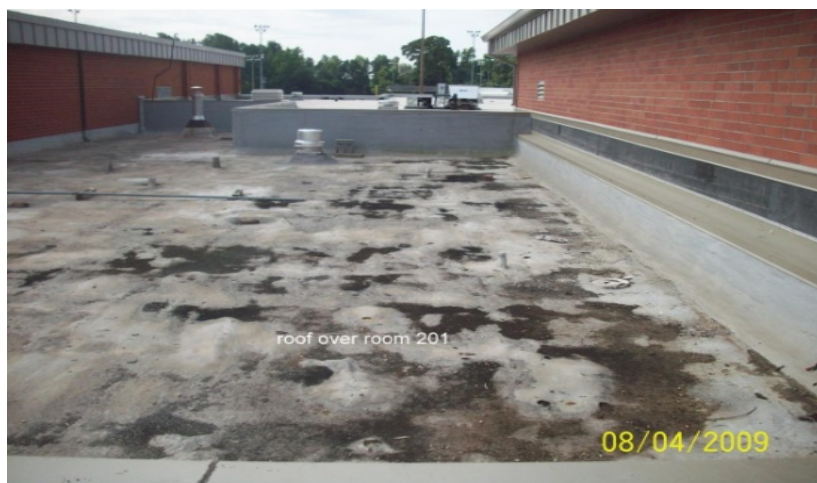
#9

OLD ROOF STRUCTURE

NEW ROOF STRUCTURE
